CHIQUITA CANYON
A Waste Connections Company

Re: Chiquita Canyon, LLC's Weekly Report on the Documentation and Tracking of Cover Issues and Monthly Summary

4050 - Chiquita Reaction Area Tracking of Fissures and Tension Cracks

JULY 2025 FISSURE AND TENSION CRACK MONITORING SUMMARY

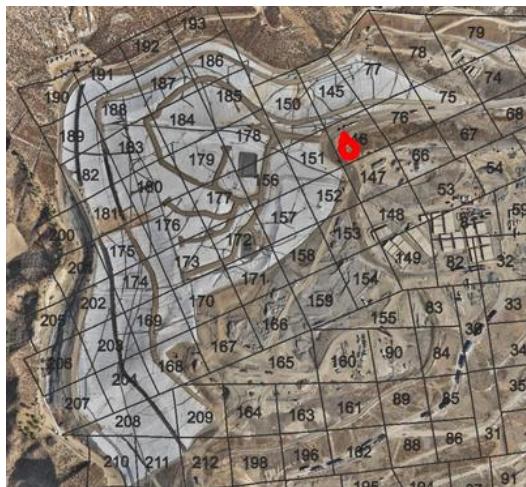
146

Using the attached image, annotate all areas where inspectors identified a fissure or tension crack.

Cracks were track walked.

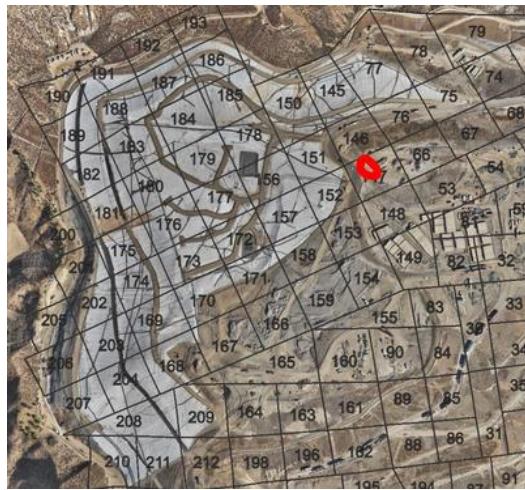
147

Using the attached image, annotate all areas where inspectors identified a fissure or tension crack.

Cracks were track walked.

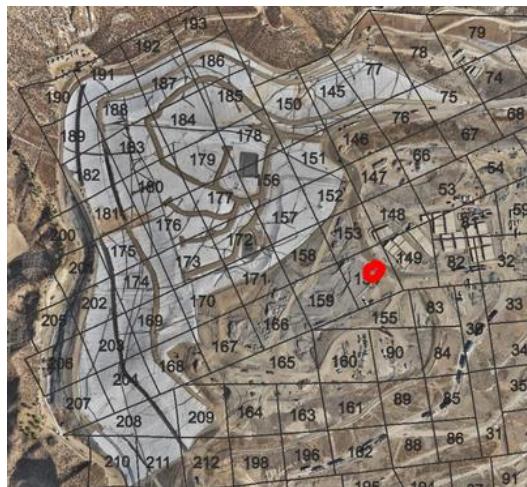
154

Using the attached image, annotate all areas where inspectors identified a fissure or tension crack.

Cracks were filled with dirt and compacted.

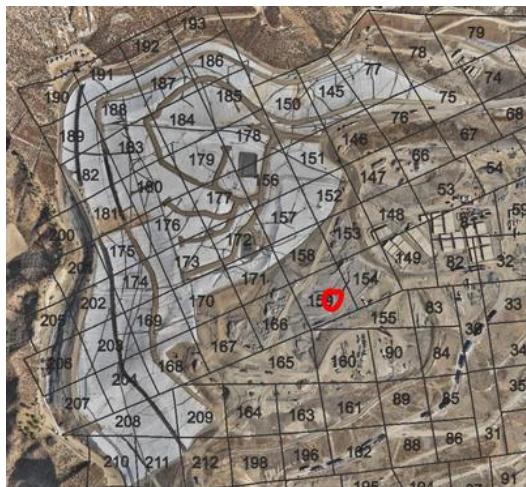
159

Using the attached image, annotate all areas where inspectors identified a fissure or tension crack.

Cracks were track walked.

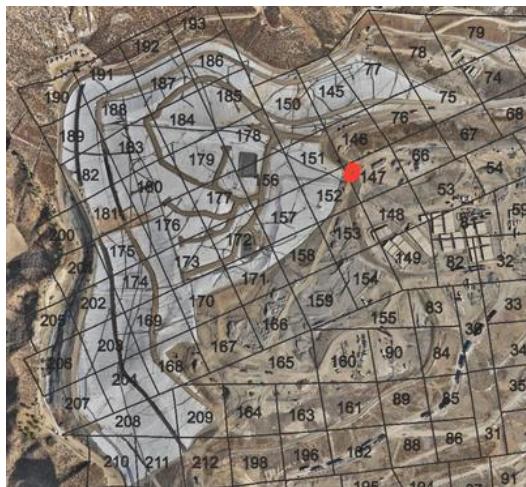
147

Using the attached image, annotate all areas where inspectors identified a fissure or tension crack.

Cracks were track walked.

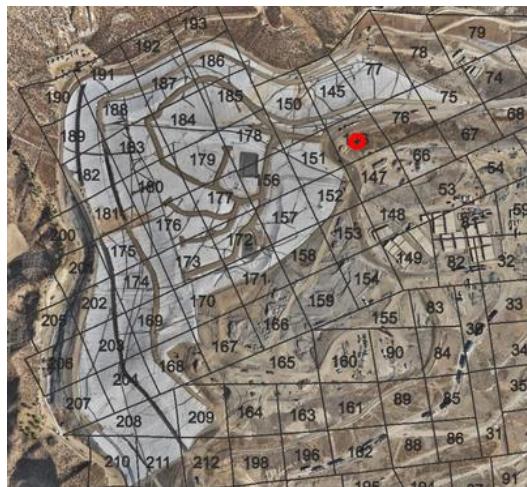
146

Using the attached image, annotate all areas where inspectors identified a fissure or tension crack.

Date and time of repairs	8 Aug 2025 11:32 AM PDT
Description of repairs	Cracks were track walked.
Dirt added	
Instability	
Are there any indications of slope stability concerns?	No

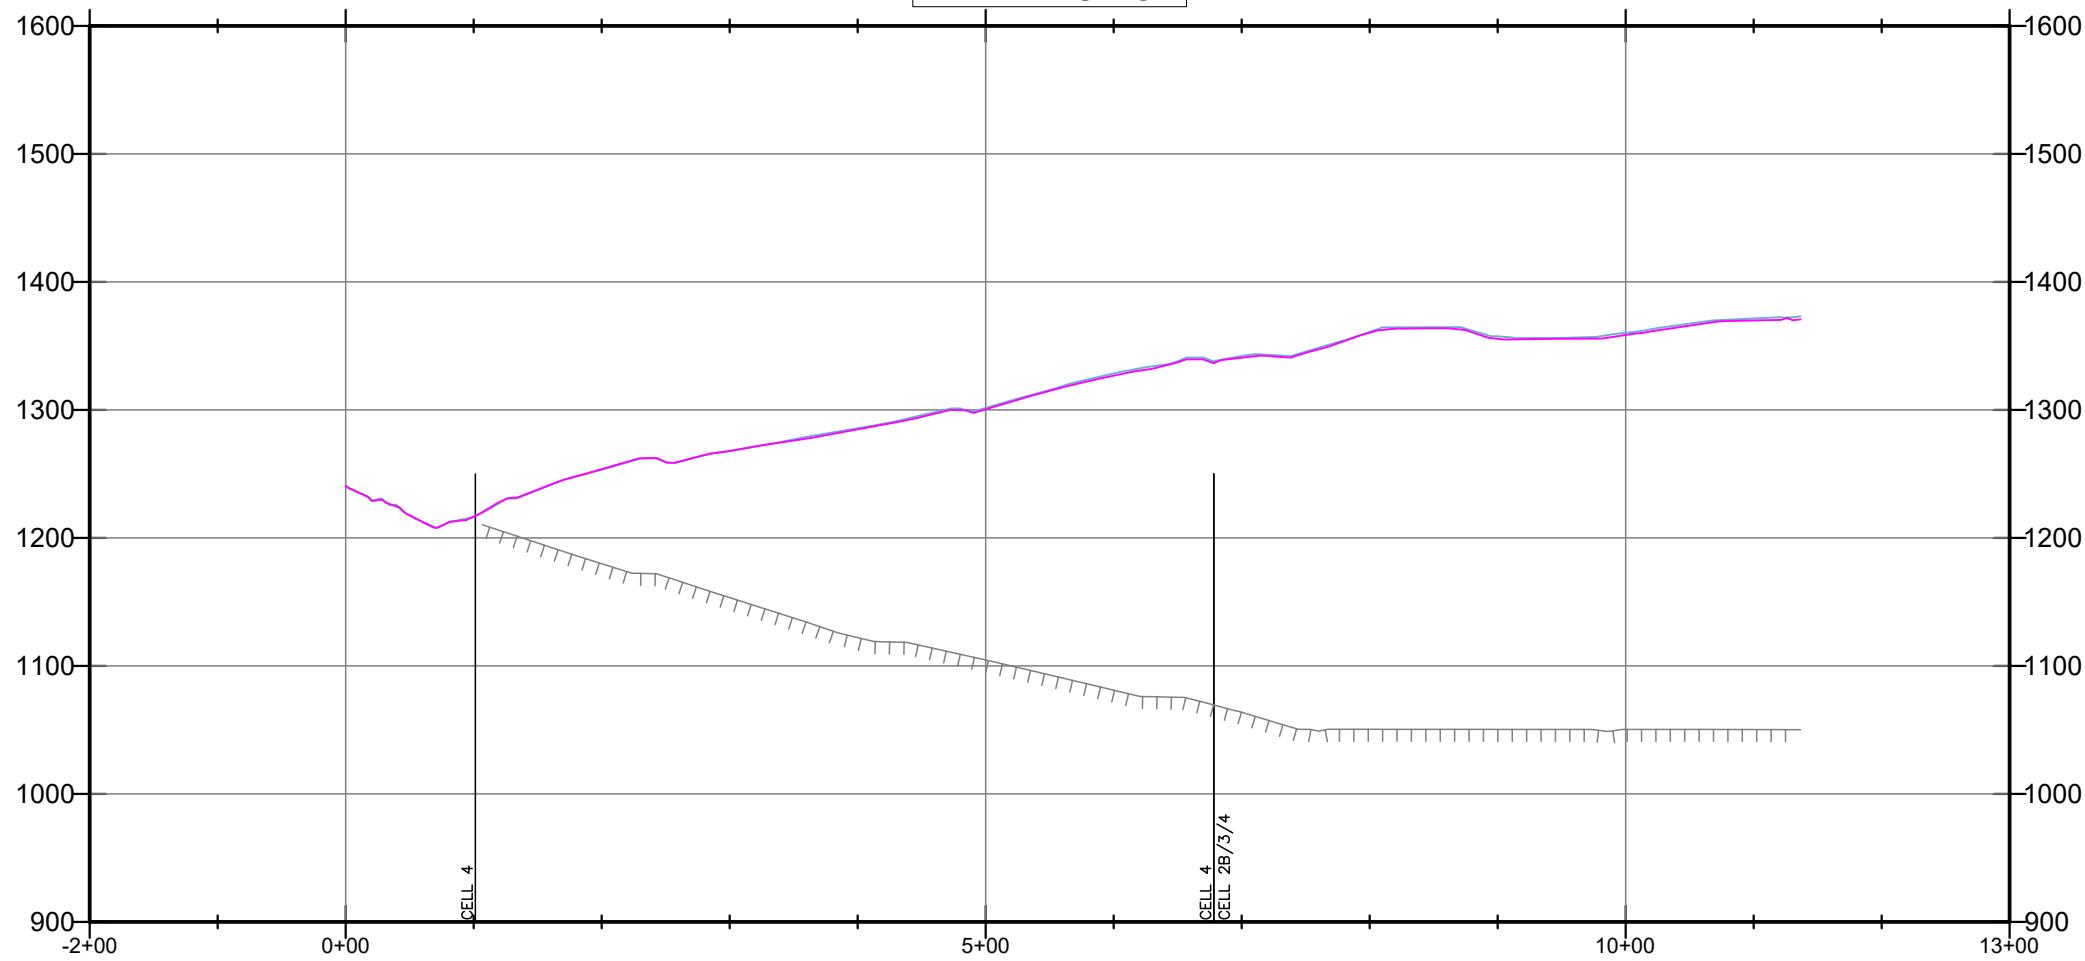
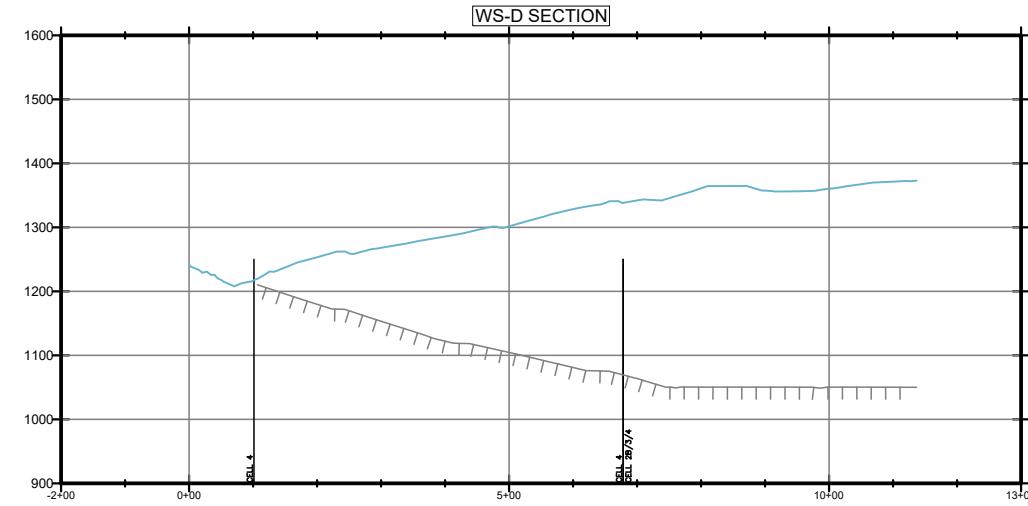
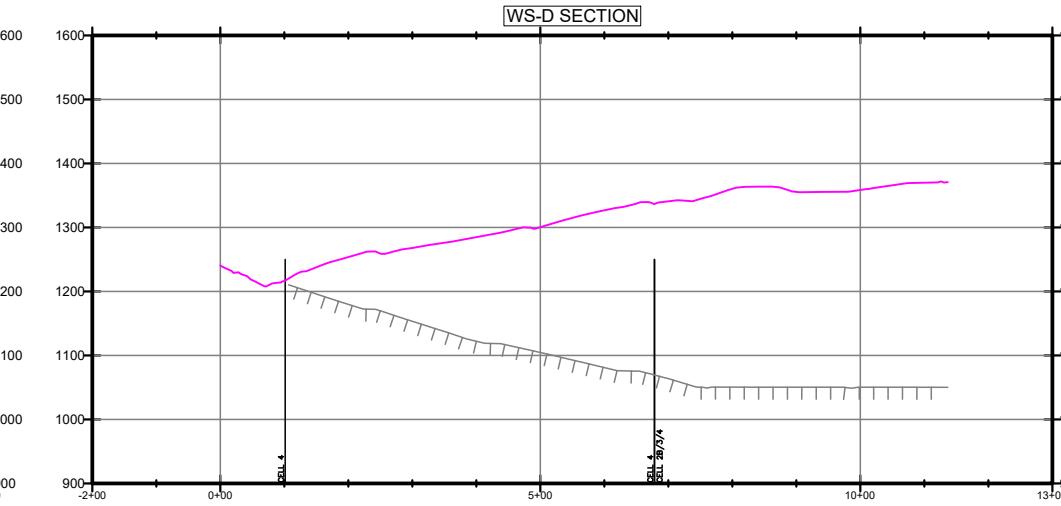
FIGURE 2D

WS-D SECTION

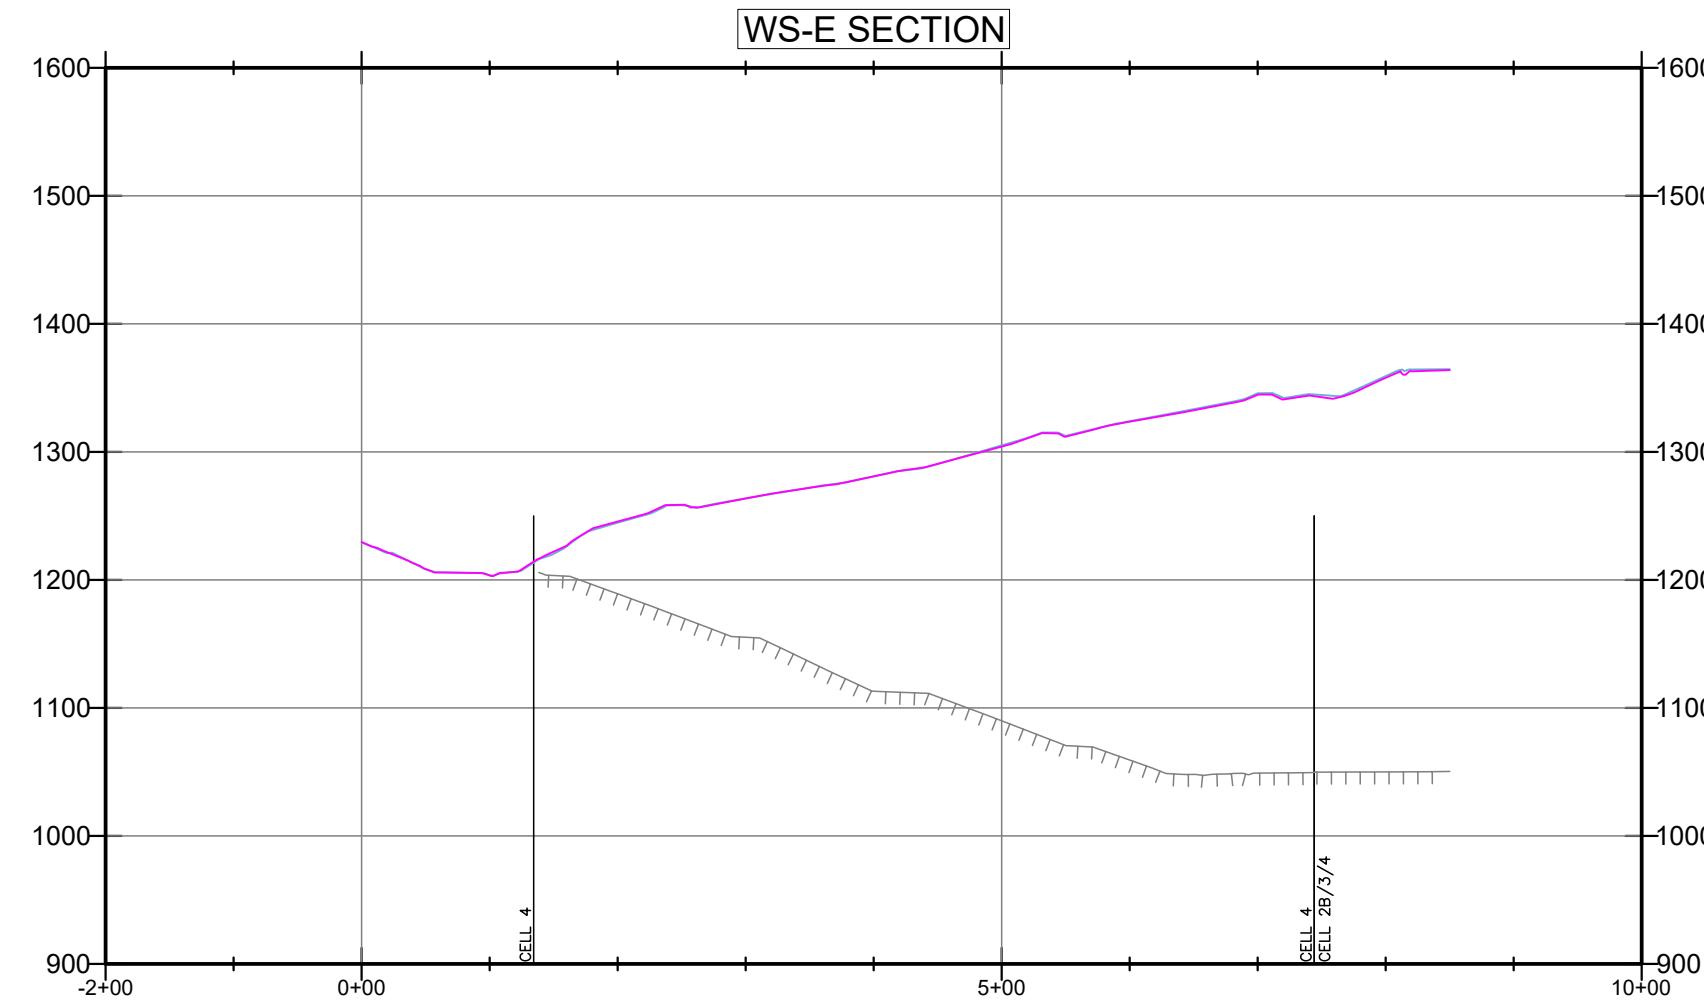
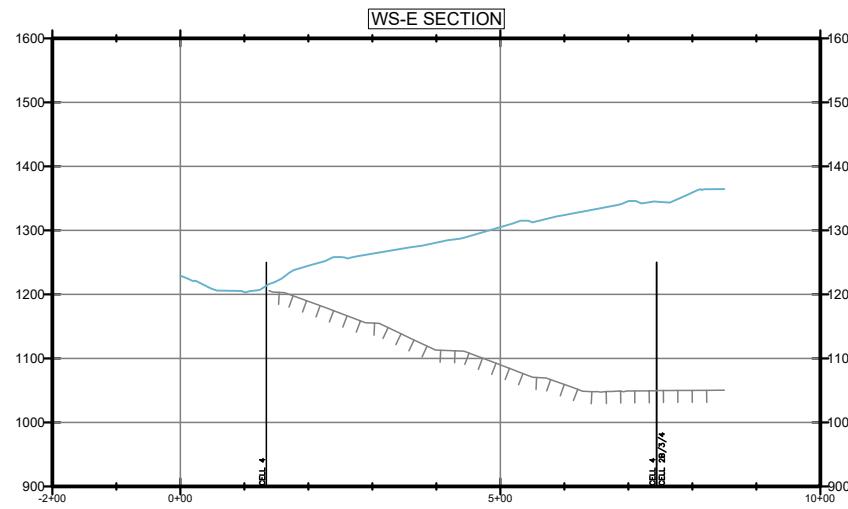
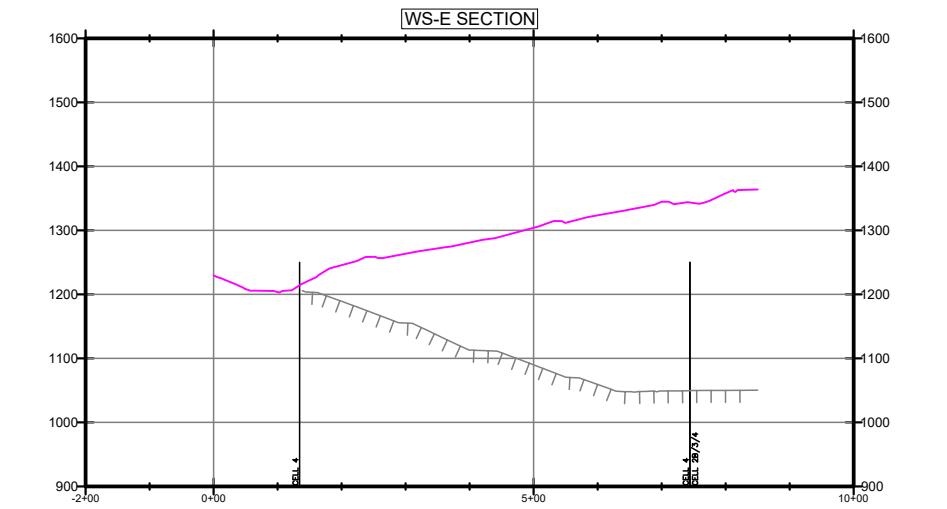
FIGURE 2E
WESTERN SLOPE CROSS SECTION E
JULY 2025 MONITORING SUMMARY
CHIQUITA CANYON LANDFILL
COUNTY OF LOS ANGELES, CA

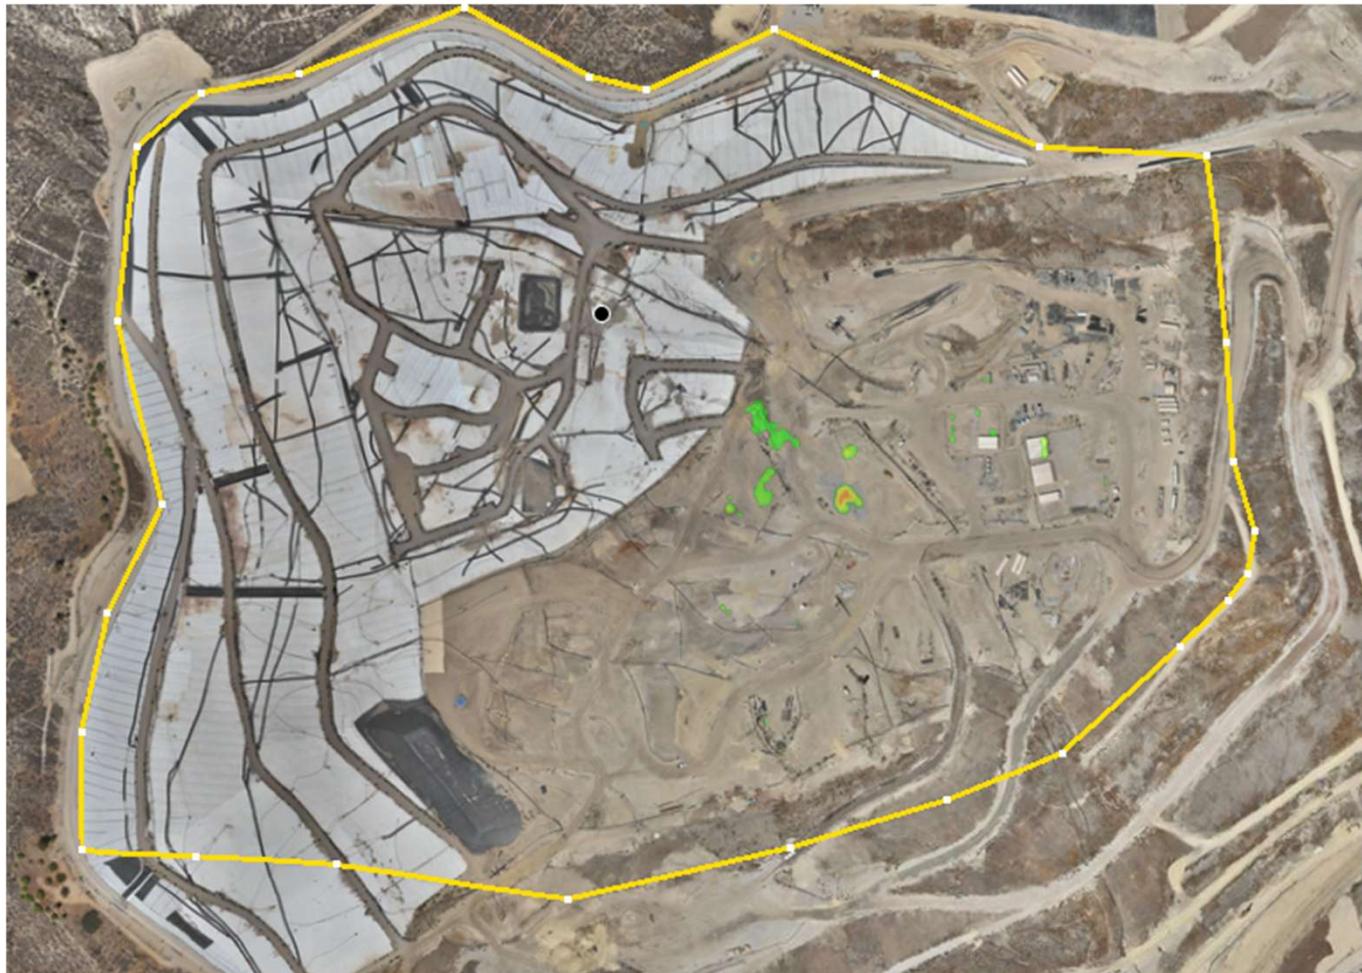
Chiquita Canyon Landfill - Isopach

July 31, 2025 Survey Image. June 28, 2025 vs July 31, 2025
