Re: Chiquita Canyon, LLC's Weekly Report on the Documentation and Tracking of Cover Issues

4050 - Chiquita Reaction Area Tracking of Fissures and Tension Cracks

4050 - Geosynthetic Cover Inspection

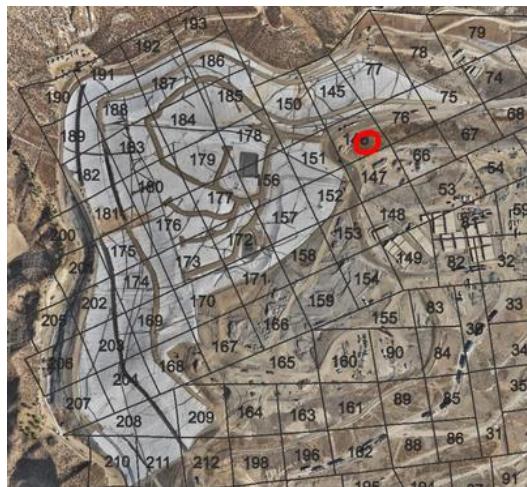
146

Yes

Using the attached image, annotate all areas where inspectors identified a fissure or tension crack.

Cracks were track walked.

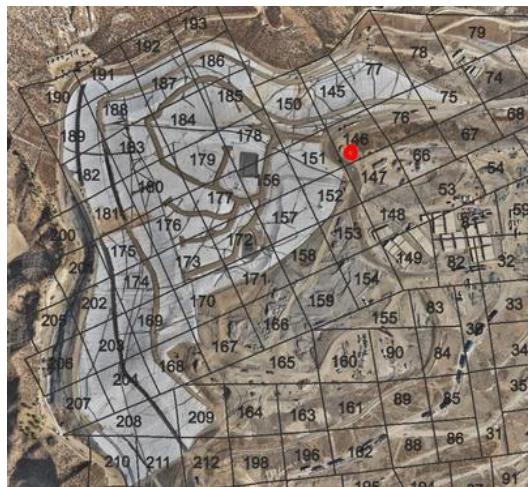
146

Yes

Using the attached image, annotate all areas where inspectors identified a fissure or tension crack.

Cracks were track walked.

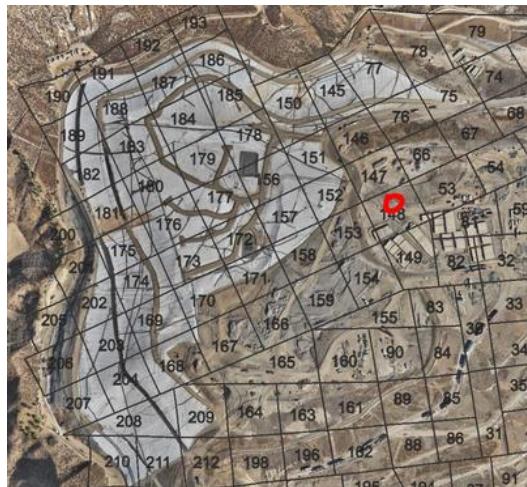
148

Yes

Using the attached image, annotate all areas where inspectors identified a fissure or tension crack.

Cracks were track walked.

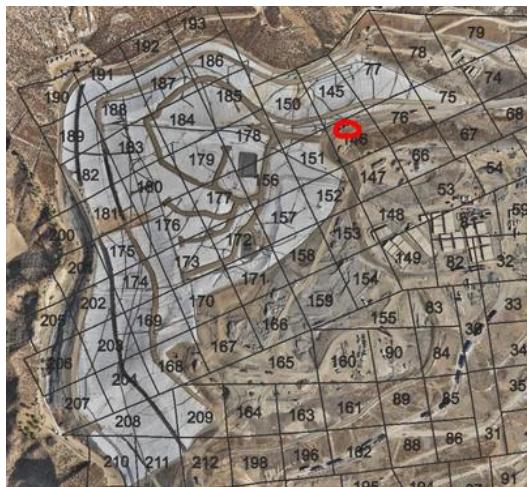
146

Yes

Using the attached image, annotate all areas where inspectors identified a fissure or tension crack.

Cracks were covered over with dirt and compacted.

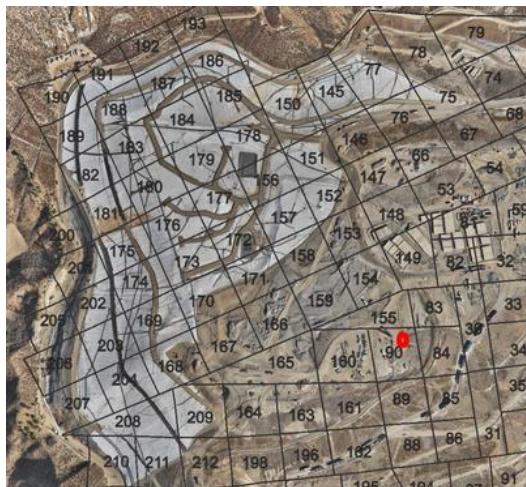
90

Yes

Using the attached image, annotate all areas where inspectors identified a fissure or tension crack.

Cracks were track walked.

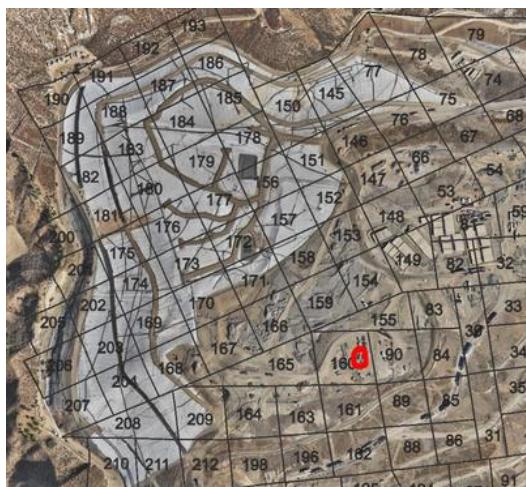
160

Yes

Using the attached image, annotate all areas where inspectors identified a fissure or tension crack.

Cracks were track walked.
