Re: Chiquita Canyon, LLC's Weekly Report on the Documentation and Tracking of Cover Issues

4050 - Chiquita Reaction Area Tracking of Fissures and Tension Cracks

4050 - Geosynthetic Cover Inspection

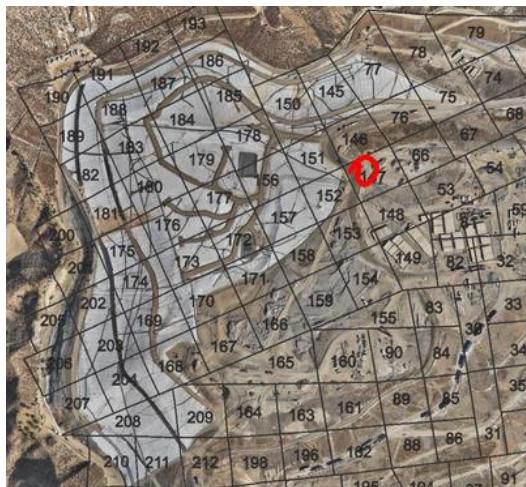
147

Using the attached image, annotate all areas where inspectors identified a fissure or tension crack.

No individual crack was over 50ft

Cracks were track walked.

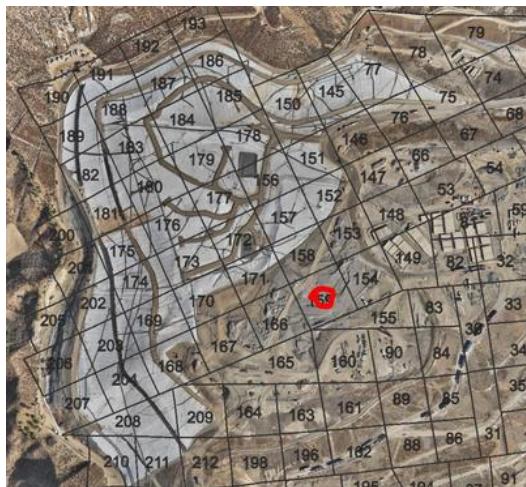
159

Using the attached image, annotate all areas where inspectors identified a fissure or tension crack.

No crack was over 50ft

Dirt was added and cracks were track walked.

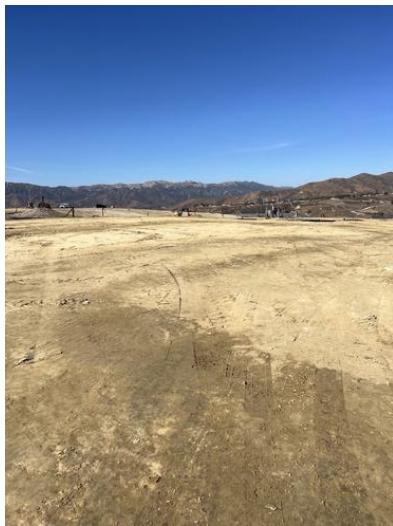
Grid 154

No

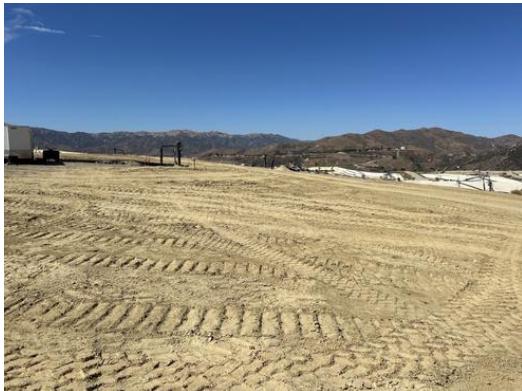
Grid 153

No

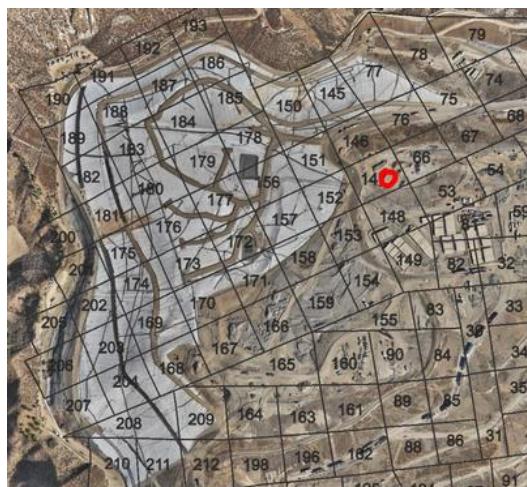
147

Using the attached image, annotate all areas where inspectors identified a fissure or tension crack.

Cracks were track walked.

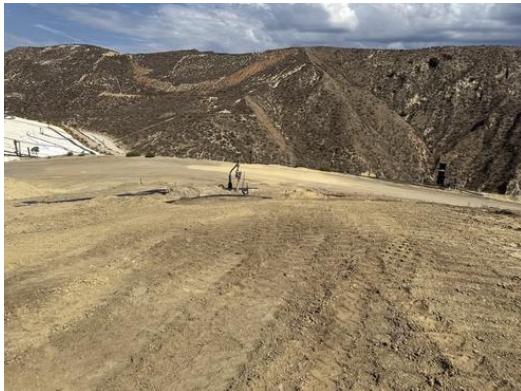
Grid 146

No
