CHIQUITA CANYON
A Waste Connections Company

Re: Chiquita Canyon, LLC's Weekly Report on the Documentation and Tracking of Cover Issues

4050 - Chiquita Reaction Area Tracking of Fissures and Tension Cracks

4050 - Geosynthetic Cover Inspection

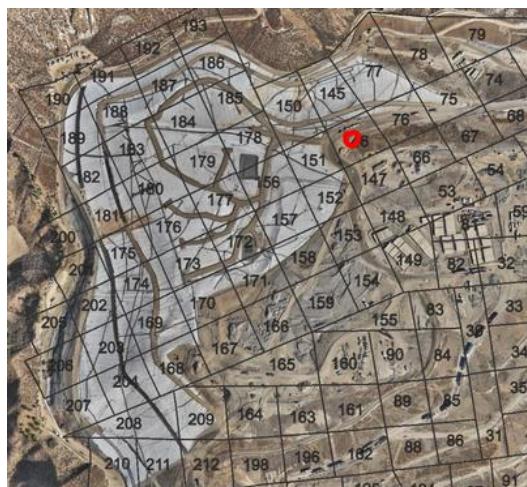
146

Yes

Dirt was added to cracks and compacted.

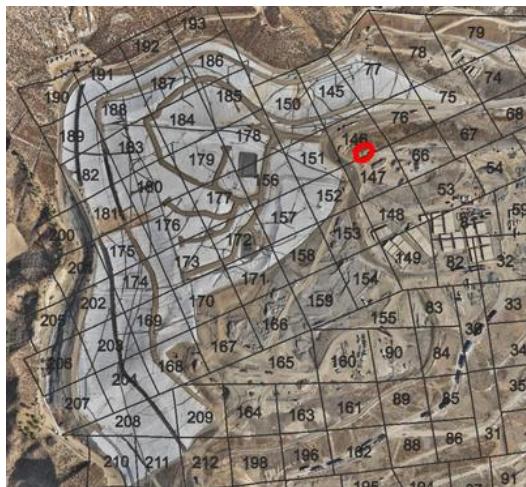
146

Horizontal Offset (width)	Small 0.5-2" in width
Vertical Offset (height)	Extra small <0.5" in height
Orientation (direction)	NE to SW
Location	Castaic CA 91384 United States (34.4363079757237, -118.64719990277636)
Was Fissure or Crack fixed? If yes, add photo and description of repairs performed	Yes

Date and time of repairs	11 Sep 2025 12:12 PM PDT
Description of repairs	Other (please describe)
Compacted with excavator	
Chiquita Reaction Area Tracking of Fissures and Tension Cracks 2

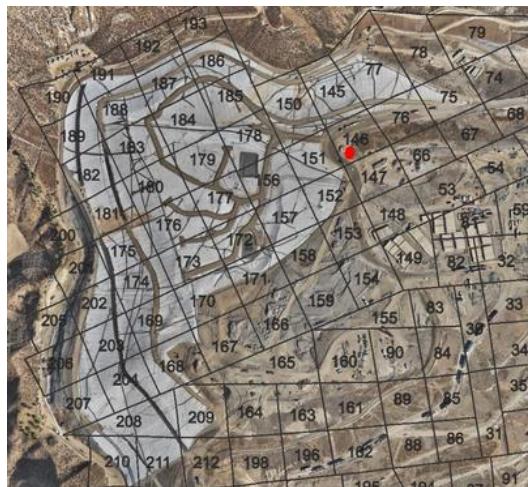
146

Length of crack (ft) or area containing multiple cracks (ft x ft) 12ft

Description of repairs Cracks were track walked.

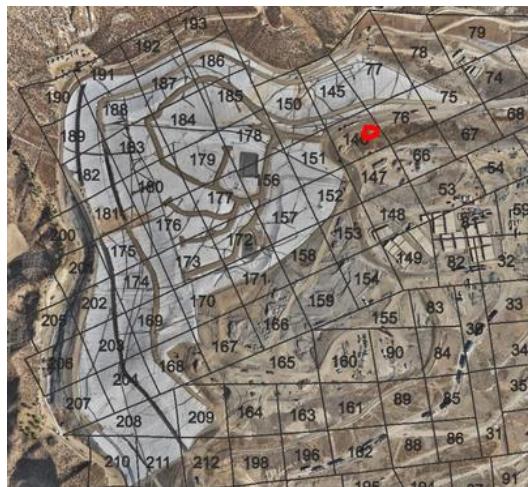
146

Length of crack (ft) or area containing multiple cracks (ft x ft)	20ft
Horizontal Offset (width)	Medium 2-4" in width
Vertical Offset (height)	Extra small <0.5" in height
Orientation (direction)	N to S

Date and time of repairs	11 Sep 2025 12:34 PM PDT
Description of repairs	Cracks were track walked.
Instability

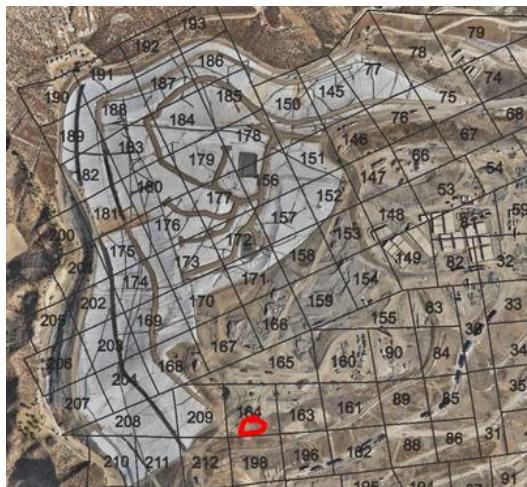
164

Multiple cracks running through area with longest crack being about 50ft

Description of repairs	Cracks were track walked.
Chiquita Reaction Area Tracking of Fissures and Tension Cracks 2

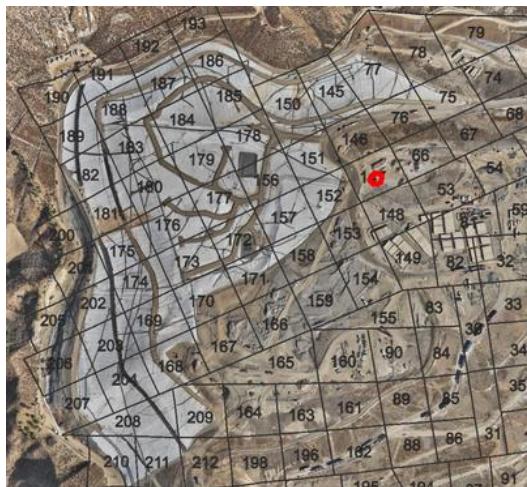
147

Fissure or Tension Crack Found?	Yes
---------------------------------	-----

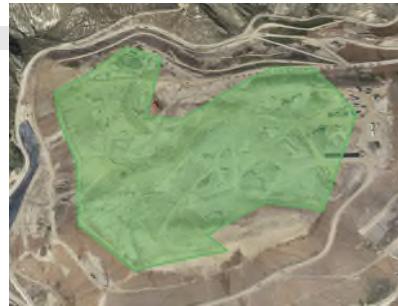
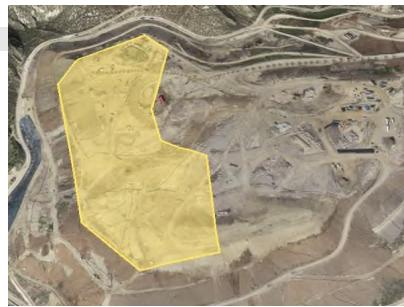
Location 2

- The charts on the following page show the settlement in cubic yards measured at a fixed location.
 - Chiquita restaked the survey benchmarks between July 31, 2025 and August 13, 2025 to maintain accuracy. After performing additional surveys, Chiquita has confirmed that the restaking caused the data to show an inflated amount of settlement, which does not accurately convey the true rate of settlement.
