December 29, 2025

Mr. Stephen Dutz
South Coast Air Quality Management District
21865 Copley Drive
Diamond Bar, California 91765

POST-EXCEEDANCE AIR MONITORING INVESTIGATION MS-04, DECEMBER 22-23, 2025 – STIPULATED ORDER FOR ABATEMENT CONDITION NO. 34(d)

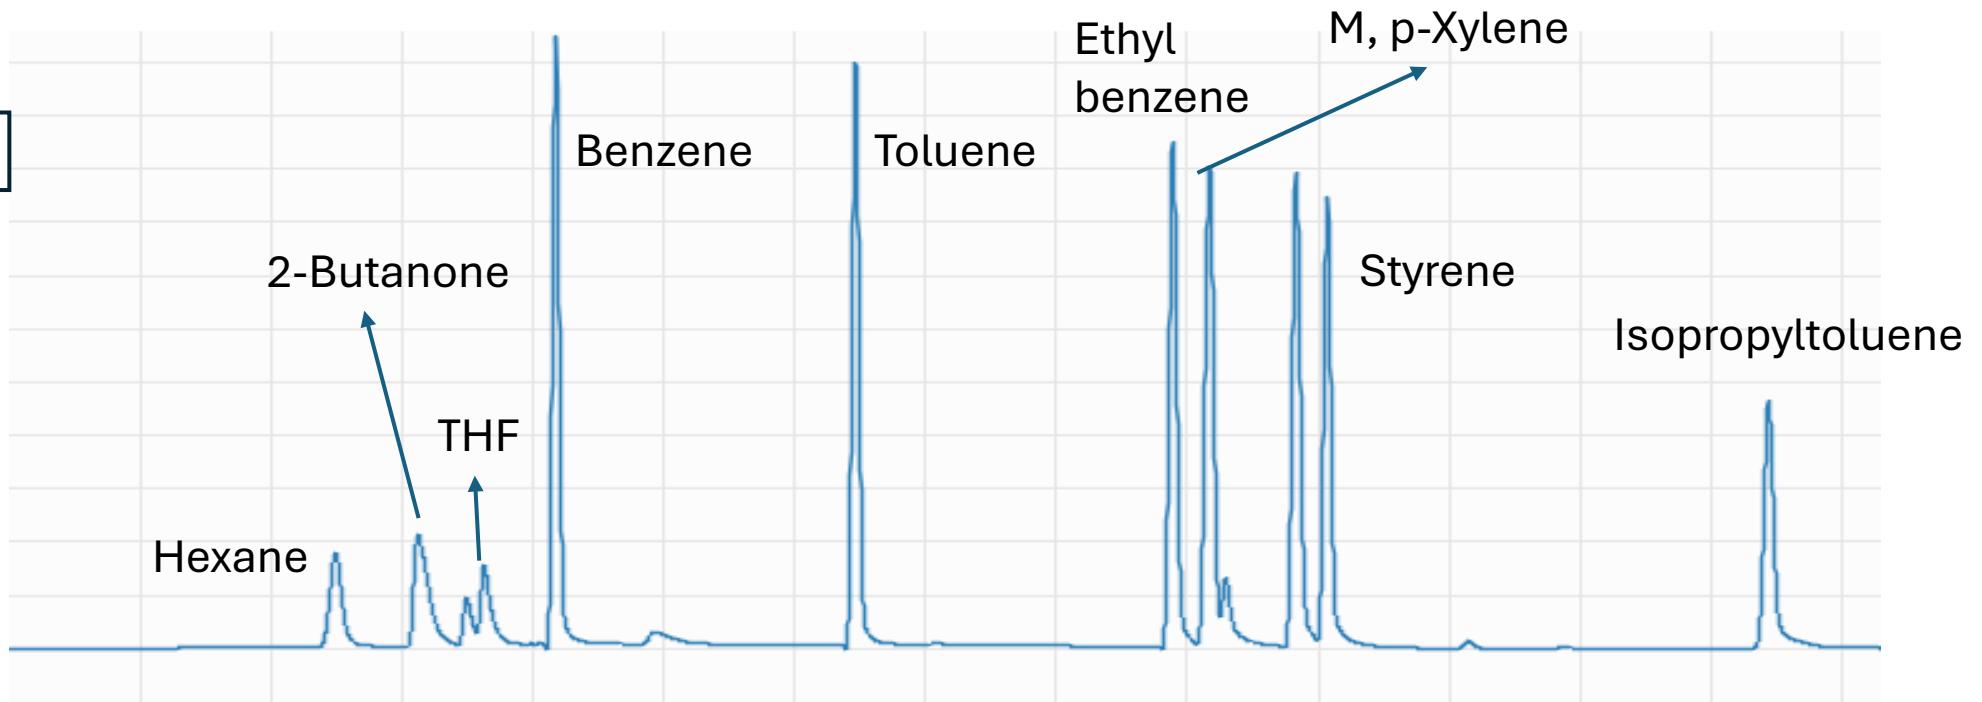
Sensor 1

All benzene data recorded at MS04 are valid, reliable, and representative of environmental conditions, with no evidence of analytical or operational anomalies.

Normal
Calibration
Peaks
