CHIQUITA CANYON
A Waste Connections Company

Re: Chiquita Canyon, LLC's Weekly Report on the Documentation and Tracking of Cover Issues

4050 - Chiquita Reaction Area Tracking of Fissures and Tension Cracks

4050 - Geosynthetic Cover Inspection

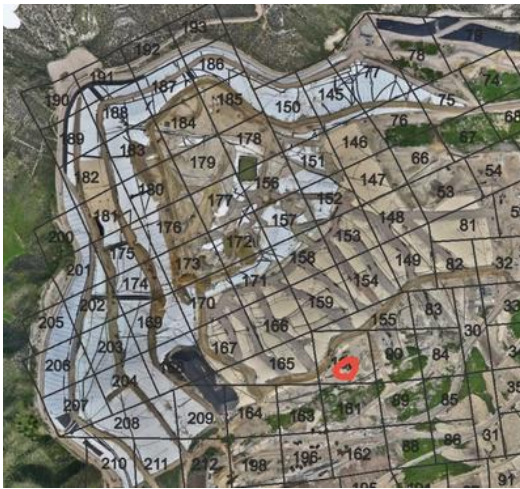
160

Length of crack (ft) or area containing multiple cracks (ft x ft) 30ft x 35ft

Was Fissure or Crack fixed? If yes, add photo and description of repairs performed Yes

Date and time of repairs 27 Jan 2026 1:21 PM PST

Description of repairs Cracks were track walked.

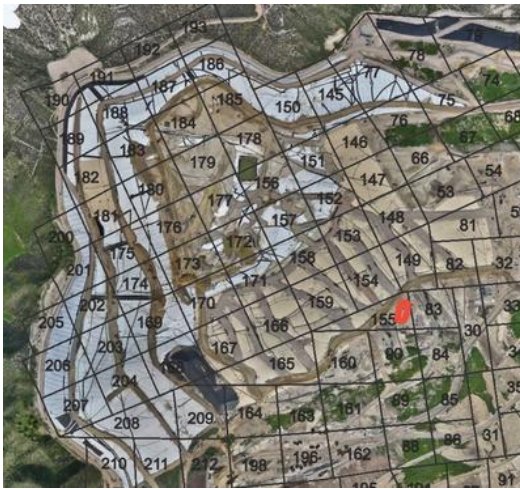
155

No individual crack over 50ft

Date and time of repairs	28 Jan 2026 10:15 AM PST
Description of repairs	Cracks were track walked.
Instability	
Are there any indications of slope stability concerns?	No
