**Re: Chiquita Canyon, LLC's Weekly Leachate Inspection Report for Stipulated Order for Abatement (Case No. 6177-4), Condition 27(c)**

Pursuant to Condition 27(c) of the Stipulated Order for Abatement (the “SOFA”) with the South Coast Air Quality Management District (“South Coast AQMD”) in Case No. 6177-4, Chiquita Canyon, LLC (“Chiquita”) encloses a compilation of the twice daily leachate seep inspection logs for the dates of January 26, 2026 through February 1, 2026.

# 4050 - Chiquita Leachate Seep/Pooling Inspection

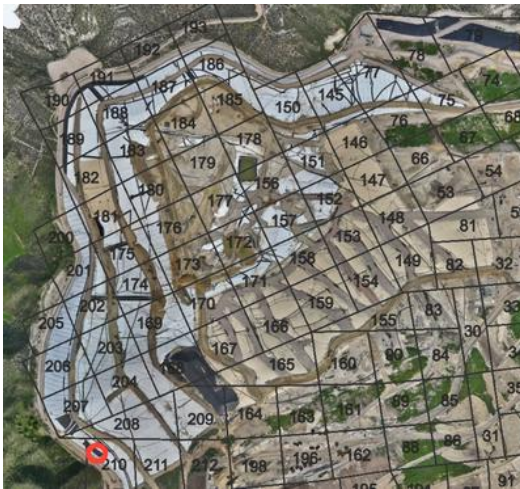
Indicate on the map the location

210

30 Jan 2026 2:30 AM PST

3 1/2 hours

6-10 gallons

100 sq ft

4 - Strong Odor

Standing free liquid

Yes

Containment measures described below.

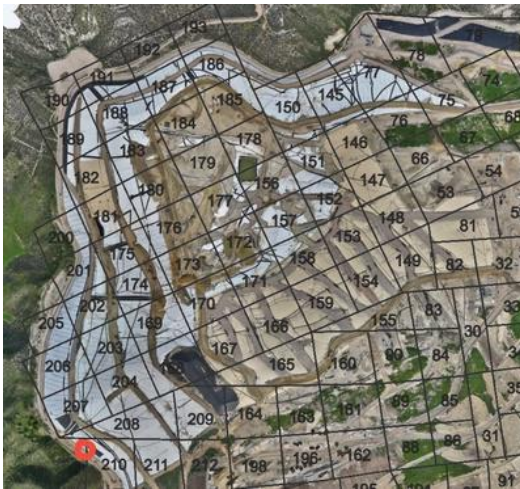
Indicate on the map the location

210

(34.43214061516819,  
-118.65141679755638)

Seep from previous inspection was not observed. Berm was created around morning seep location. Steel plate and liner placed on top to prevent atmospheric exposure. Hose inserted to remove any standing liquid should any present itself.
