CHIQUITA CANYON
A Waste Connections Company

Re: Chiquita Canyon, LLC's Weekly Report on the Documentation and Tracking of Cover Issues

Attachment: February 17, 2026 Weekly Cover Issues Report

4050 - Chiquita Reaction Area Tracking of Fissures and Tension Cracks

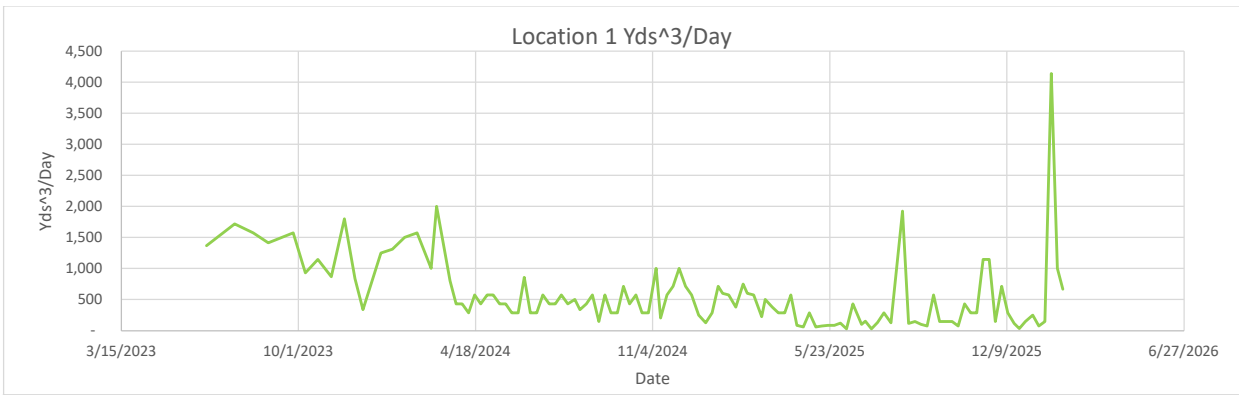
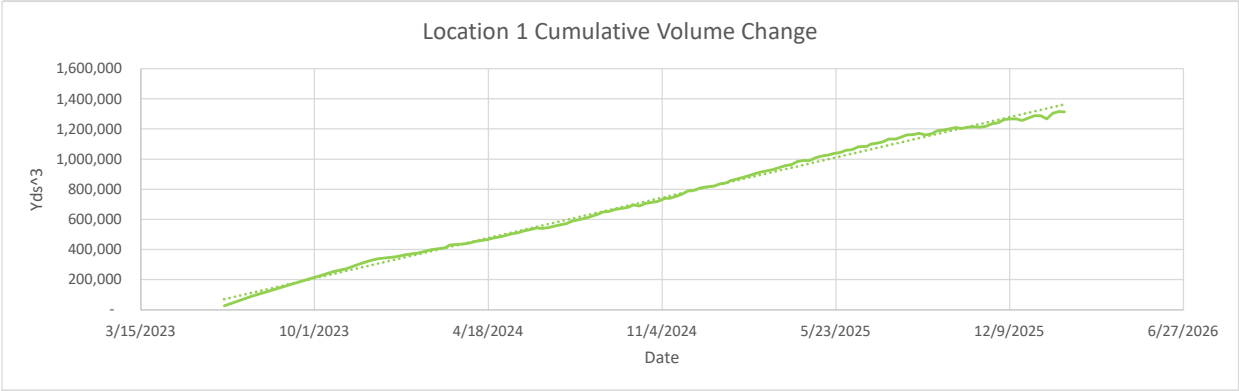
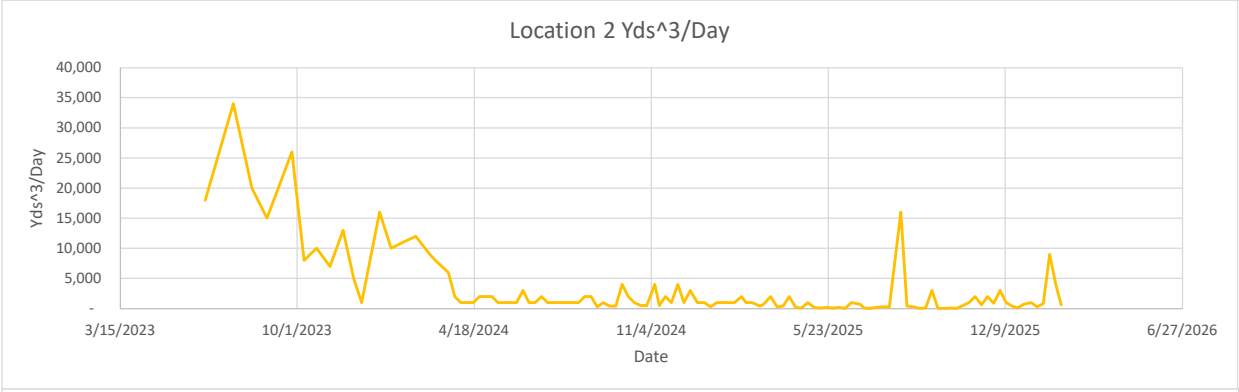
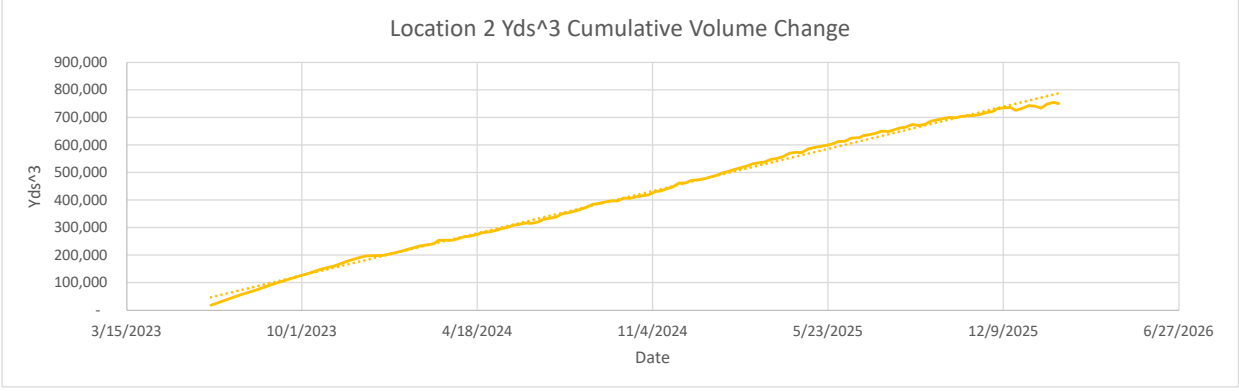
Location 1

- The charts on the following page show the settlement in cubic yards measured at a fixed location.
 - Chiquita restaked the survey benchmarks between July 31, 2025 and August 13, 2025 to maintain accuracy. After performing additional surveys, Chiquita has confirmed that the restaking caused the data to show an inflated amount of settlement, which does not accurately convey the true rate of settlement.

- On January 16, 2026, all three flares went offline as a result of high temperatures at Flares 1 and 3, and a blower failure at Flare 2. Due to the decrease in landfill gas collection, landfill gas temporarily accumulated under the geomembrane cover creating a “ballooning” effect. This ballooning effect disrupted the drone’s ability to accurately capture the amount of settlement – making it appear as though more settlement had occurred. Flares 1, 2, and 3 were initially brought back online by January 23, 2026. There have been subsequent downtimes associated with Flares 2 and 3 as described in the downtime alerts posted to Chiquita’s public website. Chiquita anticipates that the imaging, and settlement results, will return to normal by the time of the next flyover event.

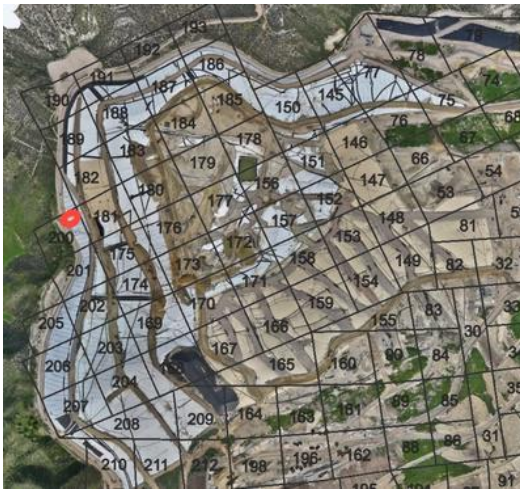
200

Notate what the issue is and what needs to be repaired

Description of repair work	Tear was patched and extrusion welded.
Date and time of repair (within 2 hours)	10 Feb 2026 1:09 PM PST
Are further permanent repairs required?	No
Date and Time of final repair (if necessary)	
Instability under the cover	
Are there any anomalous (unusual or unexpected) areas of cover damage or deformation that may indicate underlying instability?	No
Are there any signs of a downslope tension crack at the top of the slope or bulging at or near the toe of the slope?	No
Is there any movement of the equipment that vertically penetrates the cover (e.g., tilting)?	No
