Re: Chiquita Canyon, LLC's Weekly Leachate Inspection Report for Stipulated Order for Abatement (Case No. 6177-4), Condition 27(c)

Pursuant to Condition 27(c) of the Stipulated Order for Abatement with the South Coast Air Quality Management District in Case No. 6177-4 (the "Order"), Chiquita Canyon, LLC ("Chiquita") encloses a compilation of the twice daily leachate seep inspection logs for the dates of February 23, 2026 through March 1, 2026.

4050 - Chiquita Leachate Seep/Pooling Inspection

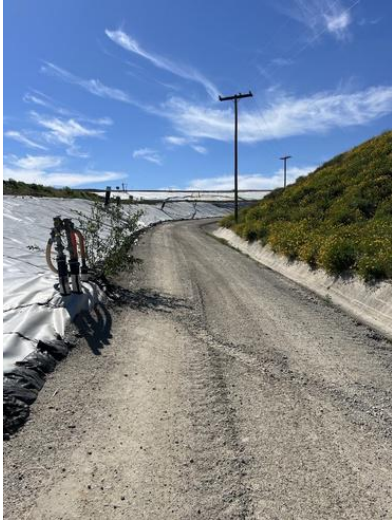
Photo 1

Has a leachate seep/pooling been located?

No

Description of area in photo where there is no leachate seepage or pooling.
