**Re: Chiquita Canyon, LLC's Weekly Report on the Documentation and Tracking of Cover Issues**

In accordance with the Local Enforcement Agency's ("LEA") May 2, 2024 letter approving Chiquita's April 16, 2024 Second Revised Written Plan for Documenting and Tracking Cover Issues ("Second Revised Written Plan"), the LEA's May 29, 2024 letter, and the LEA's June 6, 2024 Compliance Order, Chiquita presents the enclosed report for documenting and tracking cover issues for the week of March 30, 2026 to April 4, 2026.

# 4050 - Chiquita Reaction Area Tracking of Fissures and Tension Cracks

# 4050 - Geosynthetic Cover Inspection

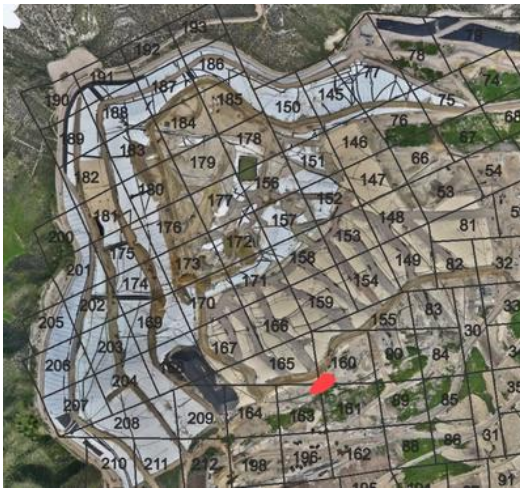
163

Yes

No individual crack 50ft or longer.

<b>Date and time of repairs</b>	31 Mar 2026 11:54 AM PDT
<b>Description of repairs</b>	Cracks were track walked.
Instability	
<b>Are there any indications of slope stability concerns?</b>	No

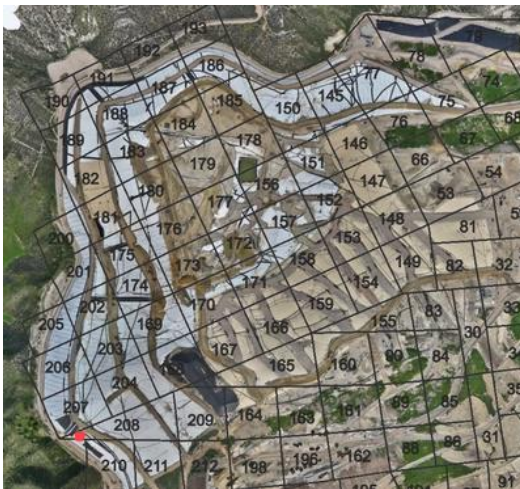
208

Weld on a previous patch failed and needs to be patched and extrusion welded.

Failed weld was re-welded
