Re: Chiquita Canyon, LLC's Weekly Report on the Documentation and Tracking of Cover Issues, Monthly Summary and Monthly Isopach Map

4050 - Chiquita Reaction Area Tracking of Fissures and Tension Cracks

MARCH 2026 FISSURE AND TENSION CRACK MONITORING SUMMARY
CHIQUITA CANYON LANDFILL
CASTAIC, CALIFORNIA

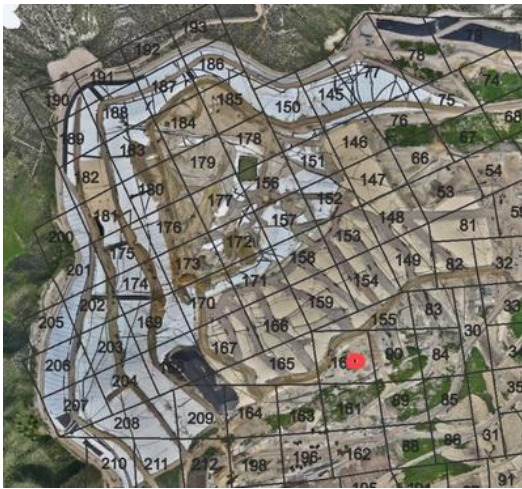
160

Length of crack (ft) or area containing multiple cracks (ft x ft) 15ft x 40ft

Cracks covered with dirt and compacted.

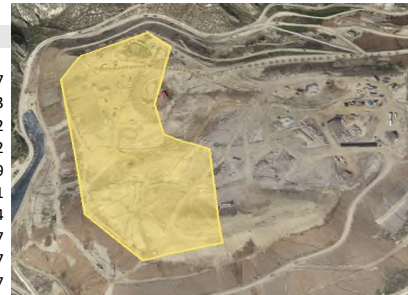
*Waste fill near reaction area
