CHIQUITA CANYON
A Waste Connections Company

Re: Chiquita Canyon, LLC's Weekly Report on the Documentation and Tracking of Cover Issues

Attachment: April 21, 2026 Weekly Cover Issues Report

4050 - Chiquita Reaction Area Tracking of Fissures and Tension Cracks

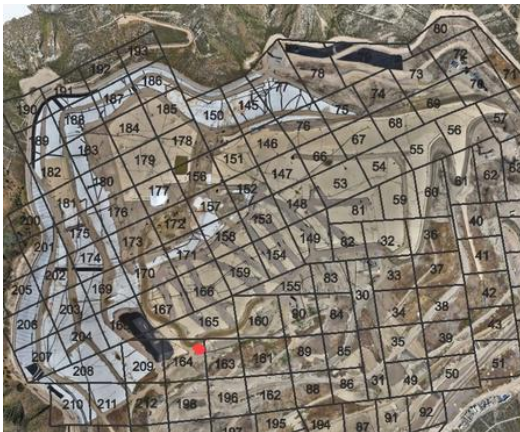
164

Yes

No individual crack 50ft or longer

Cracks were track walked.

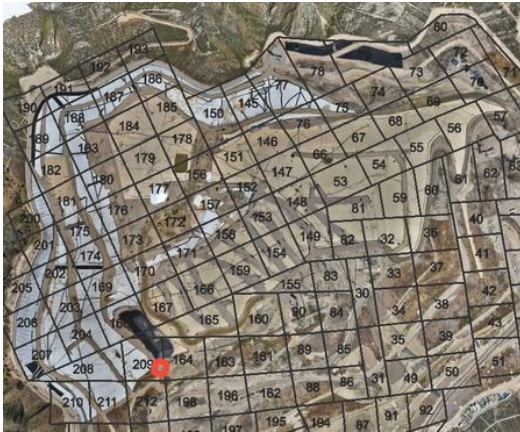
209

Length of crack (ft) or area containing multiple cracks (ft x ft)	25ft x 20ft area
Horizontal Offset (width)	Small 0.5-2" in width
Vertical Offset (height)	Extra small <0.5" in height
Orientation (direction)	E to W
Location	Castaic CA 91384 United States (34.43212343980033, -118.64906656703948)
Was Fissure or Crack fixed? If yes, add photo and description of repairs performed	Yes

Date and time of repairs	16 Apr 2026 10:50 AM PDT
Description of repairs	Cracks were track walked.
Instability	
Are there any indications of slope stability concerns?	No
