Re: Chiquita Canyon, LLC's Weekly Report on the Documentation and Tracking of Cover Issues

4050 - Chiquita Reaction Area Tracking of Fissures and Tension Cracks

4050 - Geosynthetic Cover Inspection

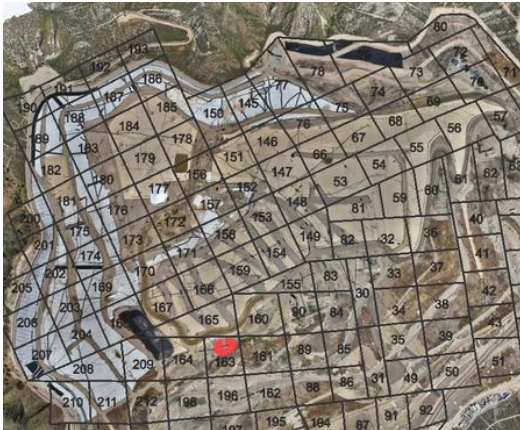
163

Using the attached image, annotate all areas where inspectors identified a fissure or tension crack.

Length of crack (ft) or area containing multiple cracks (ft x ft)	25ft x 40ft
Horizontal Offset (width)	Medium 2-4" in width
Vertical Offset (height)	Extra small <0.5" in height
Orientation (direction)	N to S
Location	Castaic CA 91384 United States (34.432890315225514, -118.6478298998814)
Was Fissure or Crack fixed? If yes, add photo and description of repairs performed	Yes

Cracks were shoveled closed and compacted by hand and later covered with additional dirt and compacted

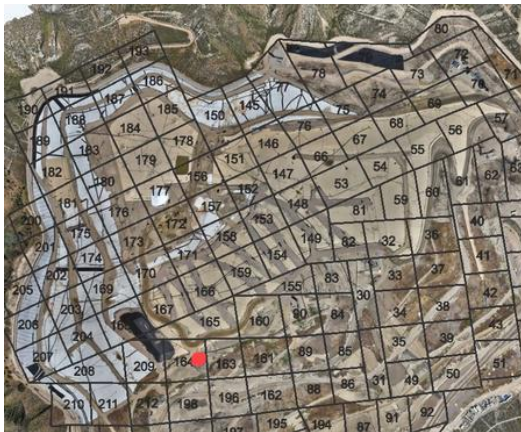
164

Using the attached image, annotate all areas where inspectors identified a fissure or tension crack.

Non individual crack 50 ft or longer.

Cracks were track walked.

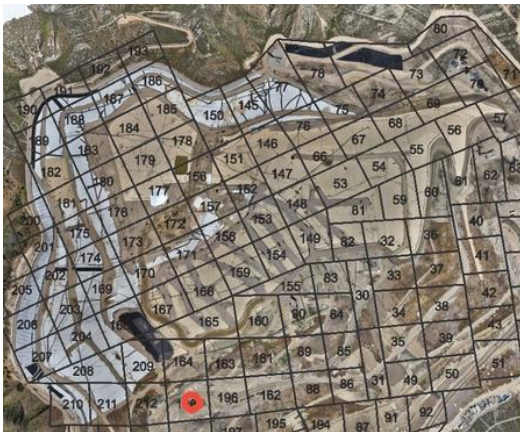
198

Using the attached image, annotate all areas where inspectors identified a fissure or tension crack.

Cracks were track walked.

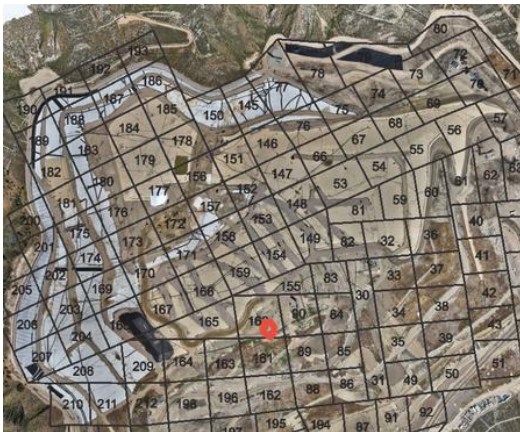
160

Using the attached image, annotate all areas where inspectors identified a fissure or tension crack.

Cracks were track walked.

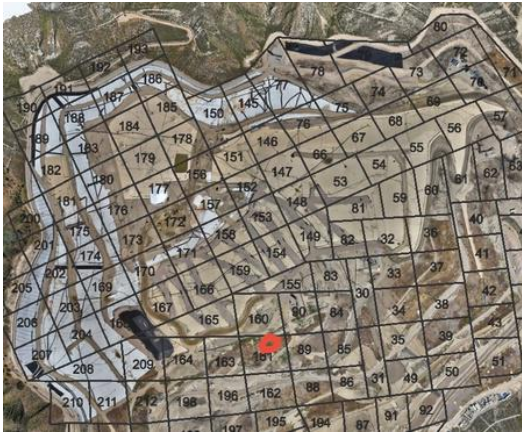
161

Using the attached image, annotate all areas where inspectors identified a fissure or tension crack.

Length of crack (ft) or area containing multiple cracks (ft x ft) 13ft x 30ft area

Date and time of repairs 19 Jun 2026 10:51 AM PDT

Description of repairs Cracks were track walked.

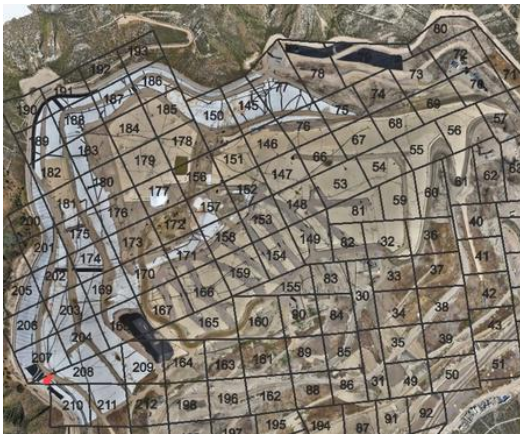
208

Notate what the issue is and what needs to be repaired

Description of repair work
