**Re: Chiquita Canyon, LLC's Weekly Leachate Inspection Report for Stipulated Order for Abatement (Case No. 6177-4), Condition 27(c)**

# 4050 - Chiquita Leachate Seep/Pooling Inspection

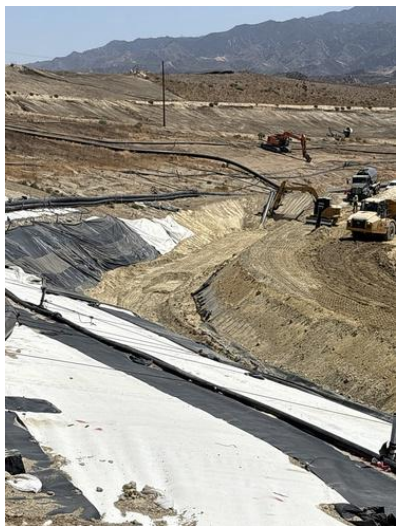
Photo 1

Westside perimeter road. None of the seepage previously observed in this area were observed at the time of this inspection, permanent repairs are being conducted to contain the seepage in this area. The seeps observed in grids 94 and 93/95 were not observed at the time of this inspection either.

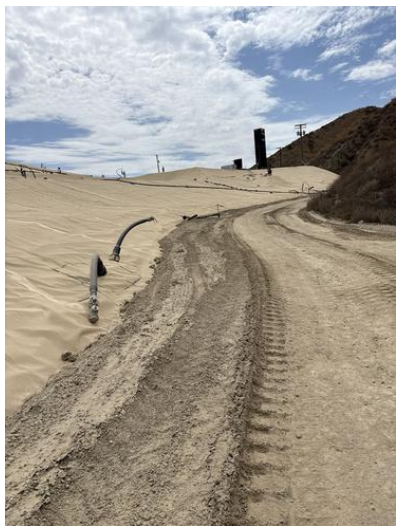
Photo 1

North perimeter road. Neither the Westside seep or the seep in grid 94 were observed during this inspection. Permanent repairs are being conducted on the westside to contain seep.

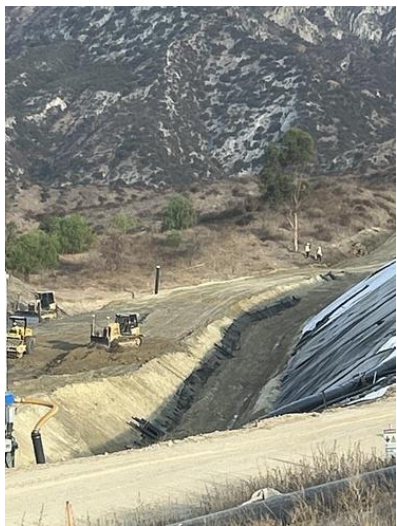
Photo 1

Westside perimeter road. None of the seepage previously observed in this area were observed at the time of this inspection. Permanent repairs are being conducted to contain seepage in this area as well.

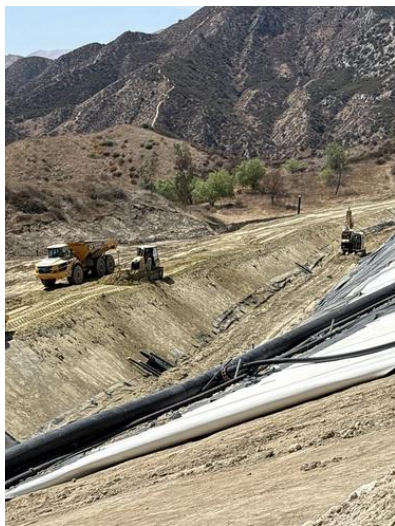
Photo 1

Westside perimeter road. None of the seepage previously observed in this area were observed at the time of this inspection. Permanent repairs are being conducted to contain seepage in this area as well.

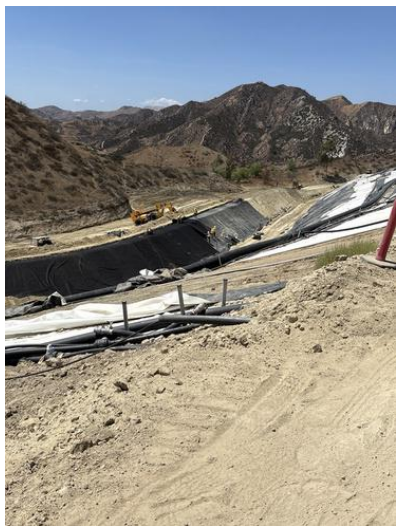
Photo 1

Westside perimeter road. None of the seepage previously observed in this area were observed at the time of this inspection, permanent repairs are being conducted to contain the seepage in this area. The seep observed in grids 94 was not observed at the time of this inspection either.

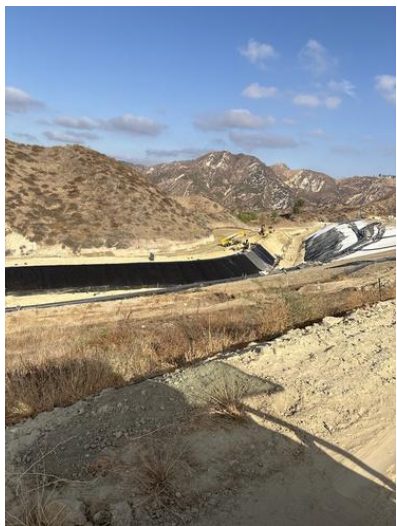
Photo 1

Westside perimeter road. None of the seepage previously observed in this area were observed at the time of this inspection, permanent repairs are being conducted to contain the seepage in this area. The seep observed in grid 94 was not observed at the time of this inspection either.

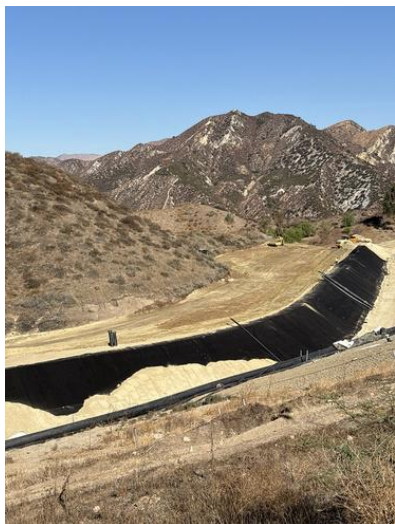
Photo 1

Westside perimeter road. None of the seepage previously observed in this area were observed at the time of this inspection, permanent repairs are being conducted to contain the seepage in this area. The seep observed in grid 94 was not observed at the time of this inspection either.

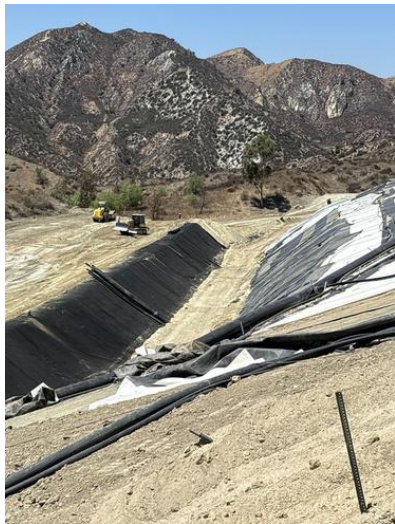
Photo 1

Westside perimeter road. None of the seepage previously observed in this area were observed at the time of this inspection, permanent repairs are being conducted to contain the seepage in this area. The seep observed in grid 94 was not observed at the time of this inspection either.

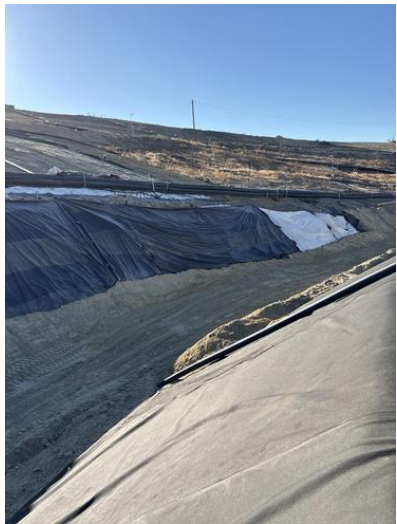
Photo 1

Westside perimeter road. None of the seepage previously observed in this area were observed at the time of this inspection, permanent repairs are being conducted to contain the seepage in this area. The seep observed in grid 94 was not observed at the time of this inspection either.

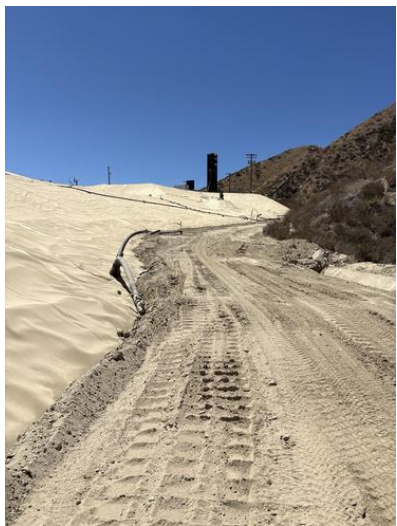
Photo 1

North perimeter road. None of the seepage observed on the Westside or in grid 94 was observed at the time of this inspection. Permanent repairs to the westside are currently underway.
