**CHIQUITA CANYON**  
*A Waste Connections Company*

**Re: Chiquita Canyon, LLC's Weekly Report on the Documentation and Tracking of Cover Issues**

Attachment: August 25, 2026 Weekly Cover Issues Report

# 4050 - Chiquita Reaction Area Tracking of Fissures and Tension Cracks

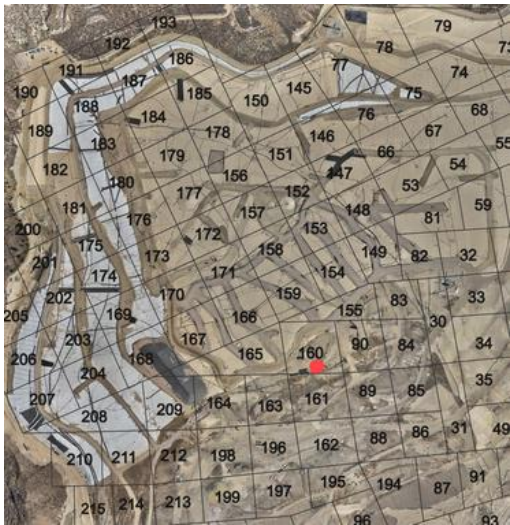
160

Using the attached image, annotate all areas where inspectors identified a fissure or tension crack.

No individual crack 50 ft or longer.

| <b>Description of repairs</b> | Cracks were track walked. |

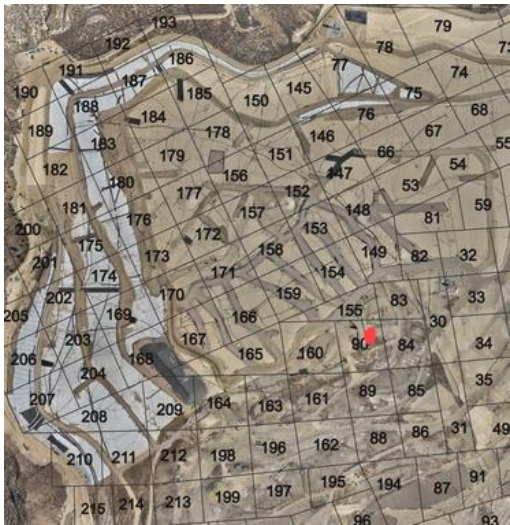
90

Using the attached image, annotate all areas where inspectors identified a fissure or tension crack.

No individual crack 50ft or longer.

| <b>Description of repairs</b> | Cracks were track walked. |

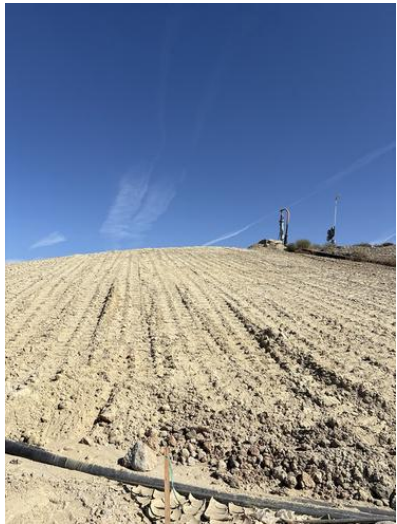
Grid 164

No

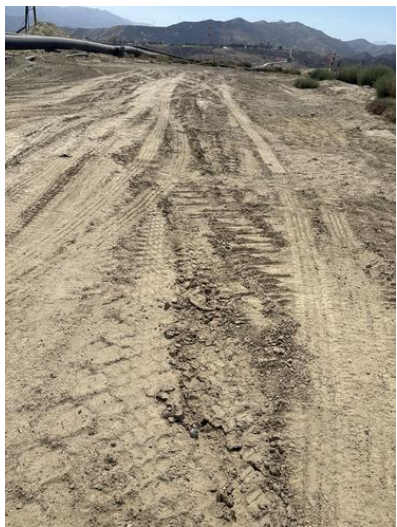
Grid 163

No

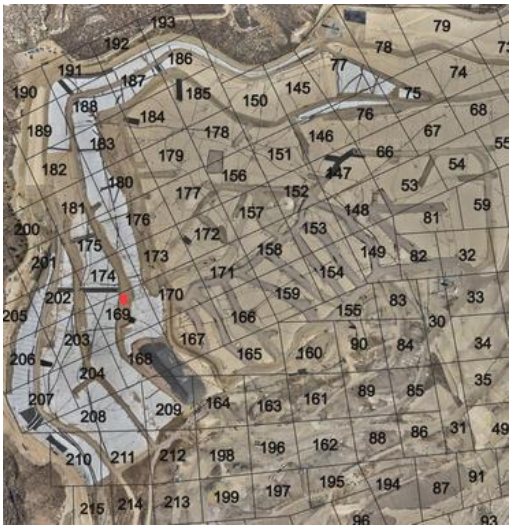
169

Using the attached image, annotate all areas where inspectors identified a fissure or tension crack.

| <b>Length of crack (ft) or area containing multiple cracks (ft x ft)</b> | 40ft x 15 ft |

Cracks were track walked.

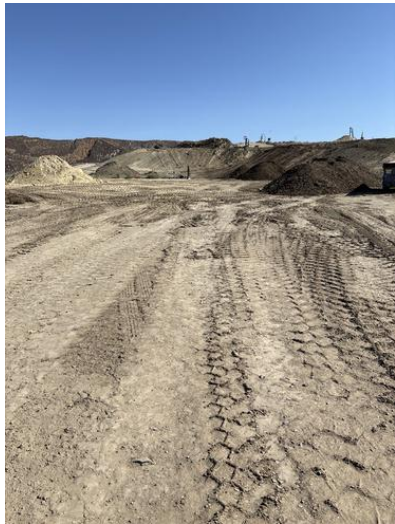
Grid 212

No
