**CHIQUITA CANYON**  
*A Waste Connections Company*

**Re: Chiquita Canyon, LLC's Weekly Report on the Documentation and Tracking of Cover Issues, Monthly Summary, and Monthly Isopach Map**

# 4050 - Chiquita Reaction Area Tracking of Fissures and Tension Cracks

# 4050 - Geosynthetic Cover Inspection

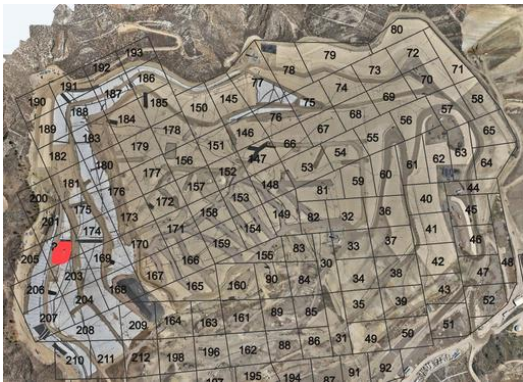
19. Multiple tears in Grid 202 need to be patched/extrusion welded. Tears taped on discovery and then patched on extrusion welded.

| <b>Are further permanent repairs required?</b> | No |
| <b>Date and Time of final repair (if necessary)</b> | 2 Sep 2026 10:36 AM PDT |
