**Re: Inspection Report Response, April 10, 2026 Inspection  
Los Angeles Regional Water Quality Control Board**

**Attachment A – April 2026 Industrial Stormwater Inspection Report**

Los Angeles Regional Water Quality Control Board  
**INDUSTRIAL STORMWATER INSPECTION REPORT**  
(State Water Resources Control Board Order WQ 2018-0028-DWQ, NPDES No. CAS000001)

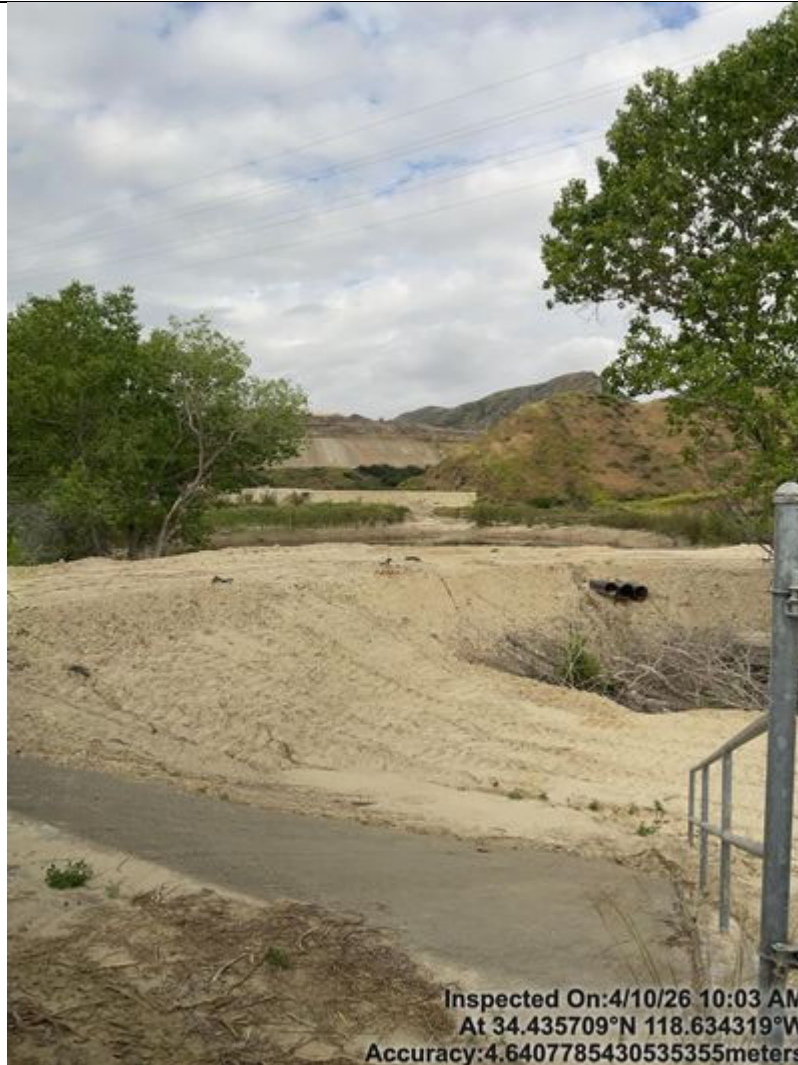
Photo 16

Bermed area of the East Basin. Mr. Breuer explained that the upgradient sub basins (sub basins 2, 3, and 4) are meant to prevent water from entering the East Basin here

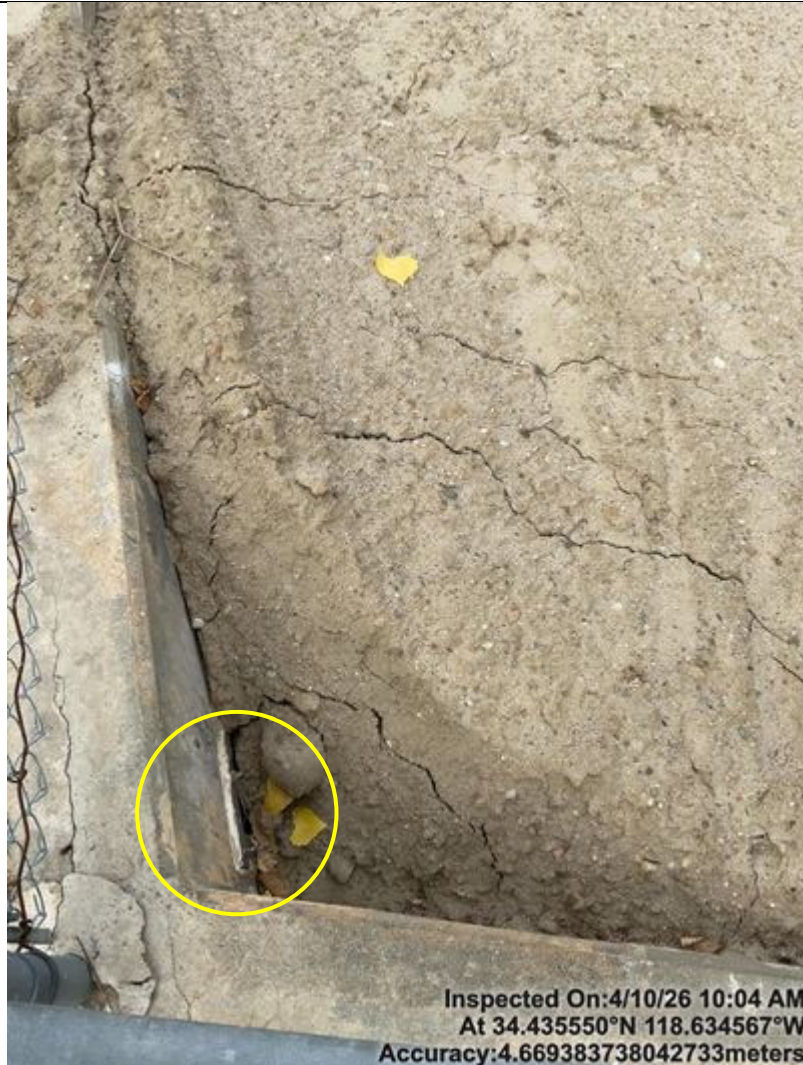
Photo 17

are meant to prevent water from entering the East Basin on the other side of the berm (Photo 17). Mr. Breuer pointed out the corner of metal plate under dirt (circled in yellow) that acts as a barrier in front of the East Basin outlet (Photos 17-19). Mr. Breuer explained that the barrier was put over the East Basin outlet in response to a leak.

Close-up view of the box plate inside the East Basin. Mr. Breuer pointed out the corner of metal plate under the dirt berm (circled in yellow) that acts as a barrier in front of the East Basin outlet. Mr. Breuer explained that the barrier was put over the East Basin outlet in response to a prior leak.

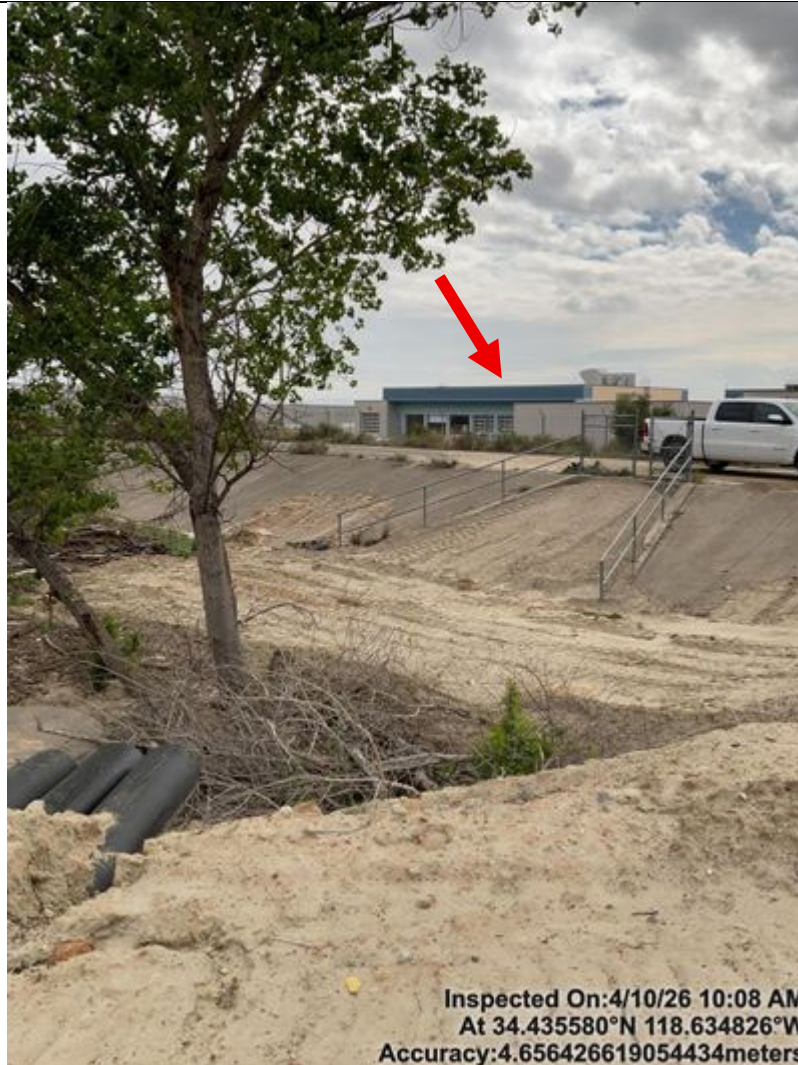
Photo 25

We then drove toward the East Basin (Photo 8). Mr. Breuer identified Sediment Basin 3 and the surrounding berm (Photos 9-13). Next, we moved toward the East Basin (Photos 14-26). I observed a red piping line in the East Basin, and Mr. Breuer told me that the red piping line is used to pump the water from the East Basin into disposal trucks (Photos 14-15, 24-25). I saw the bermed area of the East Basin (Photo 16). Mr. Breuer explained that the upgradient sub basins (sub basins 2, 3, and 4)

Pumping equipment and red piping used to pump water out of the East Basin sub basin 2, circled in yellow

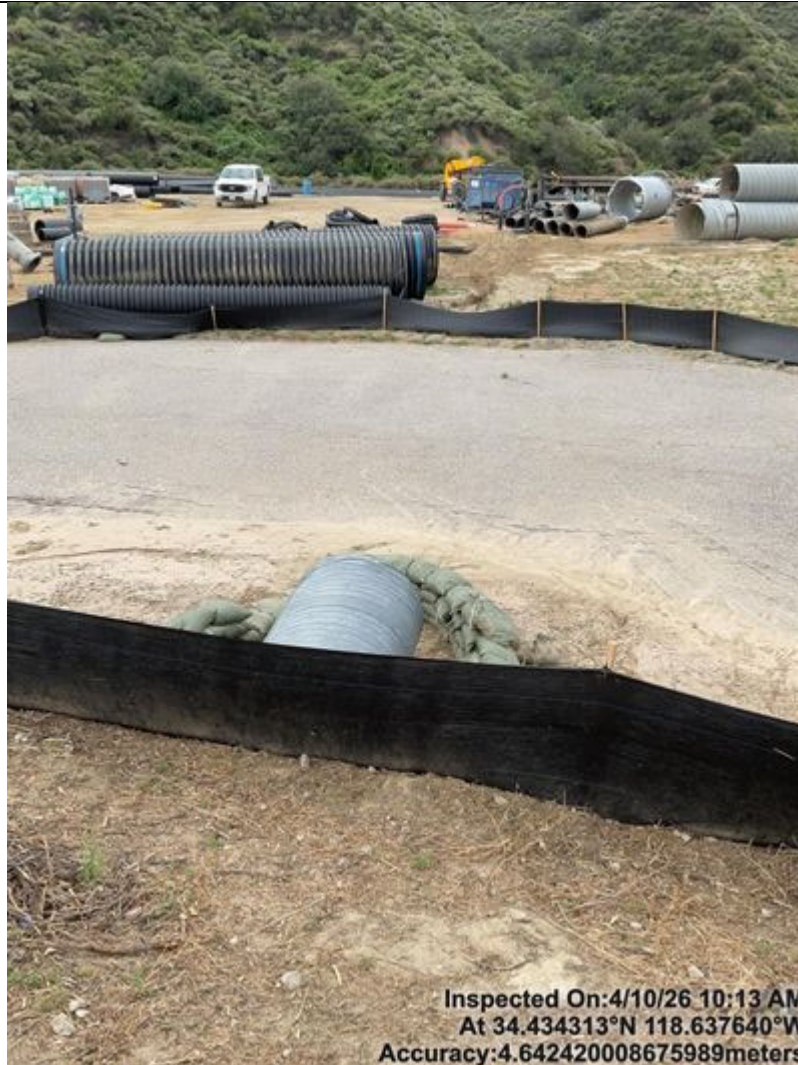
Photo 27  
Culvert with sandbags at the equipment storage area/pipe lay down yard

- The silt fence and sand bag best management practices ("BMPs") in the Canyon B area were repaired the week of June 1, 2026 as shown in the enclosed Photos 1, 2, 3, and 4. The silt fence and sand bag BMPs are maintained as needed based upon inspection and are one of many Erosion and Sediment Control BMPs installed, maintained, and implemented at the Landfill.
- Ongoing preparations for installation of the ethylene vinyl alcohol/high-density polyethylene geomembrane cover ("EVOH cover") changed the condition of the area depicted in the Report's Photo 83 and eliminated the need for the temporary hay-bale erosion control BMP at that location. The former BMP, including the hay bales and

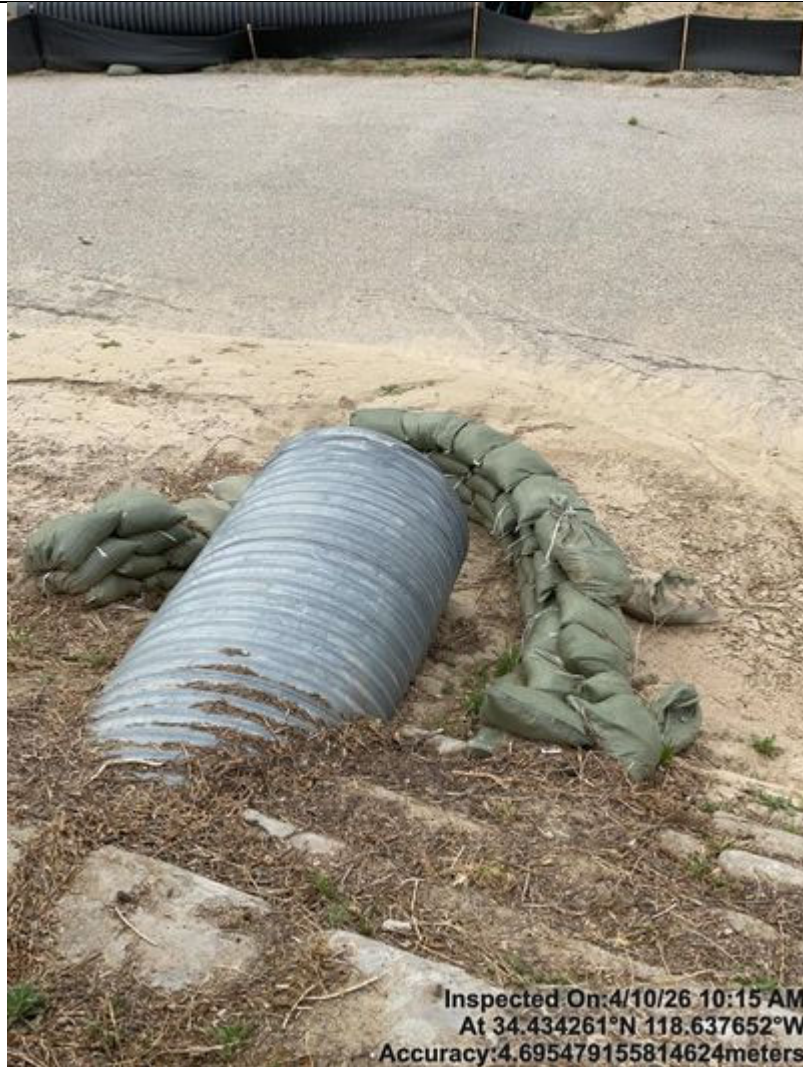
Photo 29  
Close-up of the culvert. I observed sediment accumulation around the sandbags

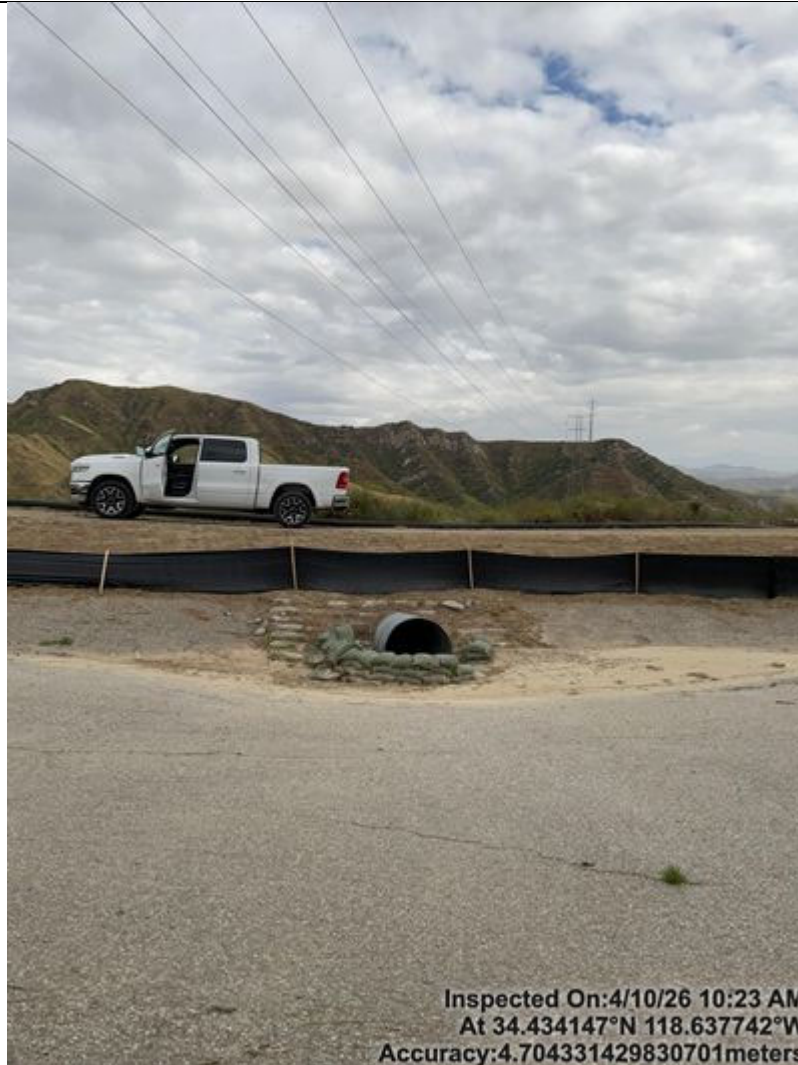
Photo 31

Culvert on map. Sediment accumulation in front of culvert. Sand bags in need of repair

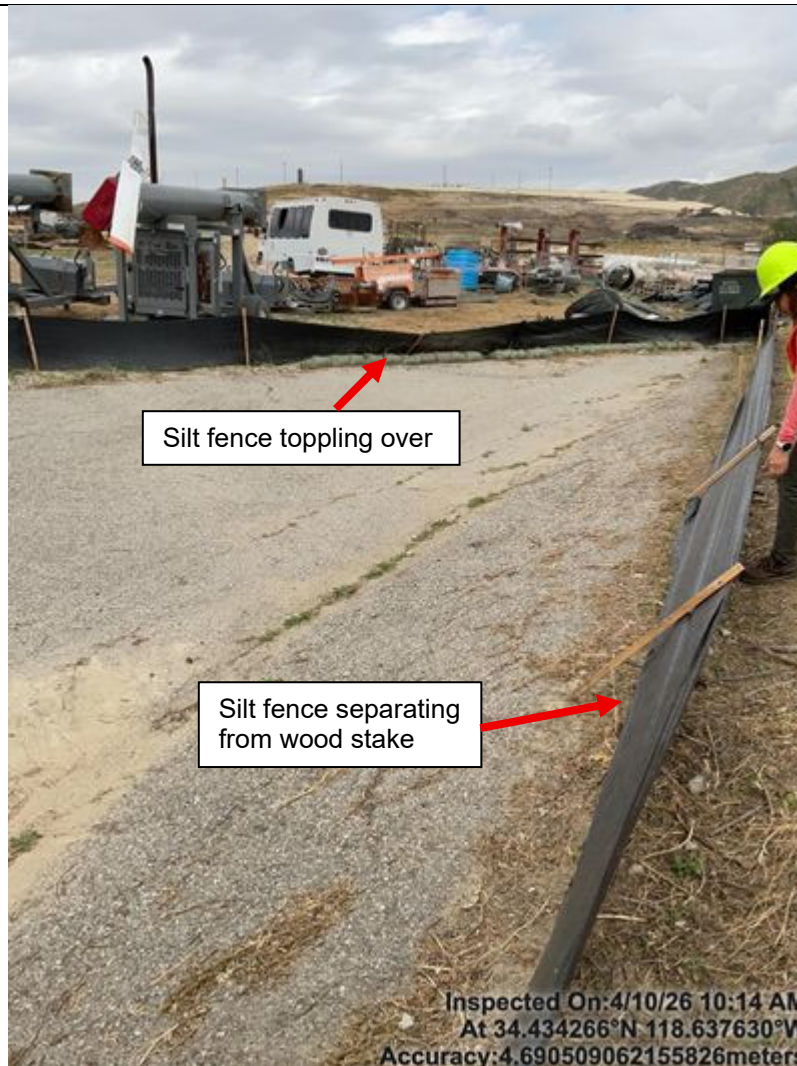
Photo 33  
Silt fence with improper installation in need of repair.

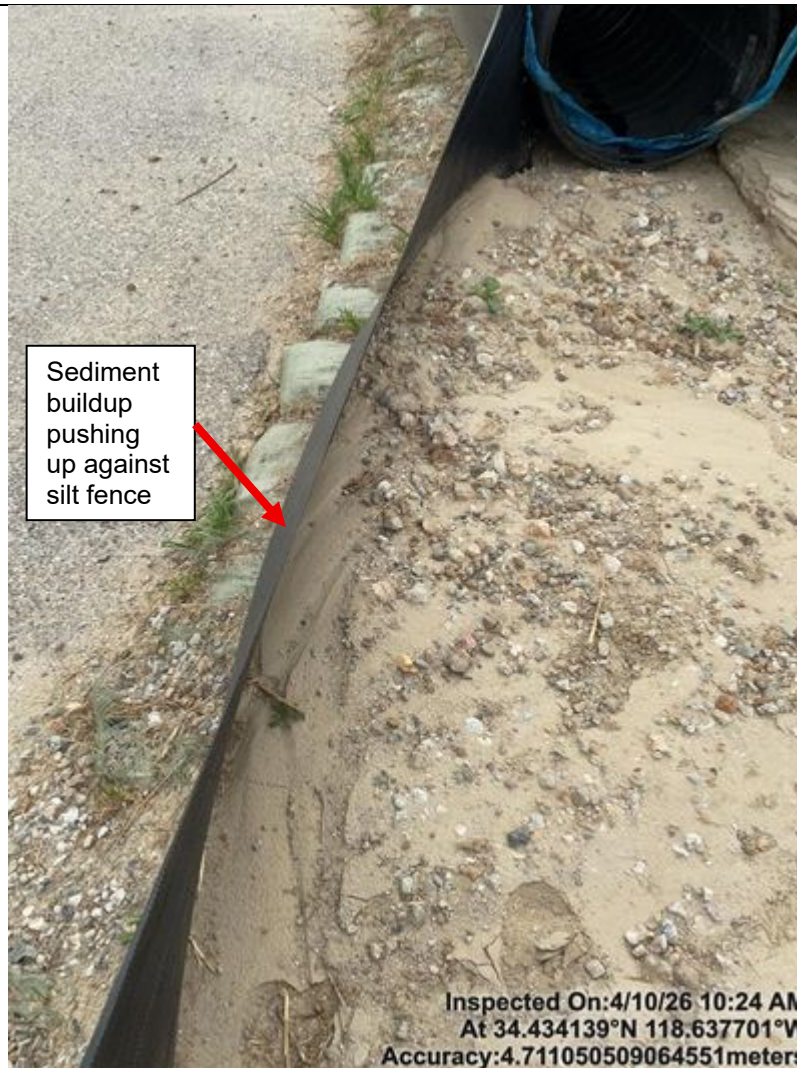
Photo 38  
Sediment buildup along silt fence

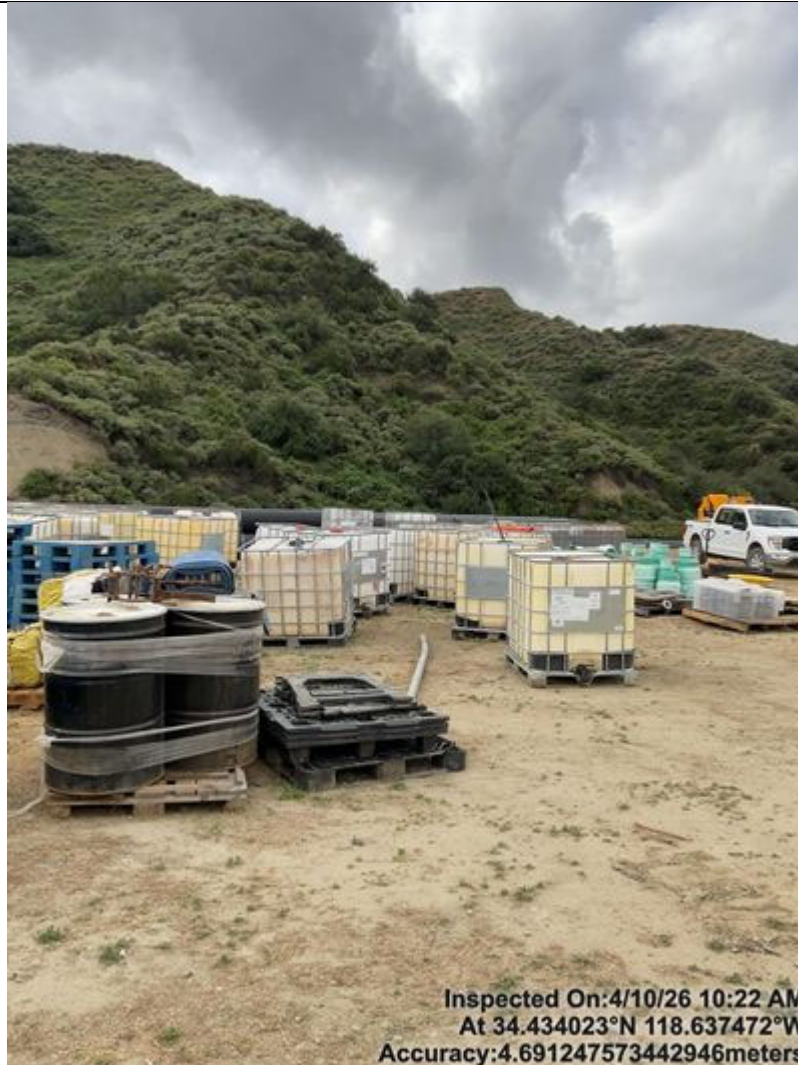
Photo 45  
Drum stored outside labeled "Red Diesel." Drum sounded empty from knock

- The drums and totes observed near the culvert were removed from the equipment storage and pipe laydown area and relocated to the Primary Canyon storage area, where they are maintained with secondary containment. See the enclosed Photo 11 showing the Canyon B equipment storage and laydown area without the drums or totes observed during the inspection.
- Chiquita actively uses this Canyon B area to store equipment necessary to operate and maintain the Landfill. Such equipment which is intended to be stored outdoors may contain varying levels of rust, which is not a significant contributor of pollutants. BMPs to address potential pollutants from equipment storage areas are implemented as outlined in the SWPPP.

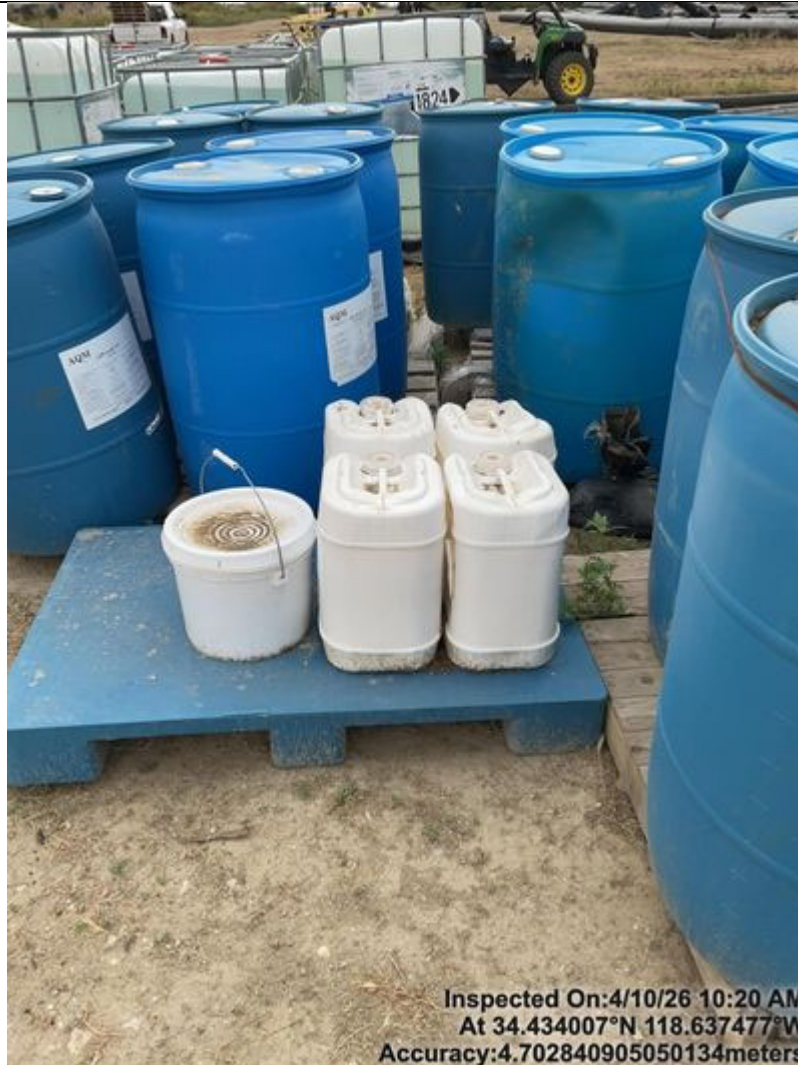
Photo 46  
Another view of the drum and tote storage

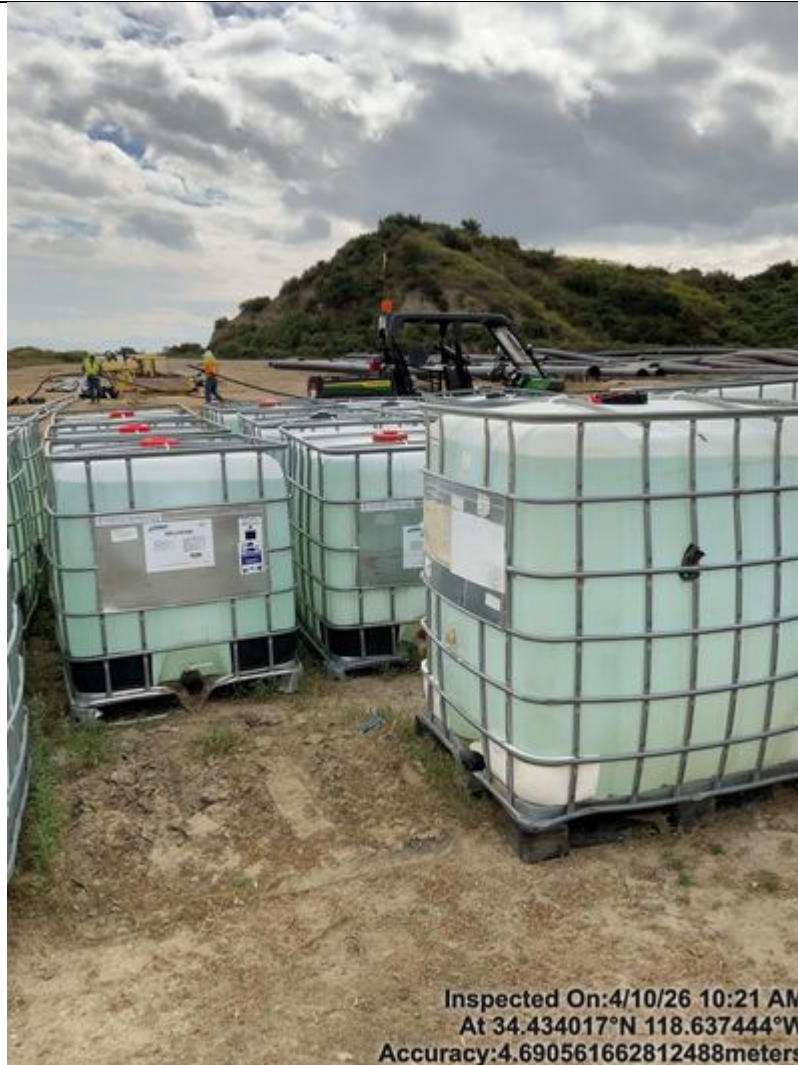
Photo 47  
Unlabeled containers stored outdoors

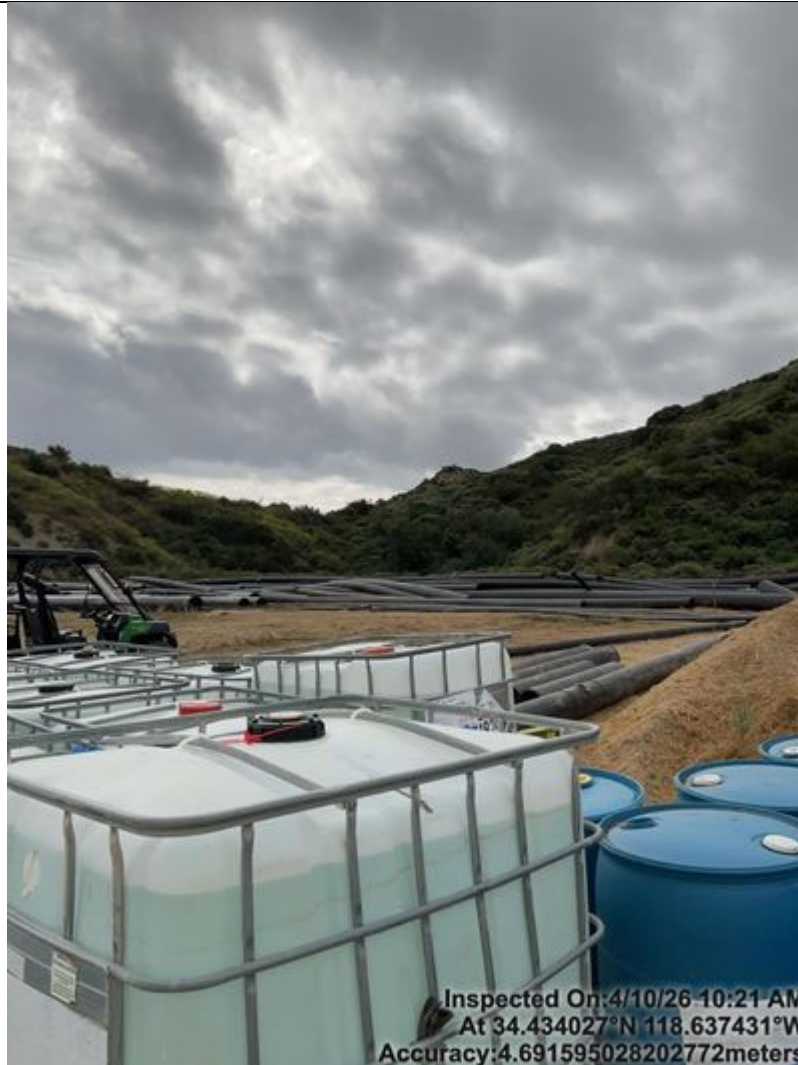
Photo 49  
Pipe lay down yard behind totes

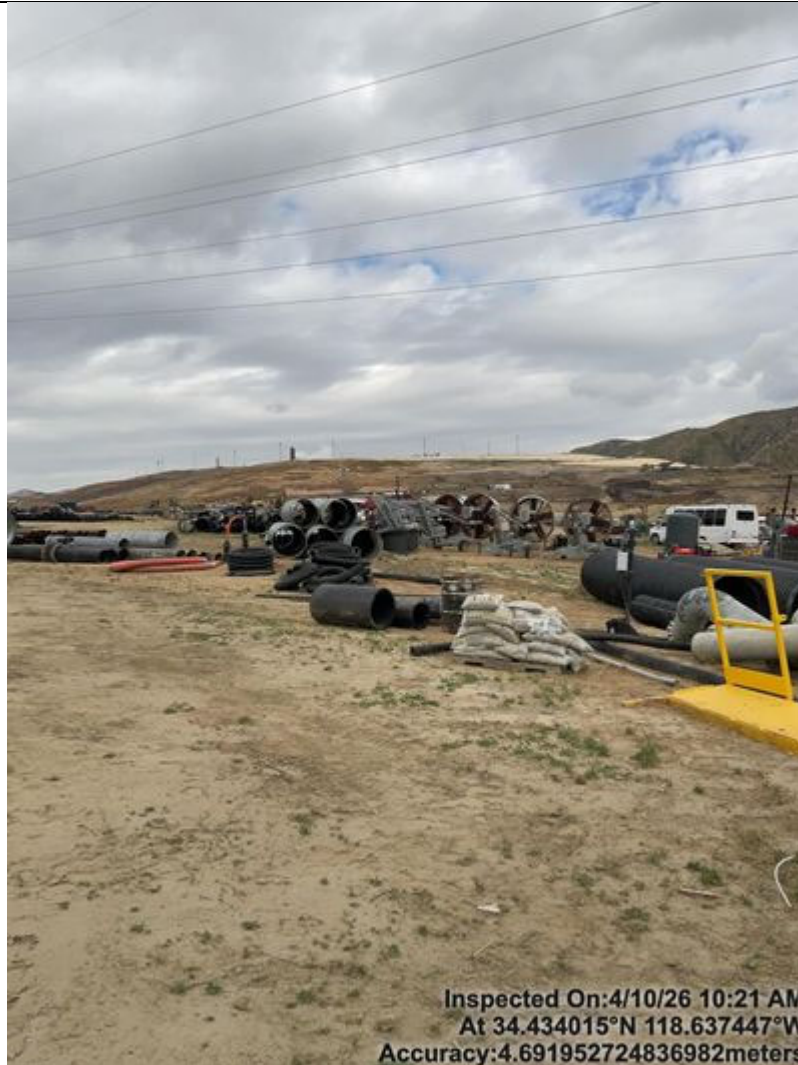
- Good Housekeeping BMPs were not observed in the equipment storage area and pipe lay down yard. This is a violation of IGP Section X.H.1.a.
- Erosion and Sediment Control BMPs were observed to be ineffective throughout the Site. This is a violation of IGP Section X.H.1.e.

Photo 50  
Outdoor equipment storage

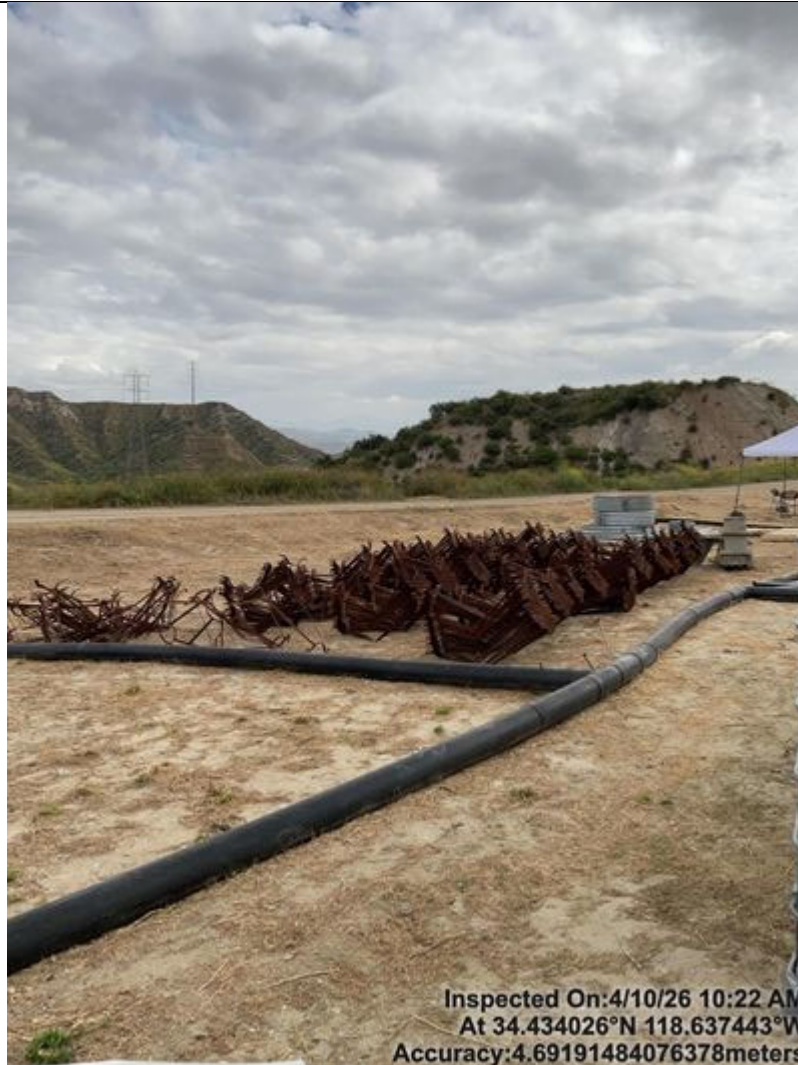
During the inspection, we observed BMPs in disrepair and discussed them with you. We also discussed BMPs that needed to be implemented in the equipment storage area, where we observed rusted metal in areas of exposure. Per our discussion, we would also like to know if pesticide and herbicide use occurs at CCL, since our monitoring results from the south basin show detection of pesticides and herbicides. Please provide the following information regarding pesticide/herbicide use at CCL:

Photo 51  
Metal material stored outdoors. I observed rust on the metal material

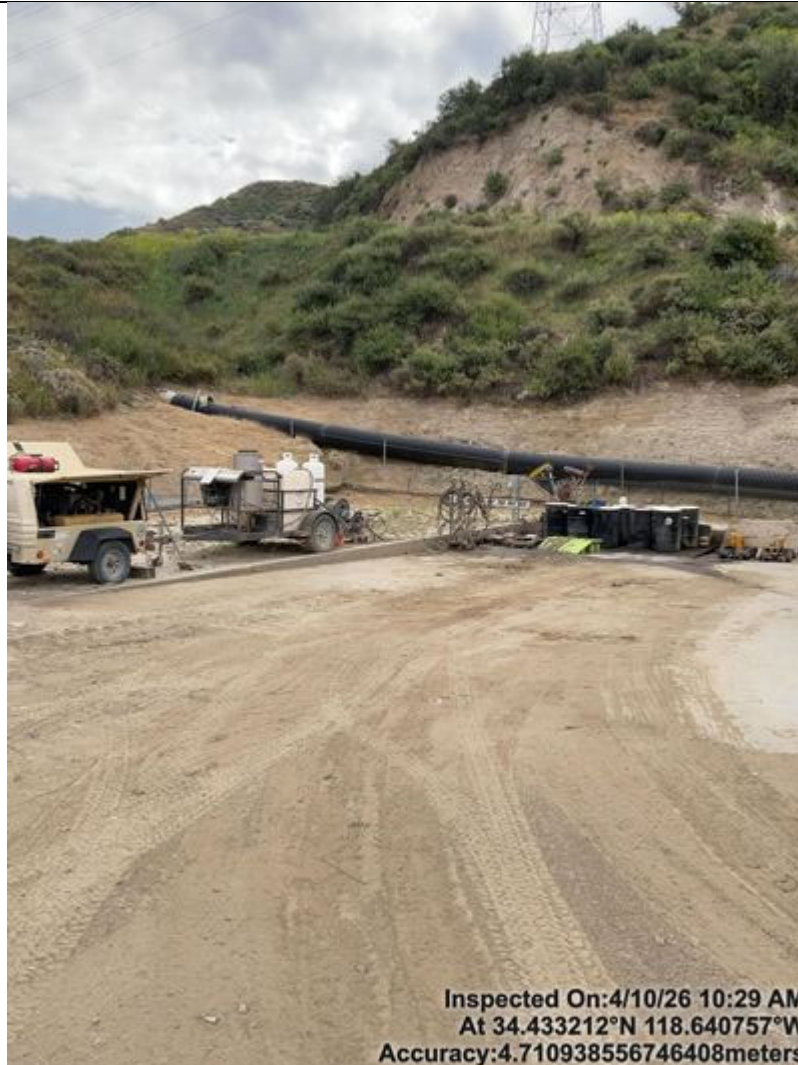
Photo 54

Equipment maintenance area with concrete under dirt. Mr. Breuer stated that the concrete area does not flow to the basins

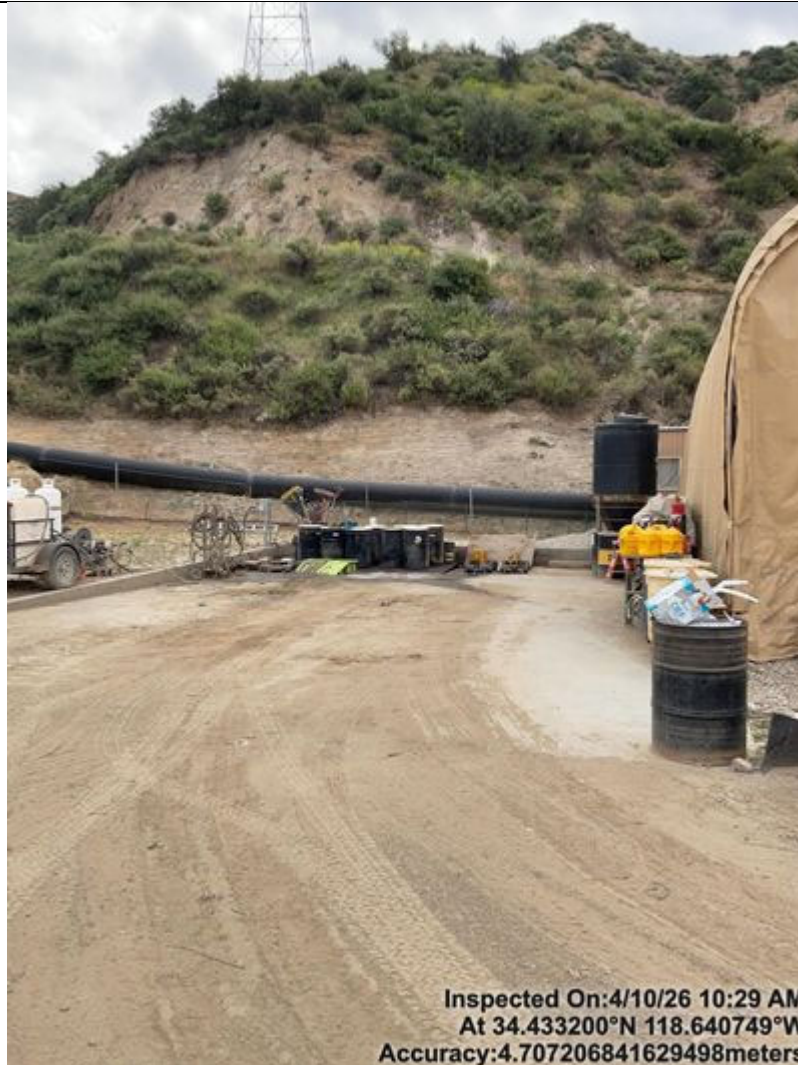
Photo 55

Equipment maintenance area with concrete under dirt. Mr. Breuer stated that the concrete area does not flow to the basins

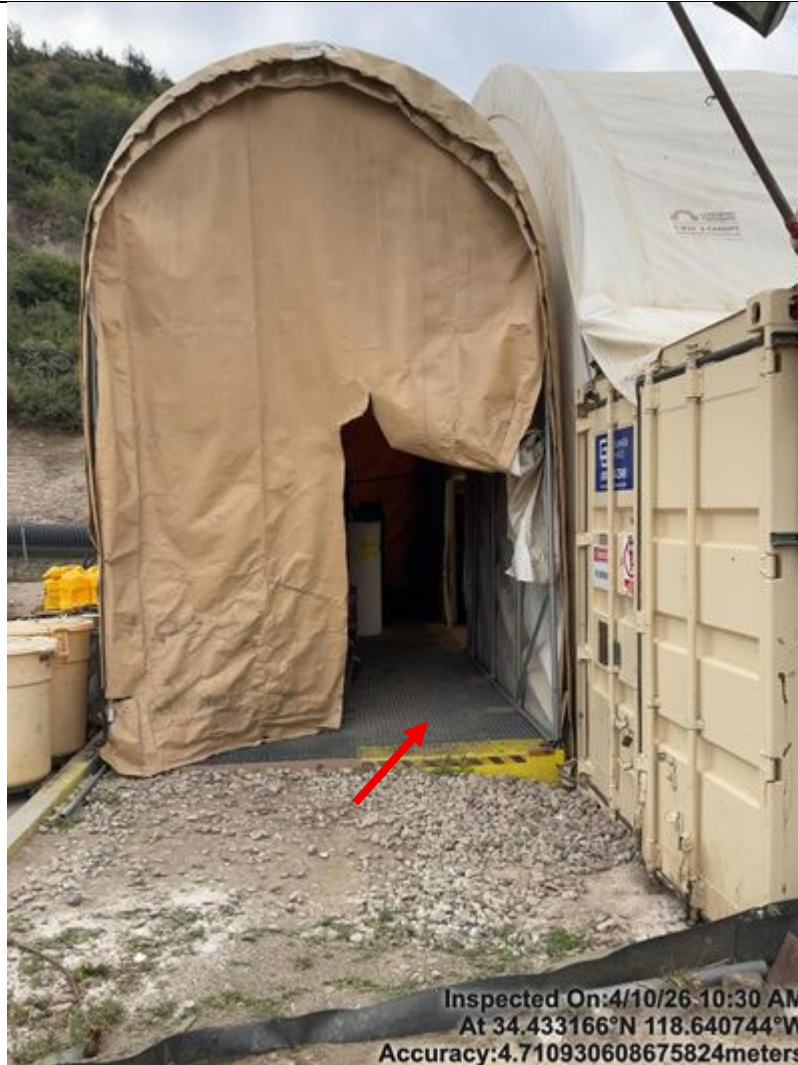
Photo 56  
Covered oil storage area with secondary containment grate below (red arrow)

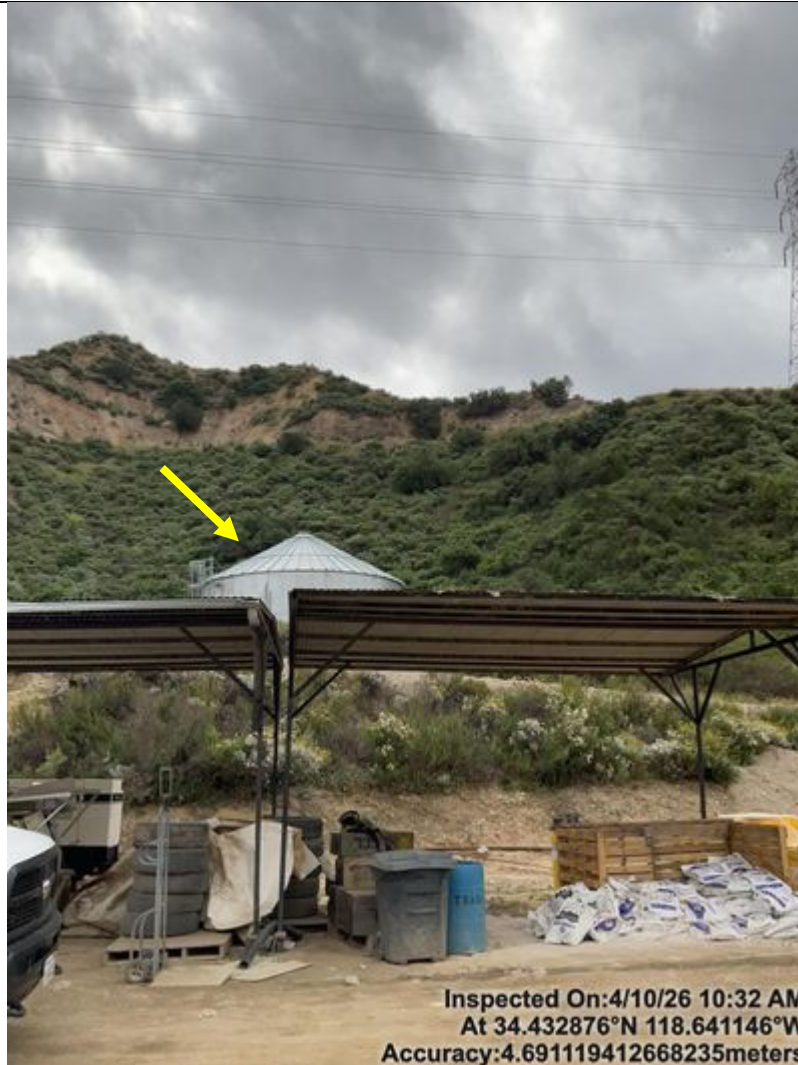
Photo 61

The yellow arrow points to the freshwater storage tank used for dust control

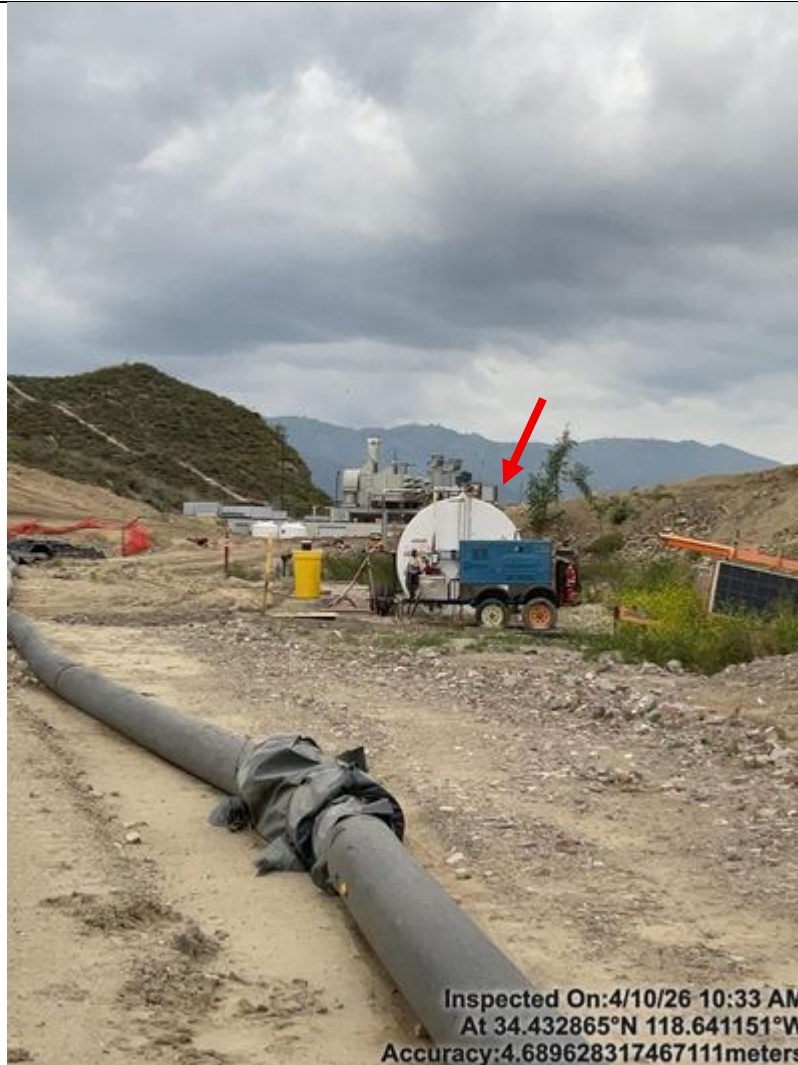
Photo 63

The red arrow points to the diesel storage and fueling area. Mr. Breuer told us that the black pipe is for storm water conveyance

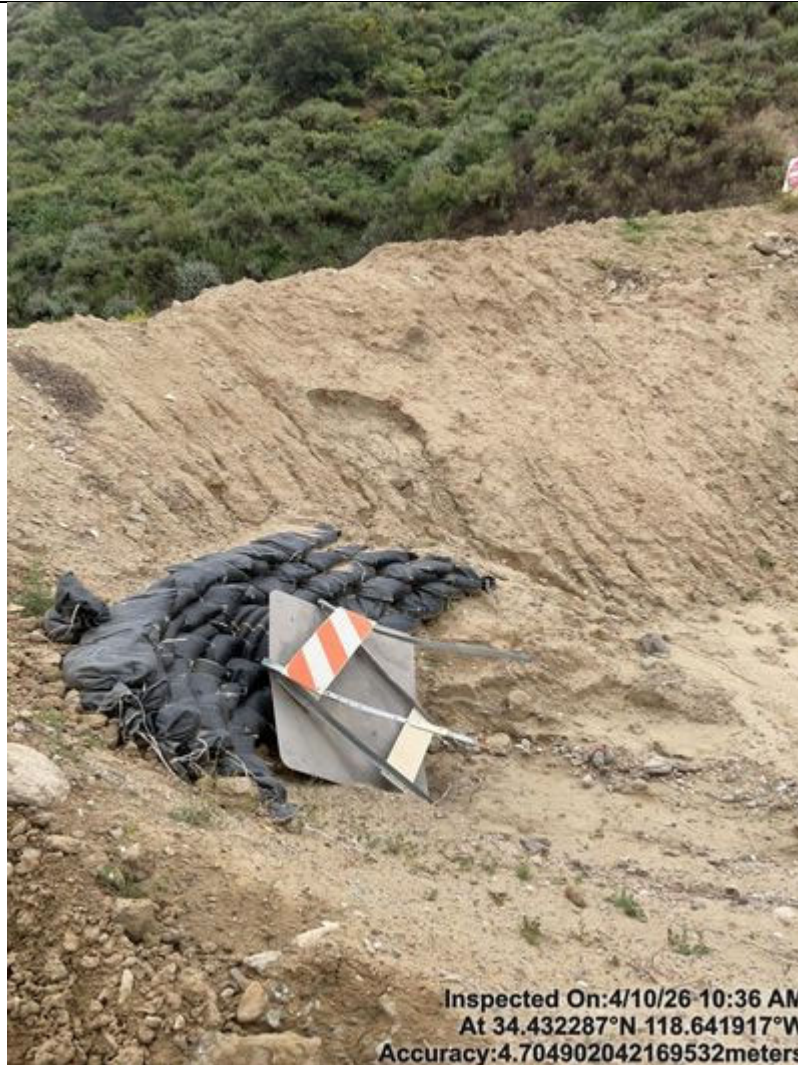
Photo 67  
Fallen sign blocking the east inlet to the South Basin

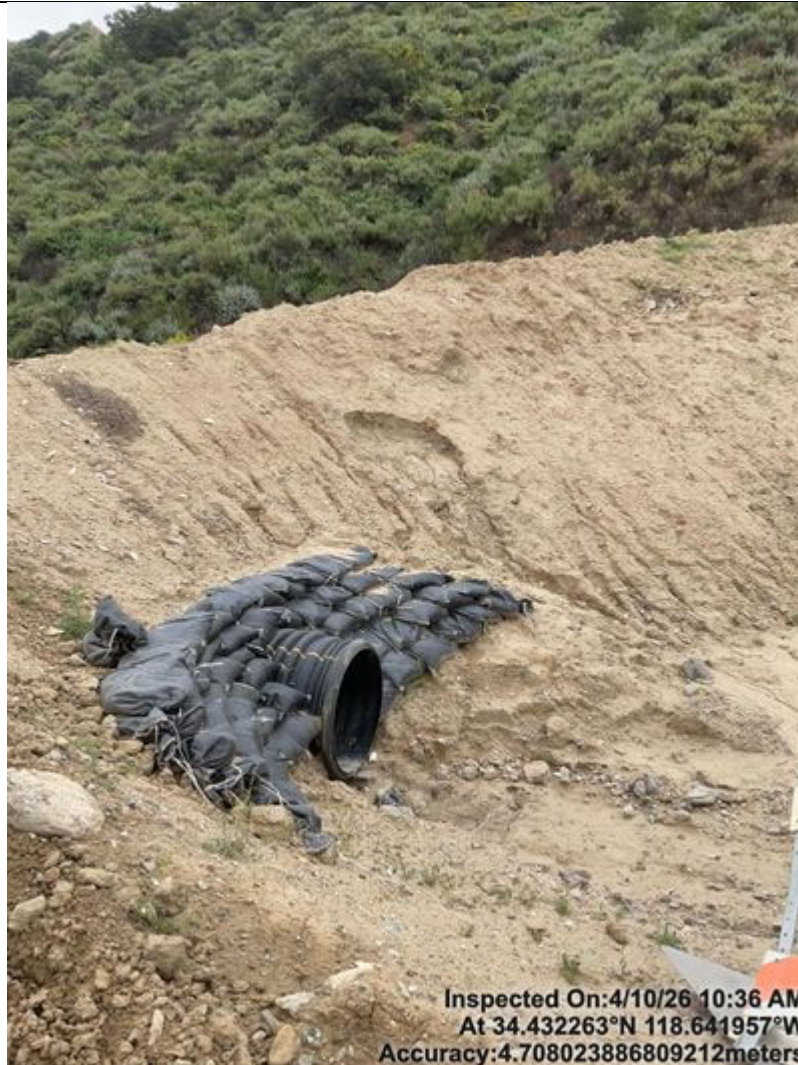
Photo 68

Mr. Breuer removed the sign blocking the east inlet to the South Basin

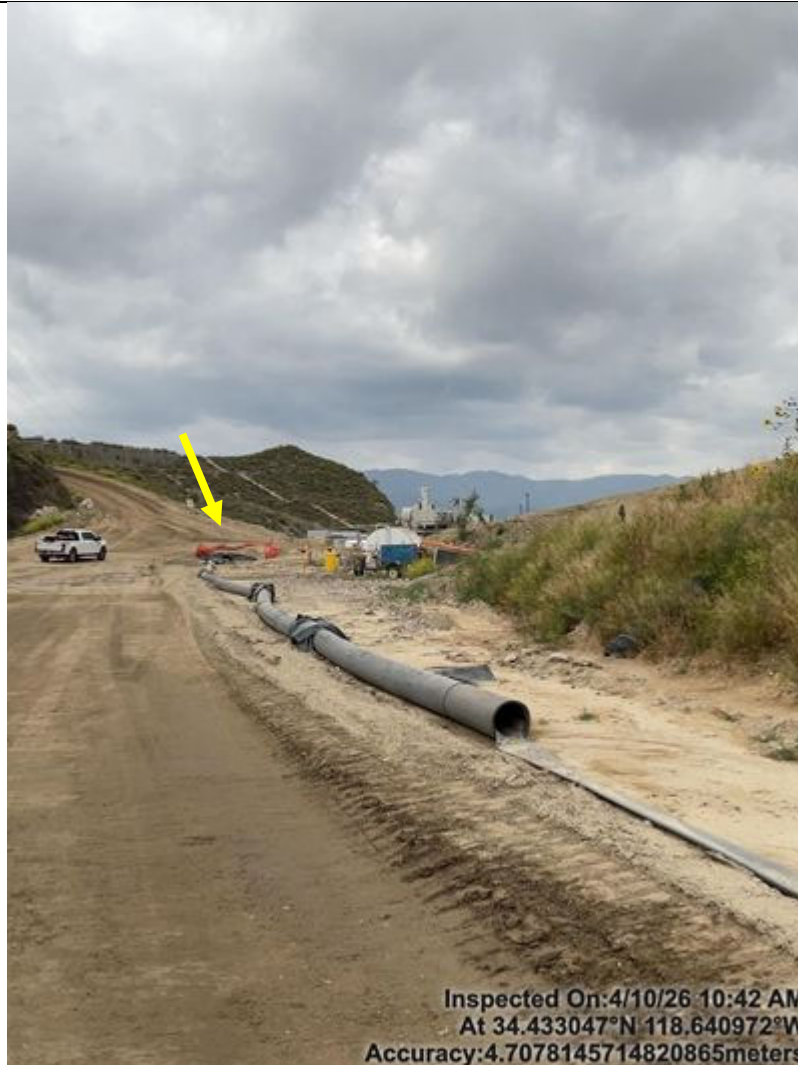
Photo 69

Black stormwater conveyance pipe. The east inlet leading to the South Basin is shown with the yellow arrow

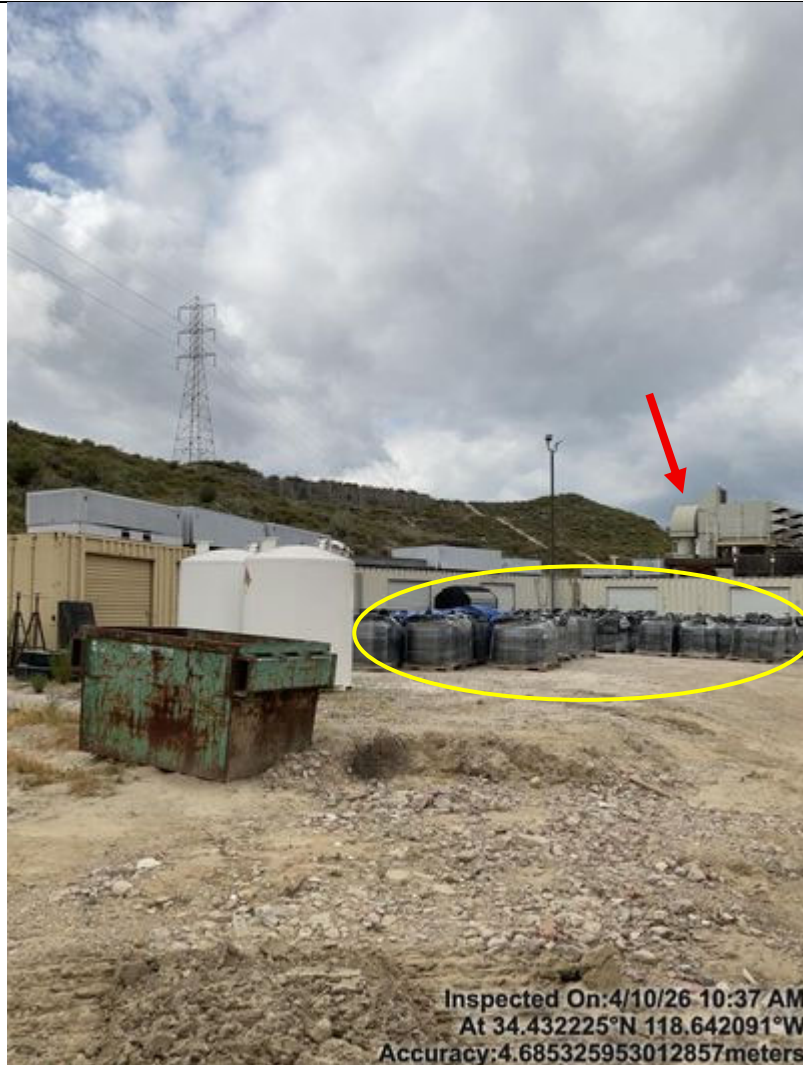
Photo 70

The red arrow points to the electric generator which Mr. Breuer stated was not in use. Mr. Breuer stated that the two white tanks are empty. Mr. Breuer also pointed out the granulated activated carbon (GAC) used for leachate treatment (circled in yellow).

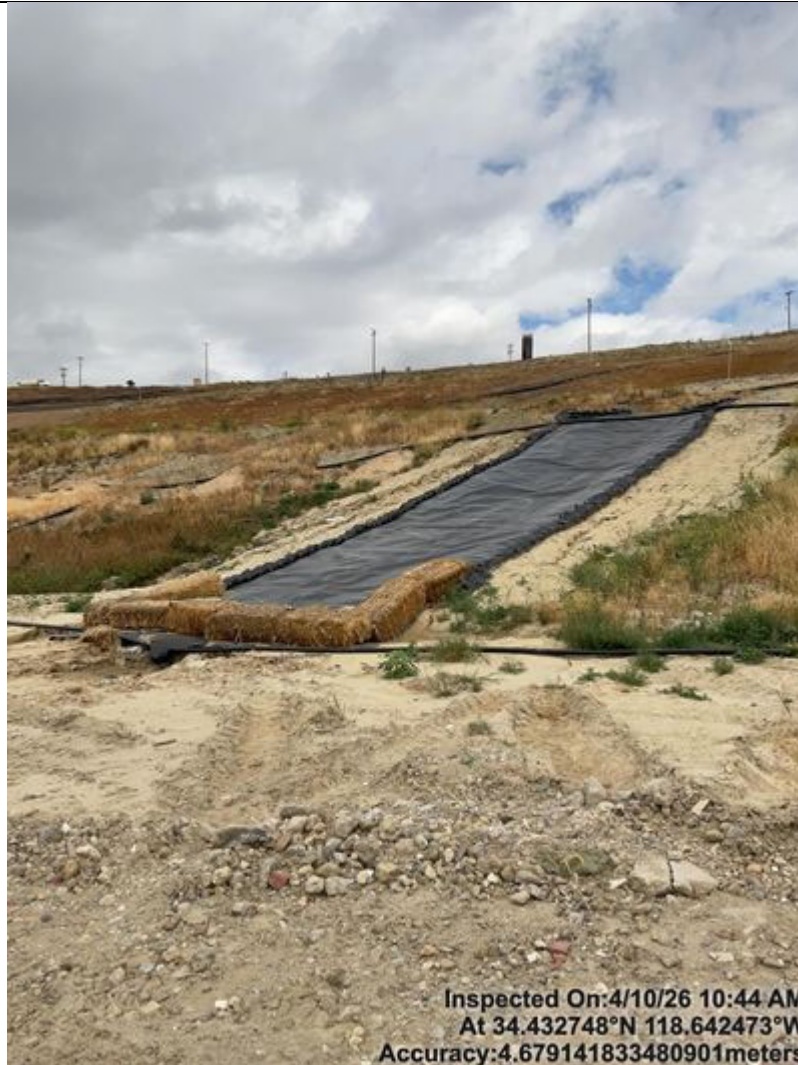
Photo 73

A view of the erosion control BMP with sandbags along the sides and hay bales at the front

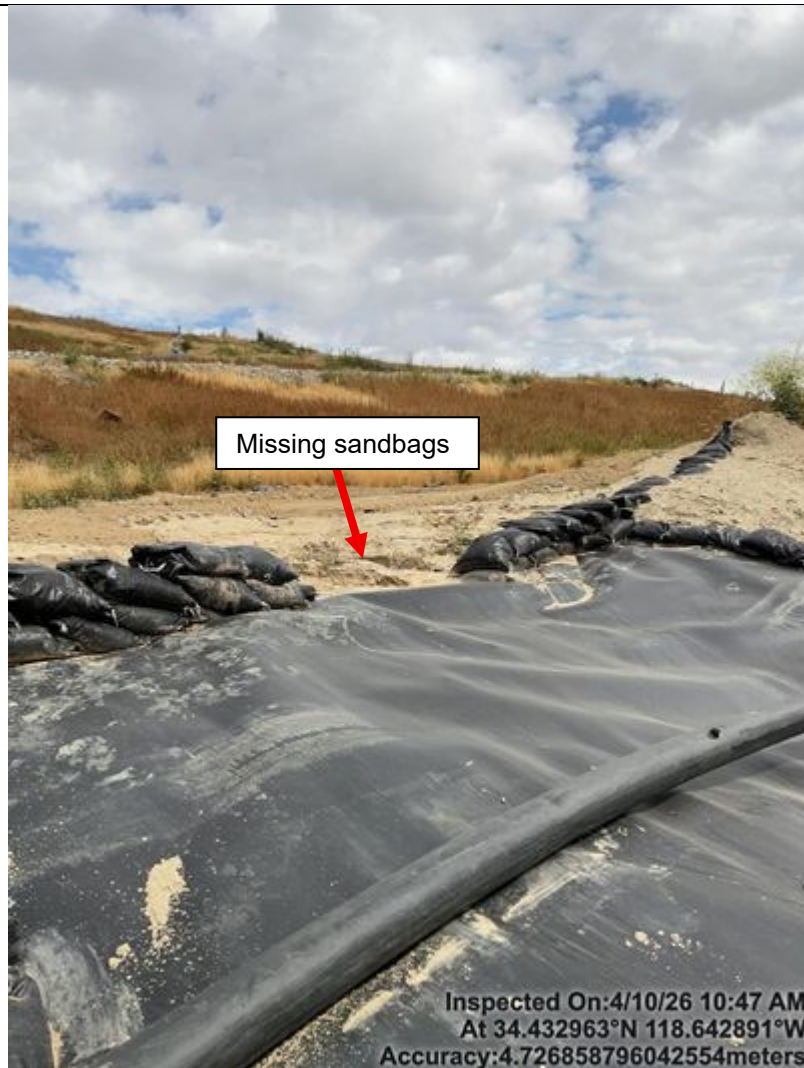
We then saw granulated activated carbon (GAC) bales outdoors (Photo 70-71). Mr. Breuer explained that GAC is used for leachate treatment. Next we drove to an erosion control BMP used to guide stormwater down the hillside (Photos 72-83). I observed erosion rills and gullies next to and under the erosion control BMP. I also observed sediment buildup behind and in front of the hay bales (Photo 83). We informed Mr. Breuer that this erosion control BMP would not be effective during a large storm event.

Photo 81  
Close-up of erosion next to erosion control BMP
