**Re: Inspection Report Response, April 10, 2026 Inspection  
Los Angeles Regional Water Quality Control Board**

**Attachment A – April 2026 Industrial Stormwater Inspection Report**

Los Angeles Regional Water Quality Control Board  
**INDUSTRIAL STORMWATER INSPECTION REPORT**  
(State Water Resources Control Board Order WQ 2018-0028-DWQ, NPDES No. CAS000001)

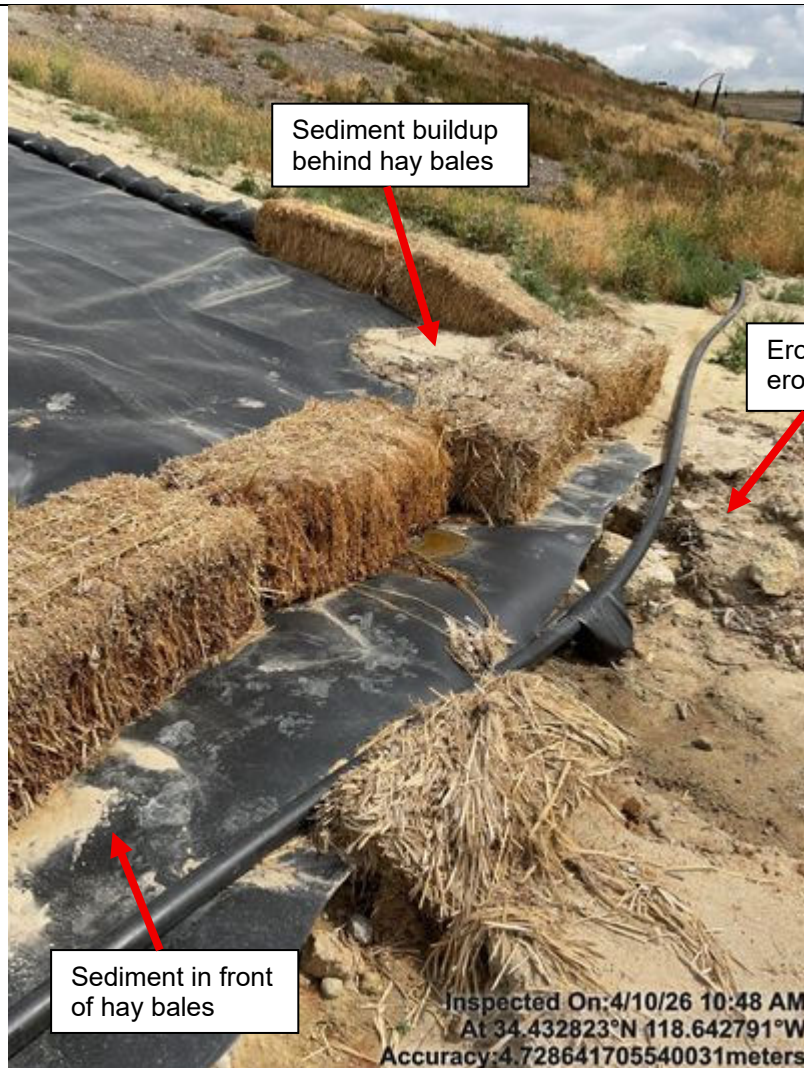
Photo 83

We then saw granulated activated carbon (GAC) bales outdoors (Photo 70-71). Mr. Breuer explained that GAC is used for leachate treatment. Next we drove to an erosion control BMP used to guide stormwater down the hillside (Photos 72-83). I observed erosion rills and gullies next to and under the erosion control BMP. I also observed sediment buildup behind and in front of the hay bales (Photo 83). We informed Mr. Breuer that this erosion control BMP would not be effective during a large storm event.

- Good Housekeeping BMPs were not observed in the equipment storage area and pipe lay down yard. This is a violation of IGP Section X.H.1.a.
- Erosion and Sediment Control BMPs were observed to be ineffective throughout the Site. This is a violation of IGP Section X.H.1.e.

Close-up of erosion control BMP. We told Mr. Breuer that this BMP in its current state would not be adequate for a large storm

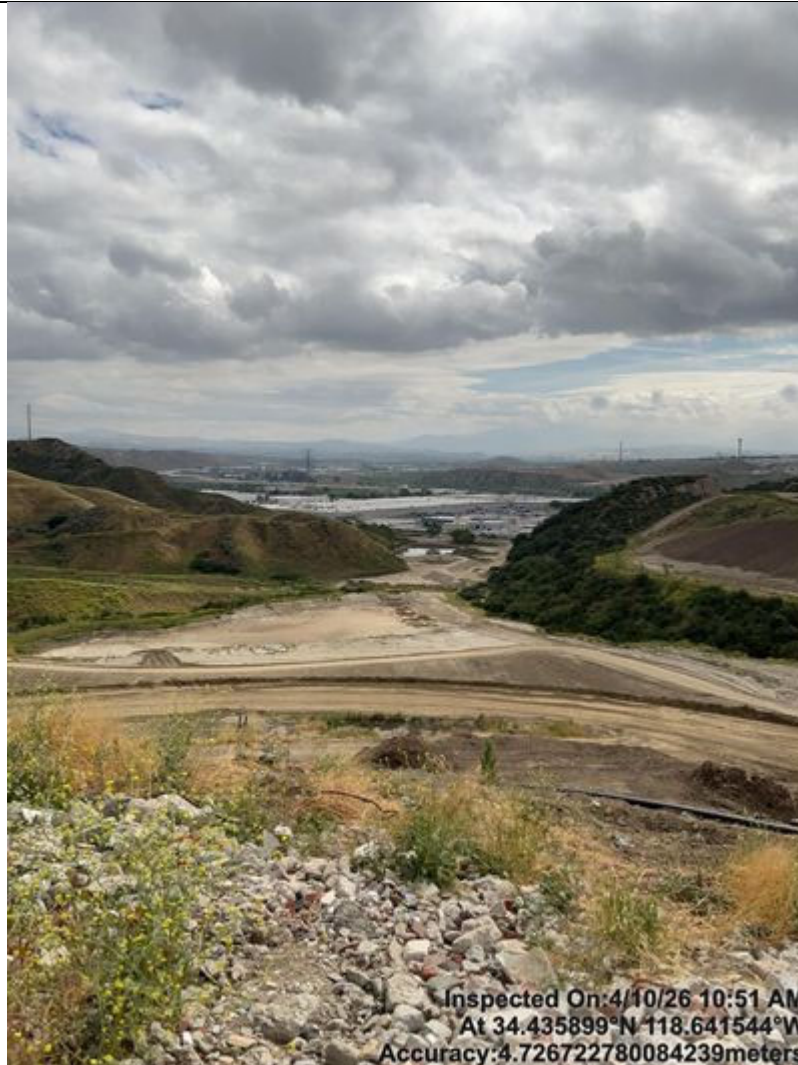
Photo 84

Aerial view of sub basin 4. Mr. Breuer stated that the standpipe would have to overflow to reach the other basins

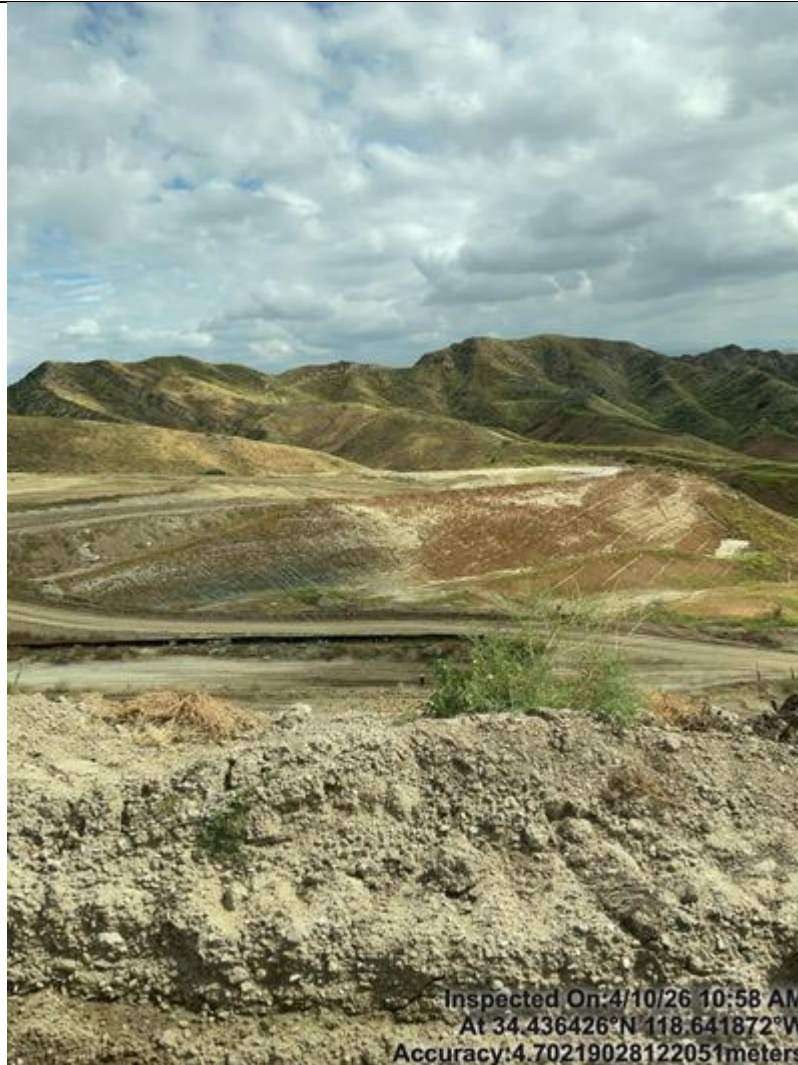
Photo 90

Hydroseeding sloped area. Mr. Breuer stated that this area has CGP coverage and would have become next landfill cell if still accepting waste. Mr. Breuer stated that he would consider this activity as part of industrial operations and not separate construction, so he would like to see if CGP coverage can be removed

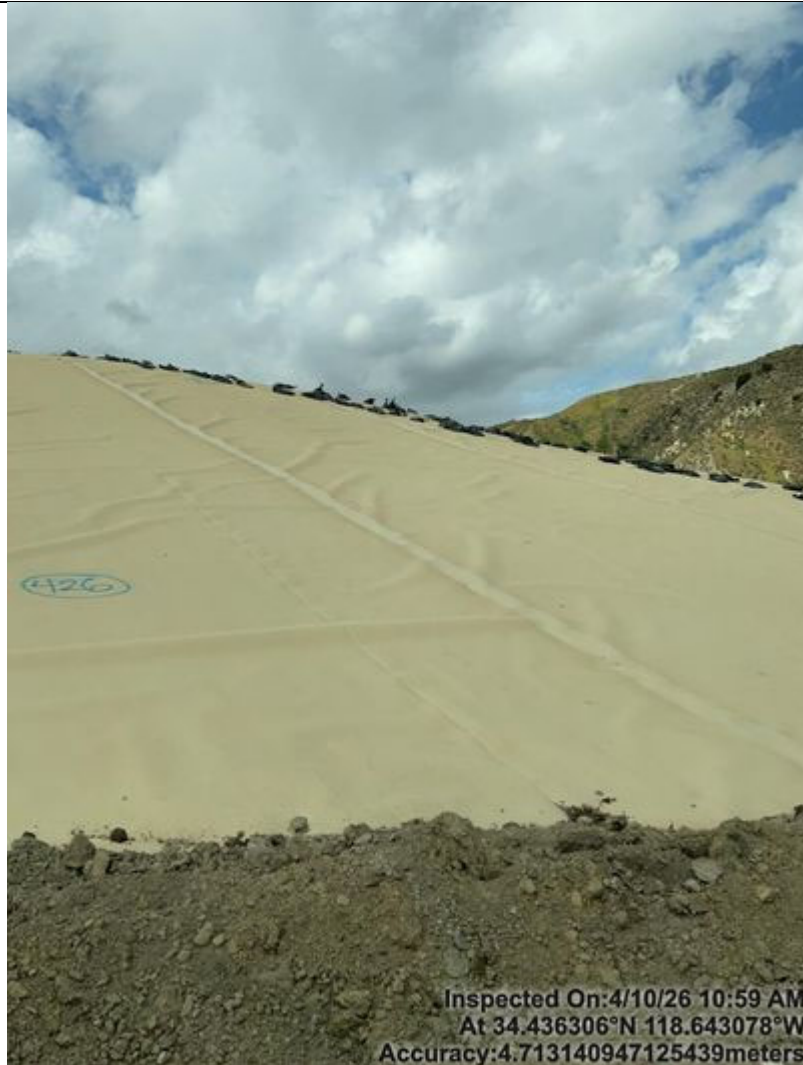
Photo 91  
EVOH cover on landfill slopes, required by DTSC

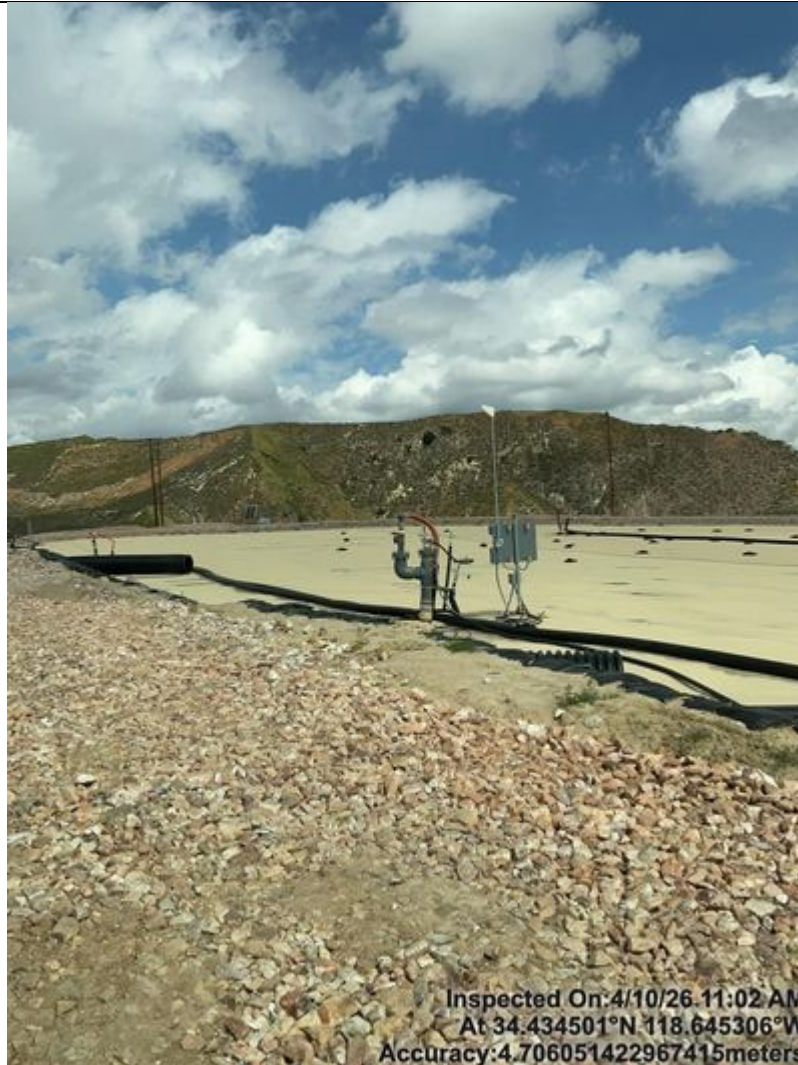
Photo 92

Well head meant to collect leachate and gas and pumping leachate goes to pipes

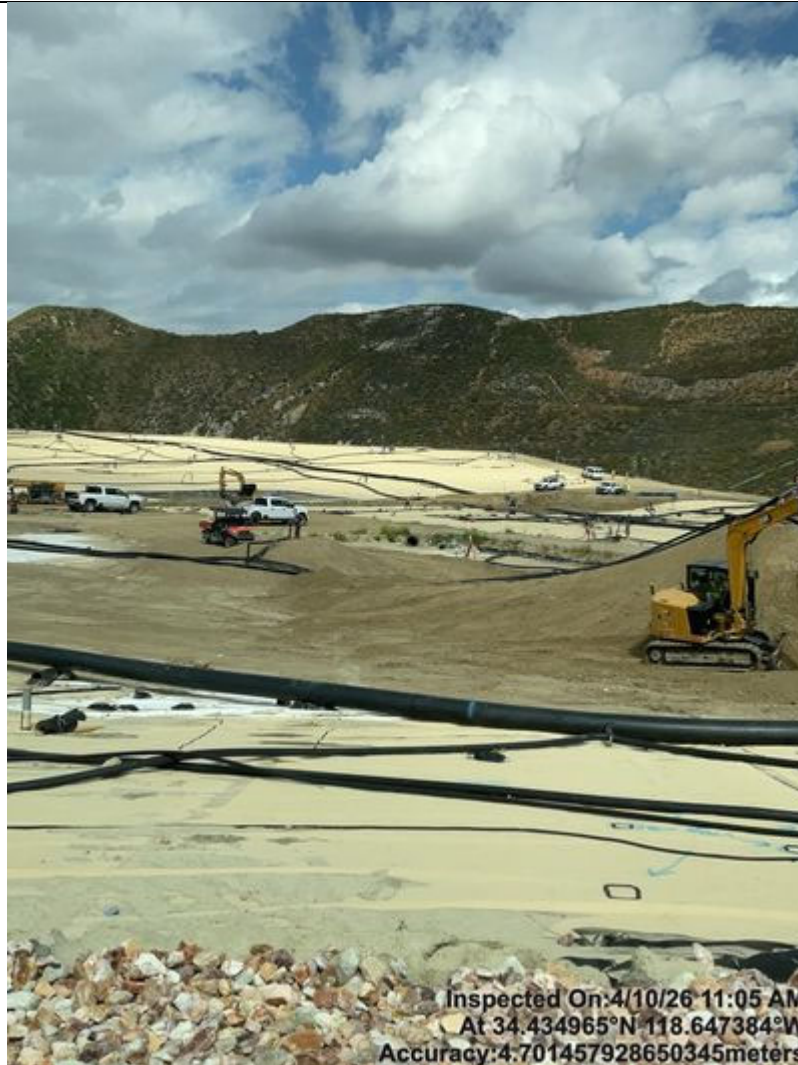
Photo 93

Top basin. If full it gets pumped to channel and can go to either South or East Basin

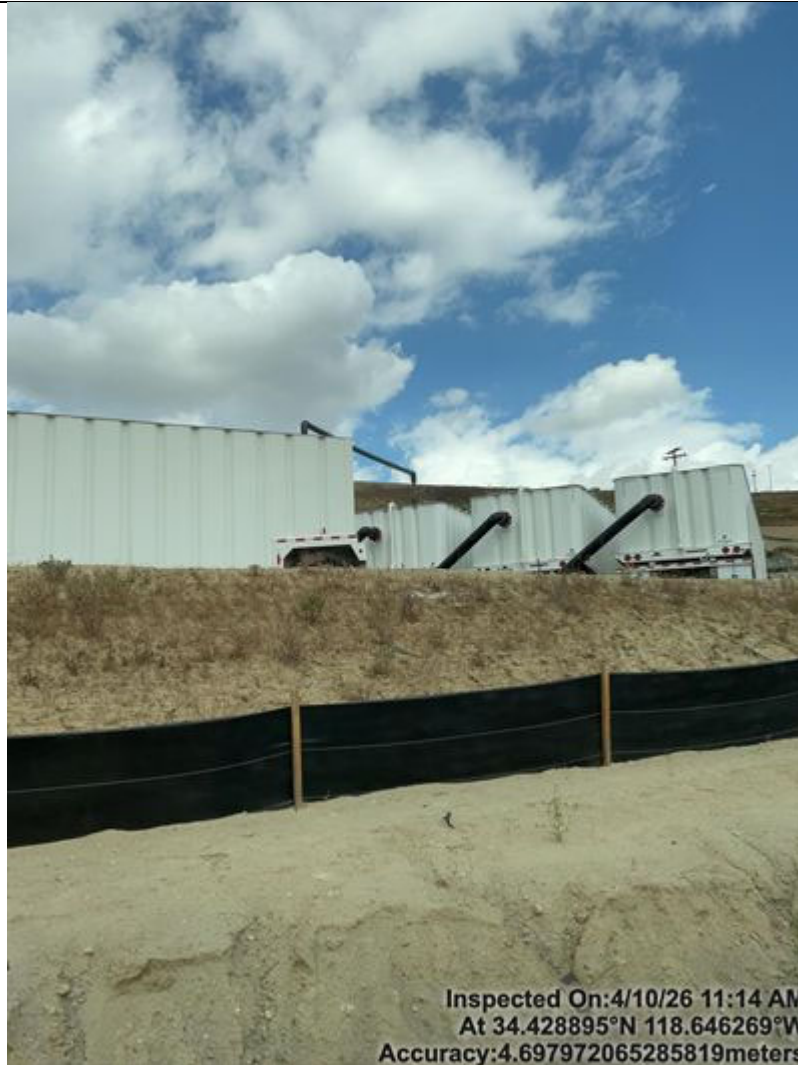
Photo 94

Clarifier and influent tanks for collected leachate. Mr. Breuer stated that 250,000 gal of leachate is collected each day. Leachate testing process is done at tank farm.

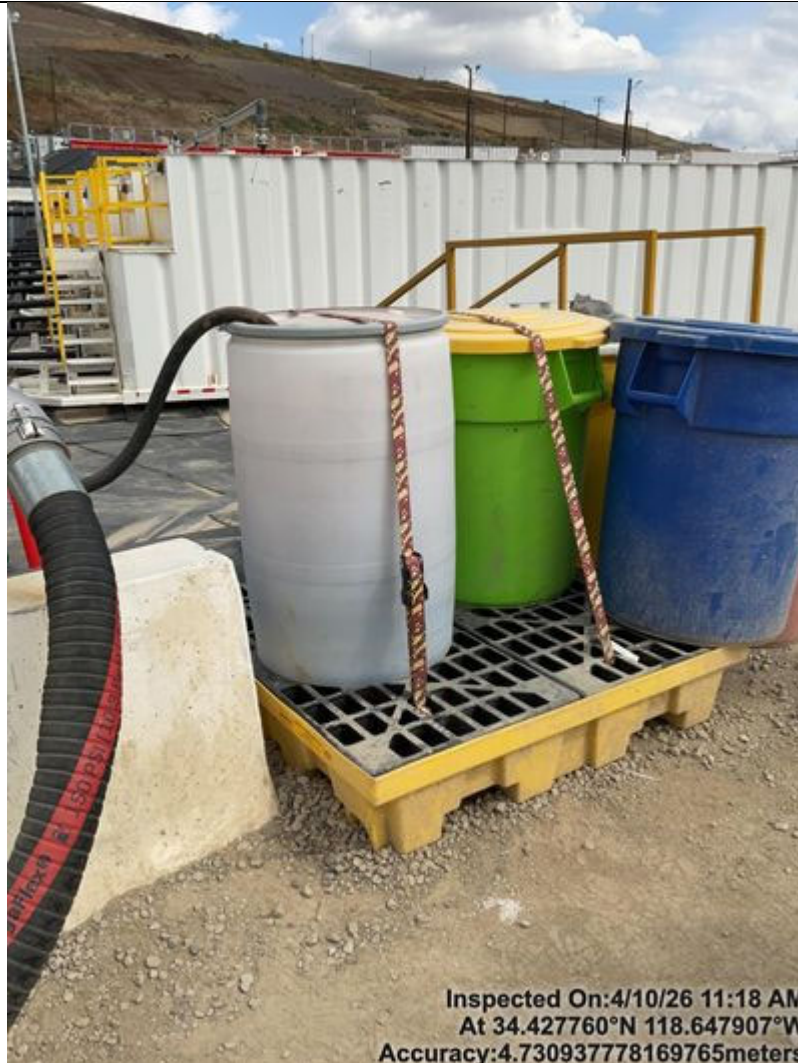
Photo 97

Drums with secondary containment used to collect drips from leachate loading into trucks via pipes. We observed leachate in the drum had a similar consistency and appearance to black coffee

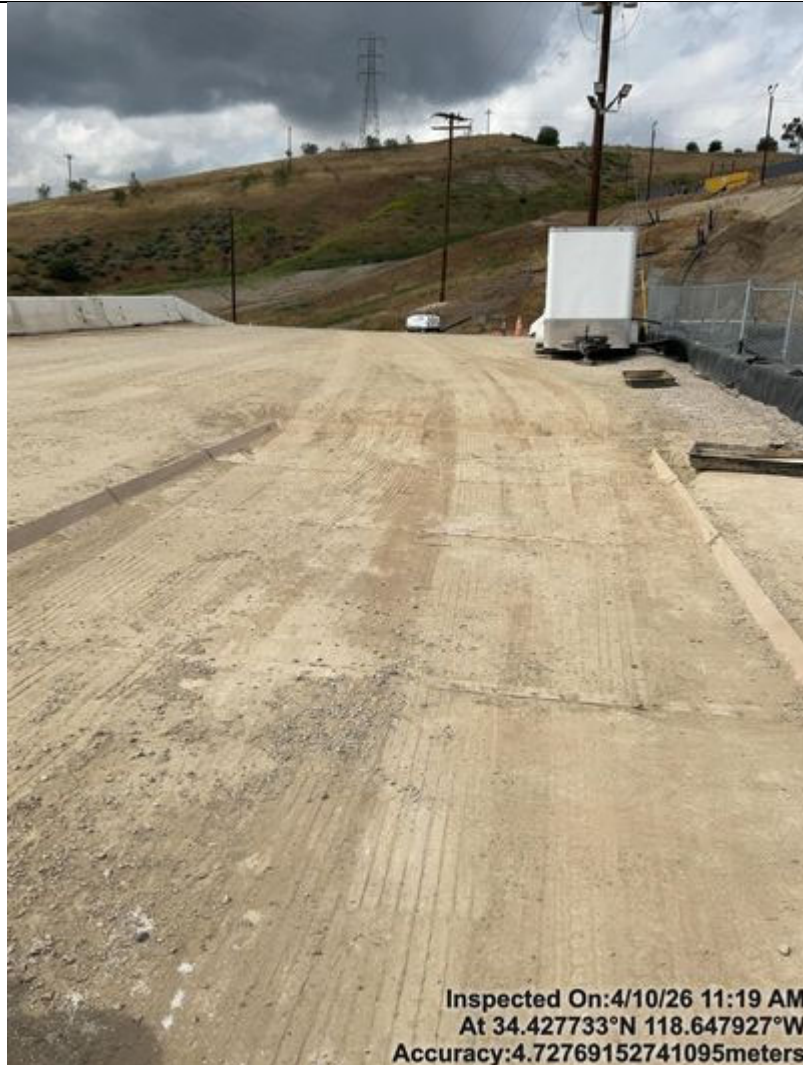
Photo 98

Loading pad for loading treated leachate into trucks. We asked which basin a leachate spill could theoretically reach if a large enough leak occurred. Mr. Breuer answered the South Basin.

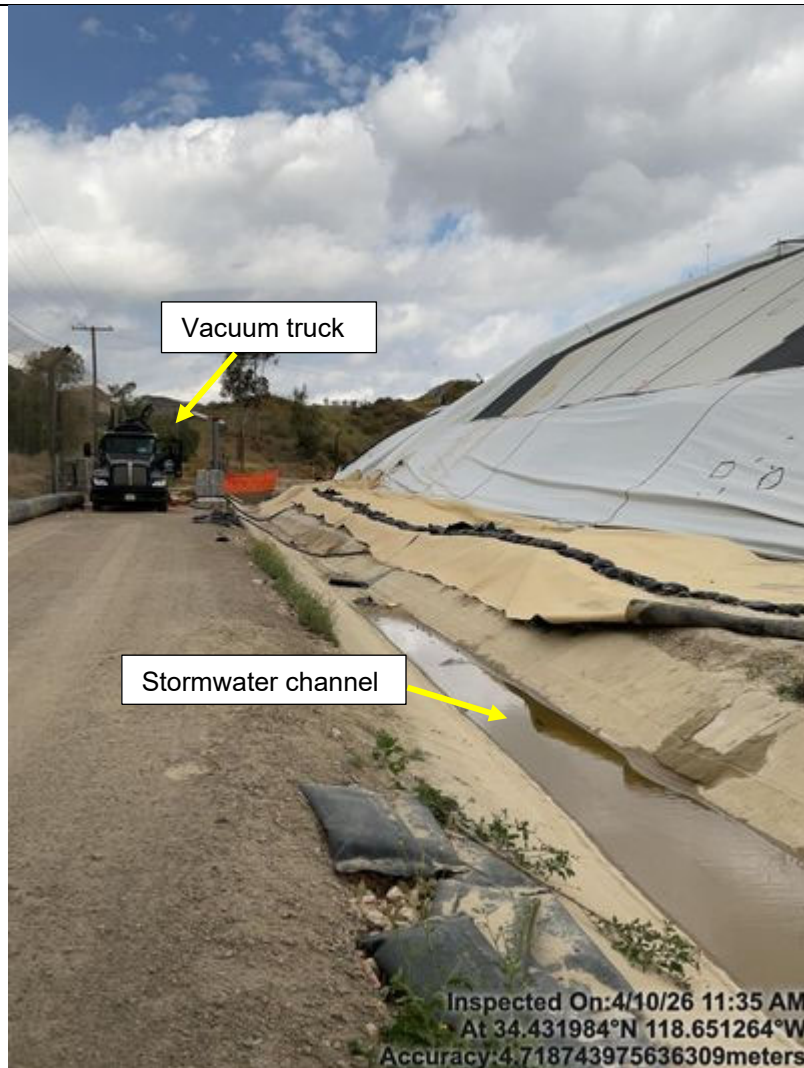
Photo 108

Tanker truck there 24/7 to make sure that no seeps get to channel

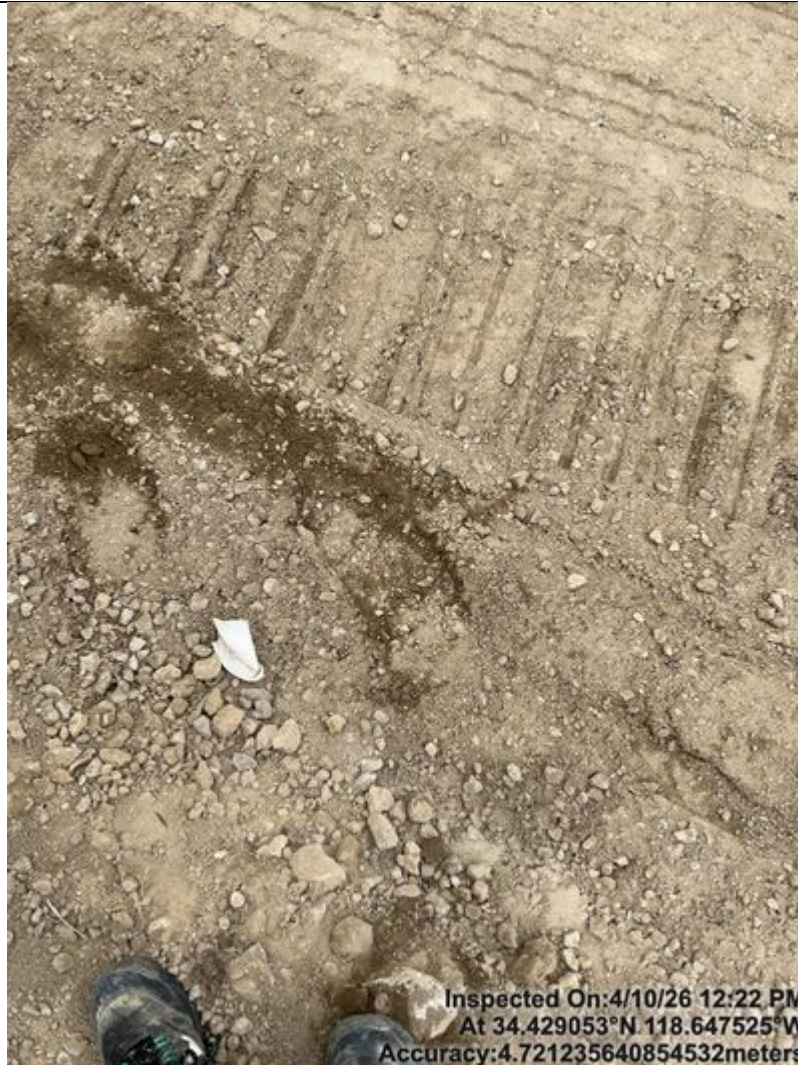
Photo 118

Ground after reported spill cleaned up. The wet spots were from water sprayed on the fresh soil for compaction after the contaminated soil was removed.

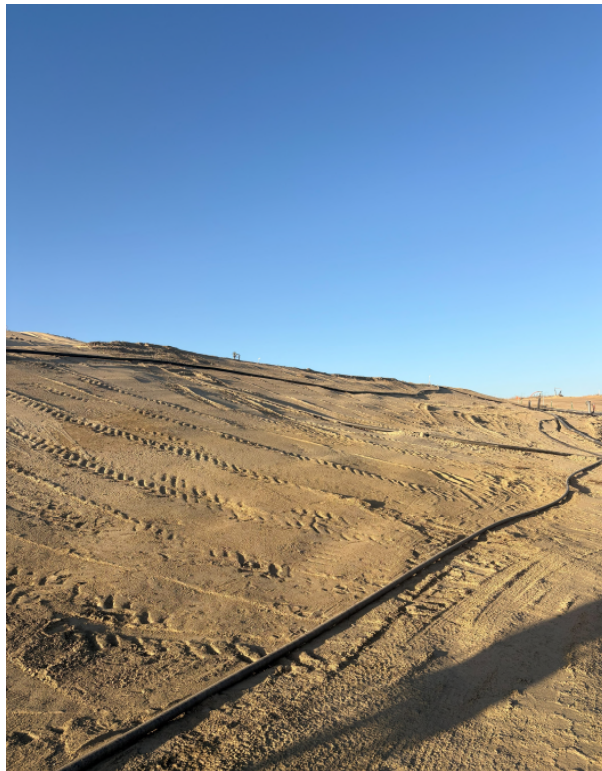
Photo 6. EVOH Preparation Work Near Former Temporary Hay-Bale Erosion Control BMP on East Slope of Main Canyon

associated accumulated sediment, was removed by Chiquita staff prior to receipt of the Report. The current condition as of September 30, 2026, of the area is shown below. The area will be covered in EVOH soon. See enclosed Photos 5 and 6.

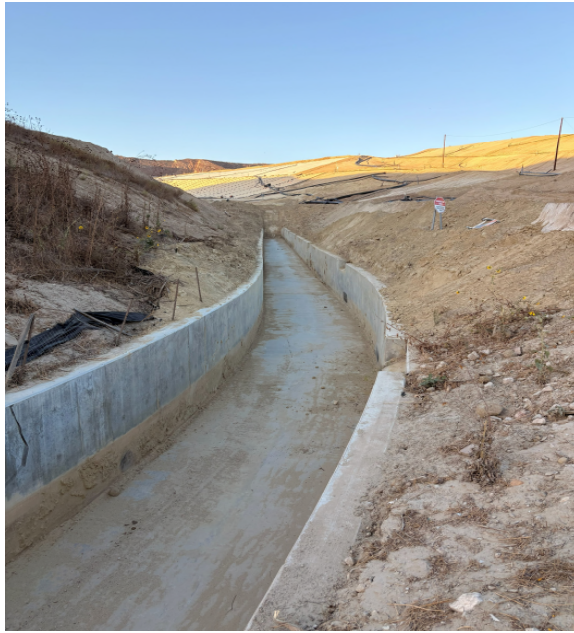
Photo 7. Box Culvert Near West Toe of Landfill

- The area identified in the Report's Photos 100-103 was subsequently incorporated into the West Toe project. As part of that work, the stormwater channel area and the material within it were covered, graded, and compacted, so the previously observed sediment is no longer exposed within the channel. The dirt check dams remain in place as flow-control BMPs for potential spills, leaks, or seeps. The check dams are installed and functioning as intended, which was verified during the September 6, 2026 rain event. The enclosed Photos 7, 8, and 9 show the channel and check-dam conditions as of September 30, 2026.

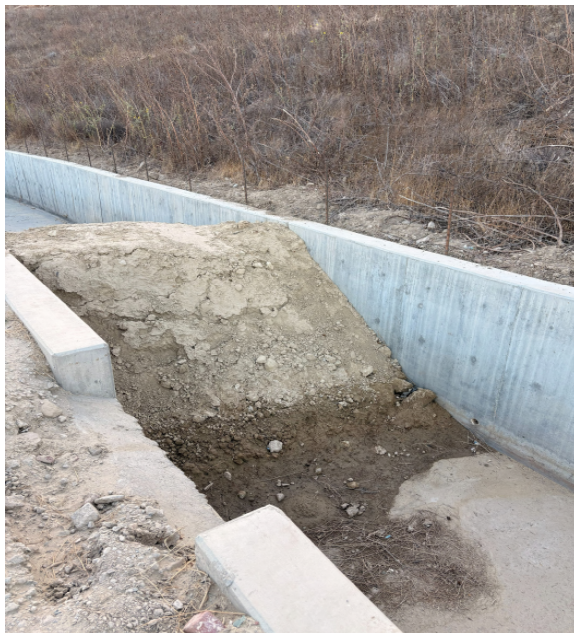
Photo 8. Check Dam in Box Culvert Near West Toe of Landfill

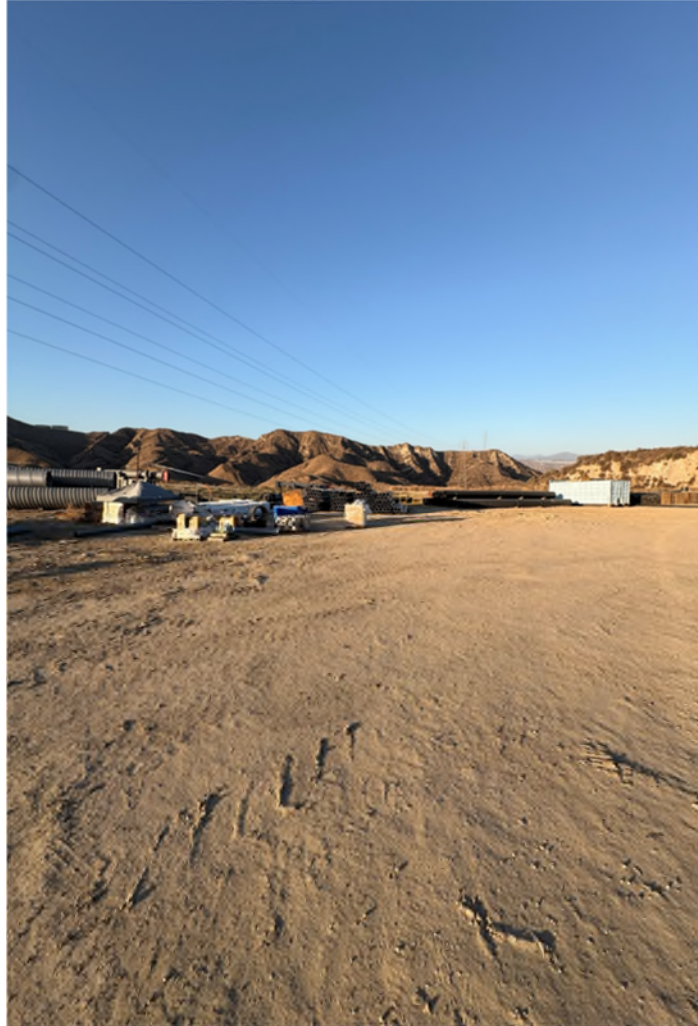
Photo 11. Canyon B Equipment Storage and Laydown Without Drums or Totes

- The drums and totes observed near the culvert were removed from the equipment storage and pipe laydown area and relocated to the Primary Canyon storage area, where they are maintained with secondary containment. See the enclosed Photo 11 showing the Canyon B equipment storage and laydown area without the drums or totes observed during the inspection.
- Chiquita actively uses this Canyon B area to store equipment necessary to operate and maintain the Landfill. Such equipment which is intended to be stored outdoors may contain varying levels of rust, which is not a significant contributor of pollutants. BMPs to address potential pollutants from equipment storage areas are implemented as outlined in the SWPPP.
