SCS ENGINEERS

15 de junio de 2026

Asunto: Informe Mensual de mayo de 2026 Conforme a los Objetivos 1A-3 y 5 de la Orden de Cumplimiento de la LEA del 6 de junio de 2024 y a la Carta del 30 de julio de 2024, Vertedero de Chiquita Canyon, Castaic, California

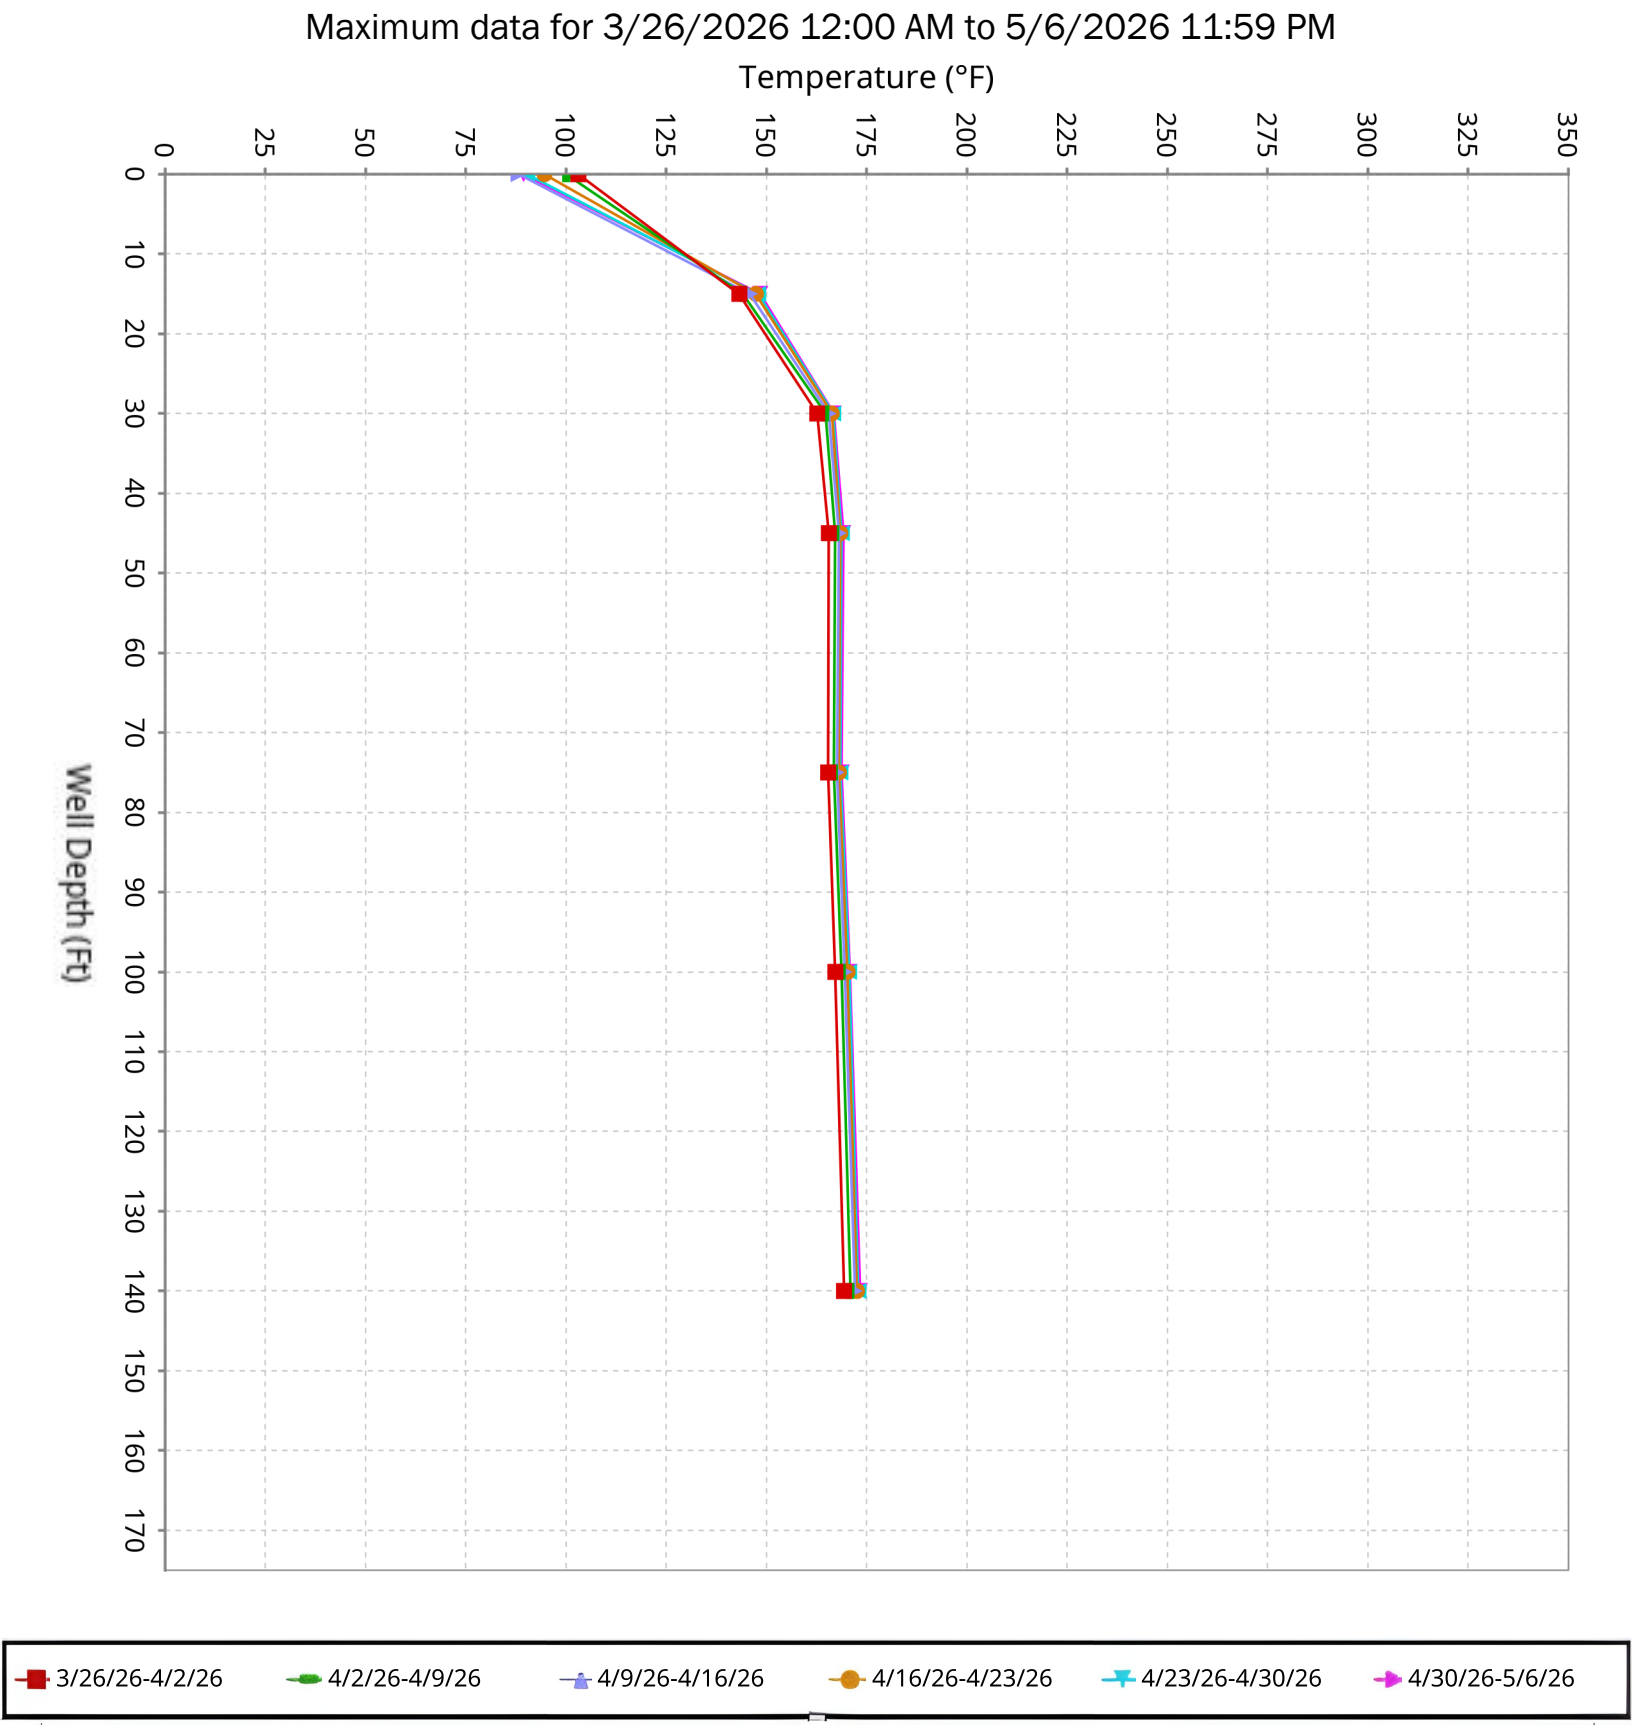
Vertical Temperature Profiles from Temperature Probes at Chiquita Landfill for TP-14

TP-14- The 150 foot thermocouple reported a maximum temperature of 2305 o May 10th, which was anomalous and likely associated with a potential thermocouple malfunction. As a result the report temperatures from May 11 to 15th are considered anomalous also. The 150 foot thermocouple was replaced on May 16thand temperature were consistent with previously recorded values.

- The 45-foot thermocouple remained consistent with previous recoded temperatures.
- TP-14
  - The 150-foot thermocouple reported a maximum temperature of 249°F on May 10th, which was anomalous and likely associated with a potential thermocouple sensor malfunction. As a result, the reported temperatures of 0°F from May 11th to May 15th are also considered anomalous. The 150-foot thermocouple was replaced on May 16th and temperatures were consistent with previous recorded values.

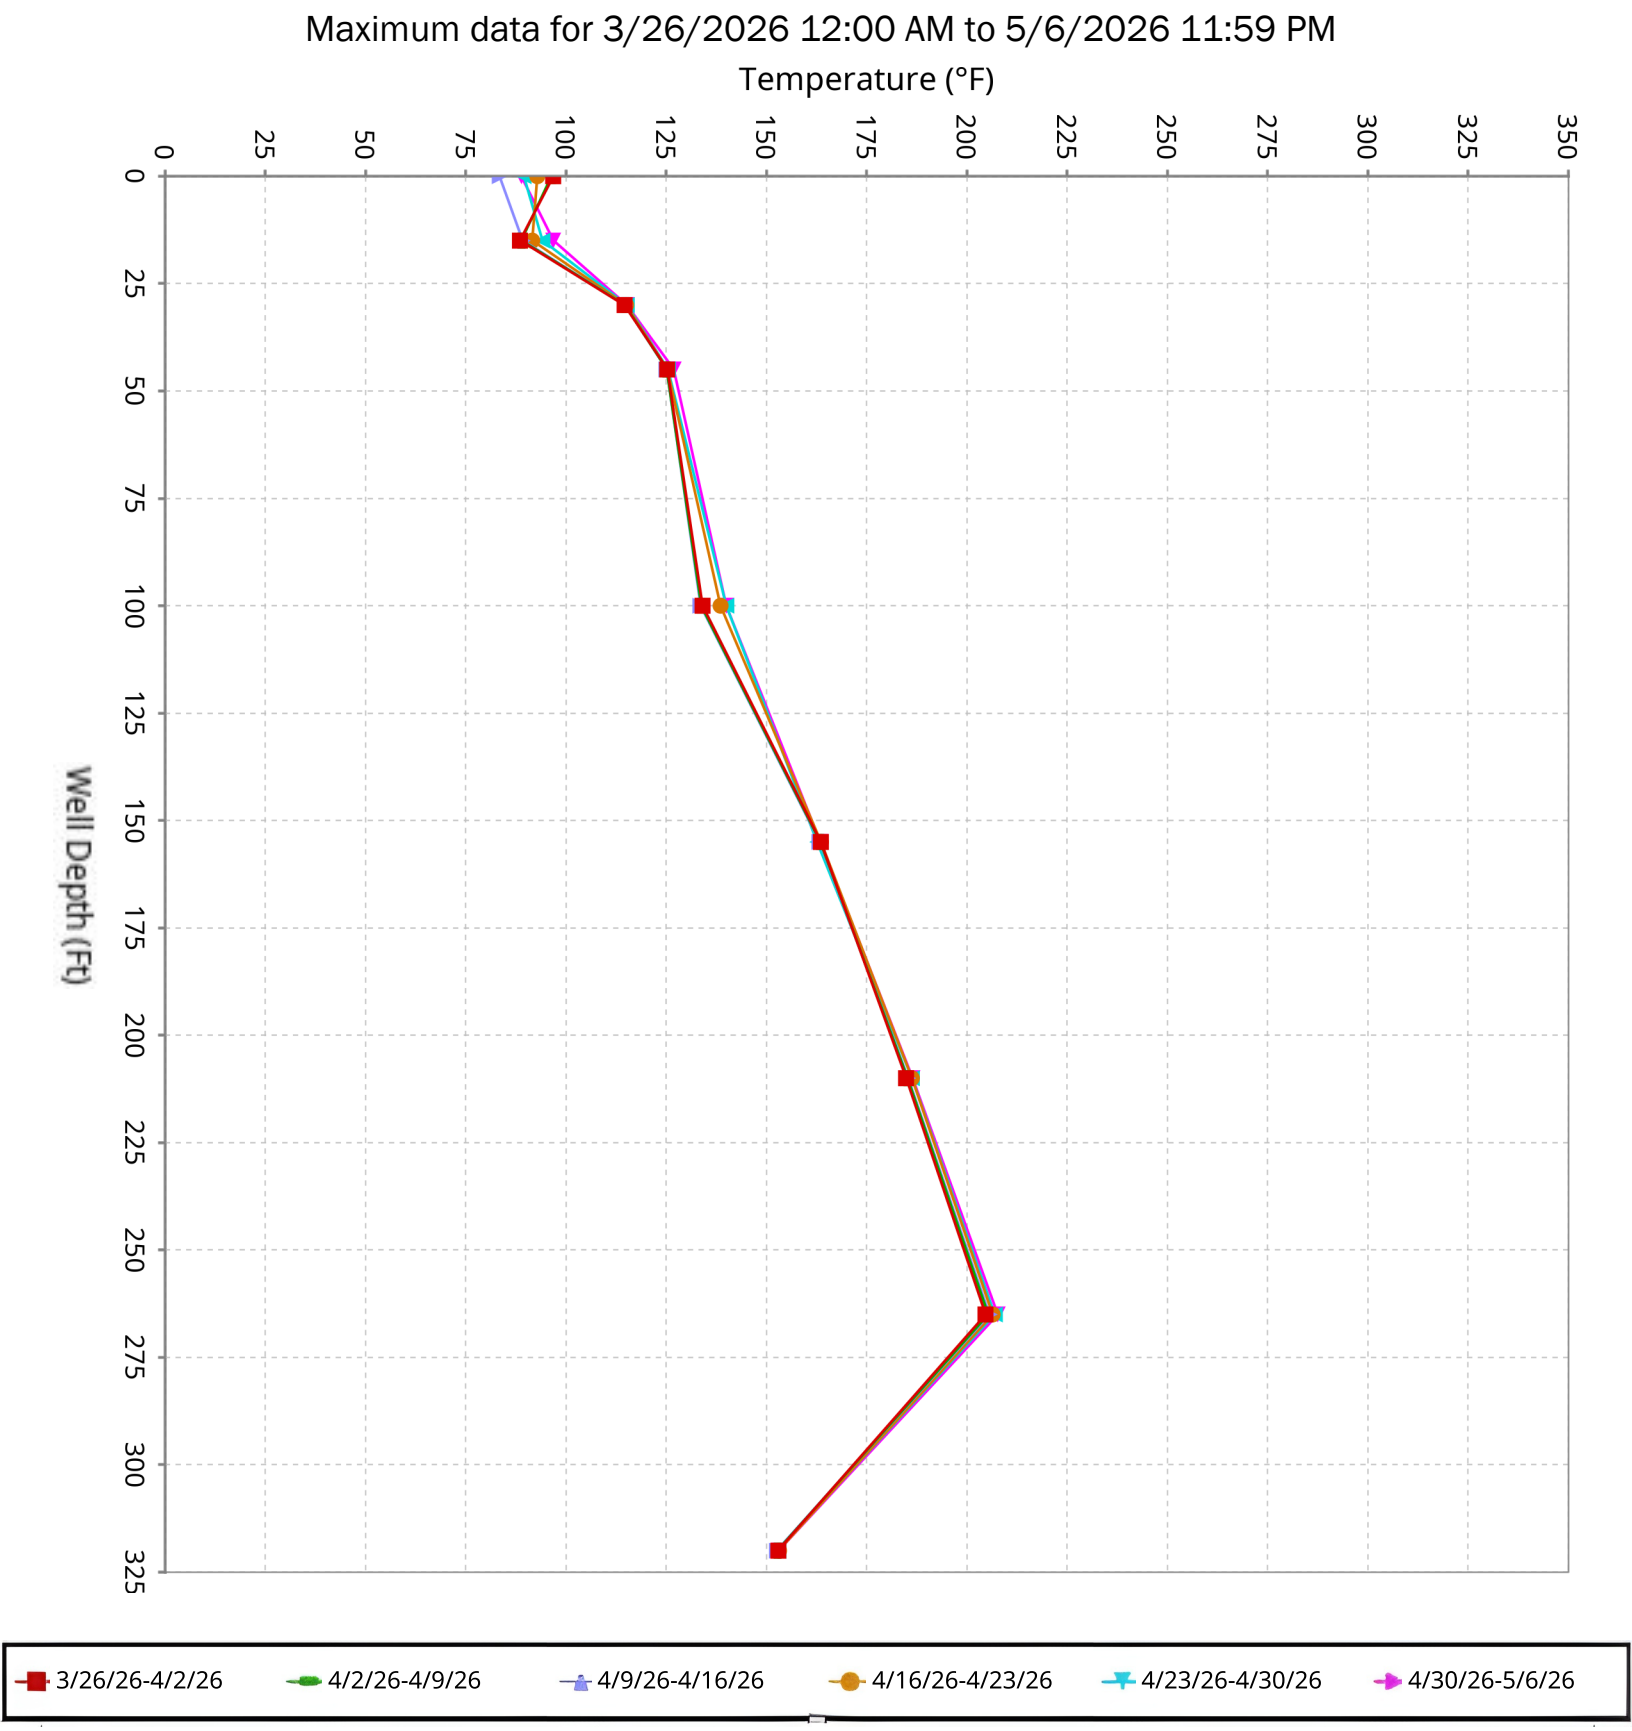
Vertical Temperature Profiles from Temperature Probes at Chiquita Landfill for TP-23

- TP-23
  - The 15-foot thermocouple remained consistent with previous recorded temperatures.
  - The reported maximum temperature reading of 2508°F is considered anomalous and is believed to be associated with a potential thermocouple sensor malfunction. The sensor remains under evaluation and investigation.
- TP-36
  - The 250-foot thermocouple was evaluated due to low temperatures on April 6th and wiring that had come loose was corrected. After fixing the wiring issues, temperatures returned to 136°F as previously recorded prior to March 21st.

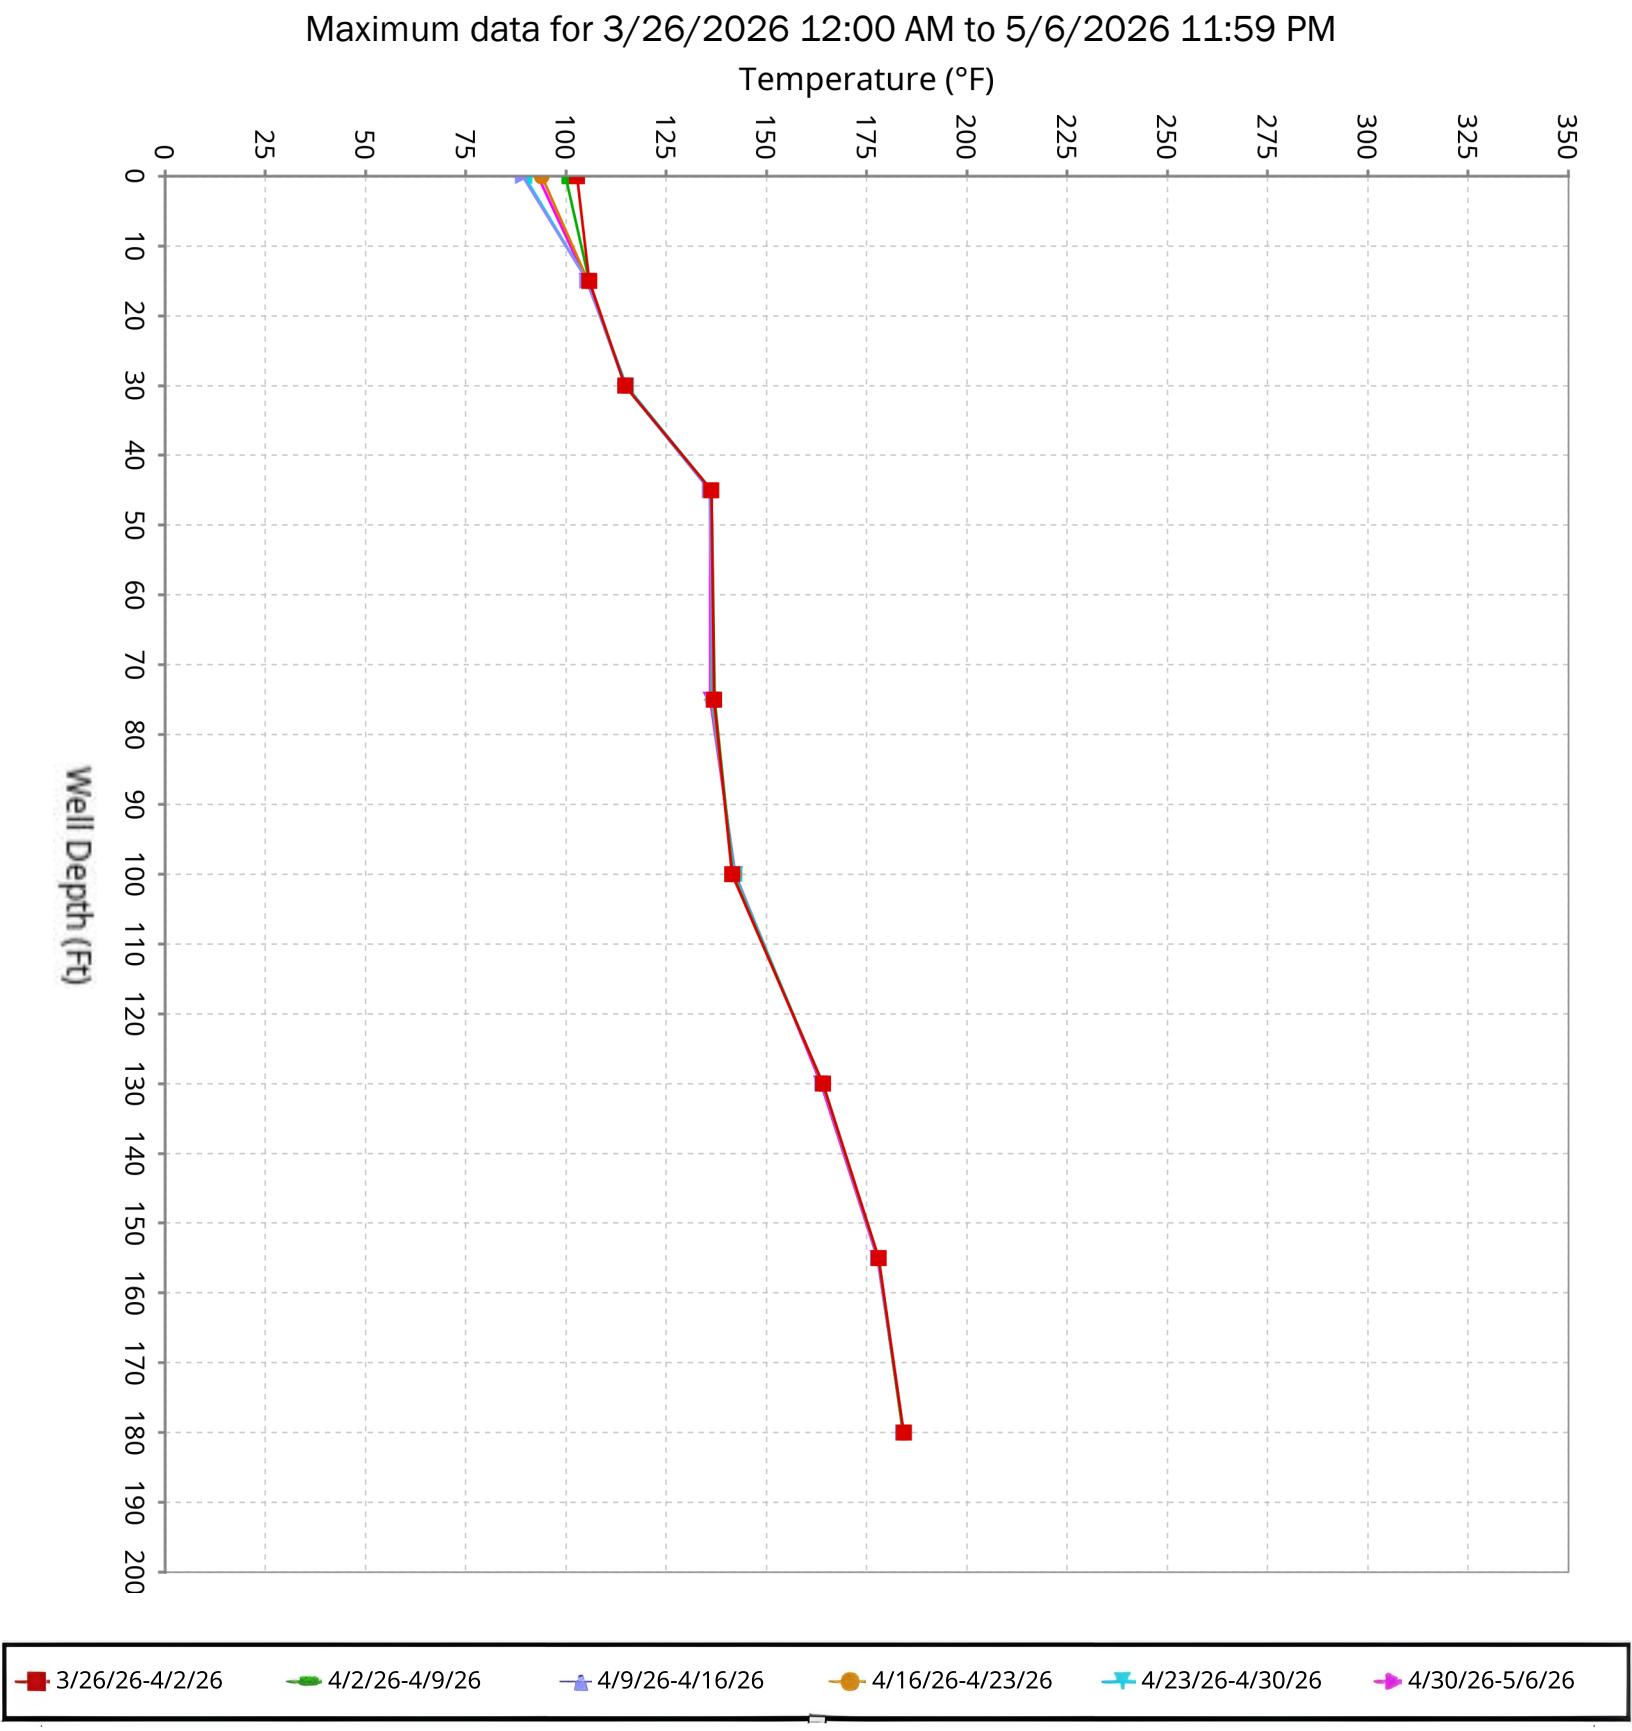
Vertical Temperature Profiles from Temperature Probes at Chiquita Landfill for TP-36

- TP-36
  - The 250-foot thermocouple was evaluated due to low temperatures on April 6th and wiring that had come loose was corrected. After fixing the wiring issues temperatures returned to 136°F as previously recorded prior to March 21st.

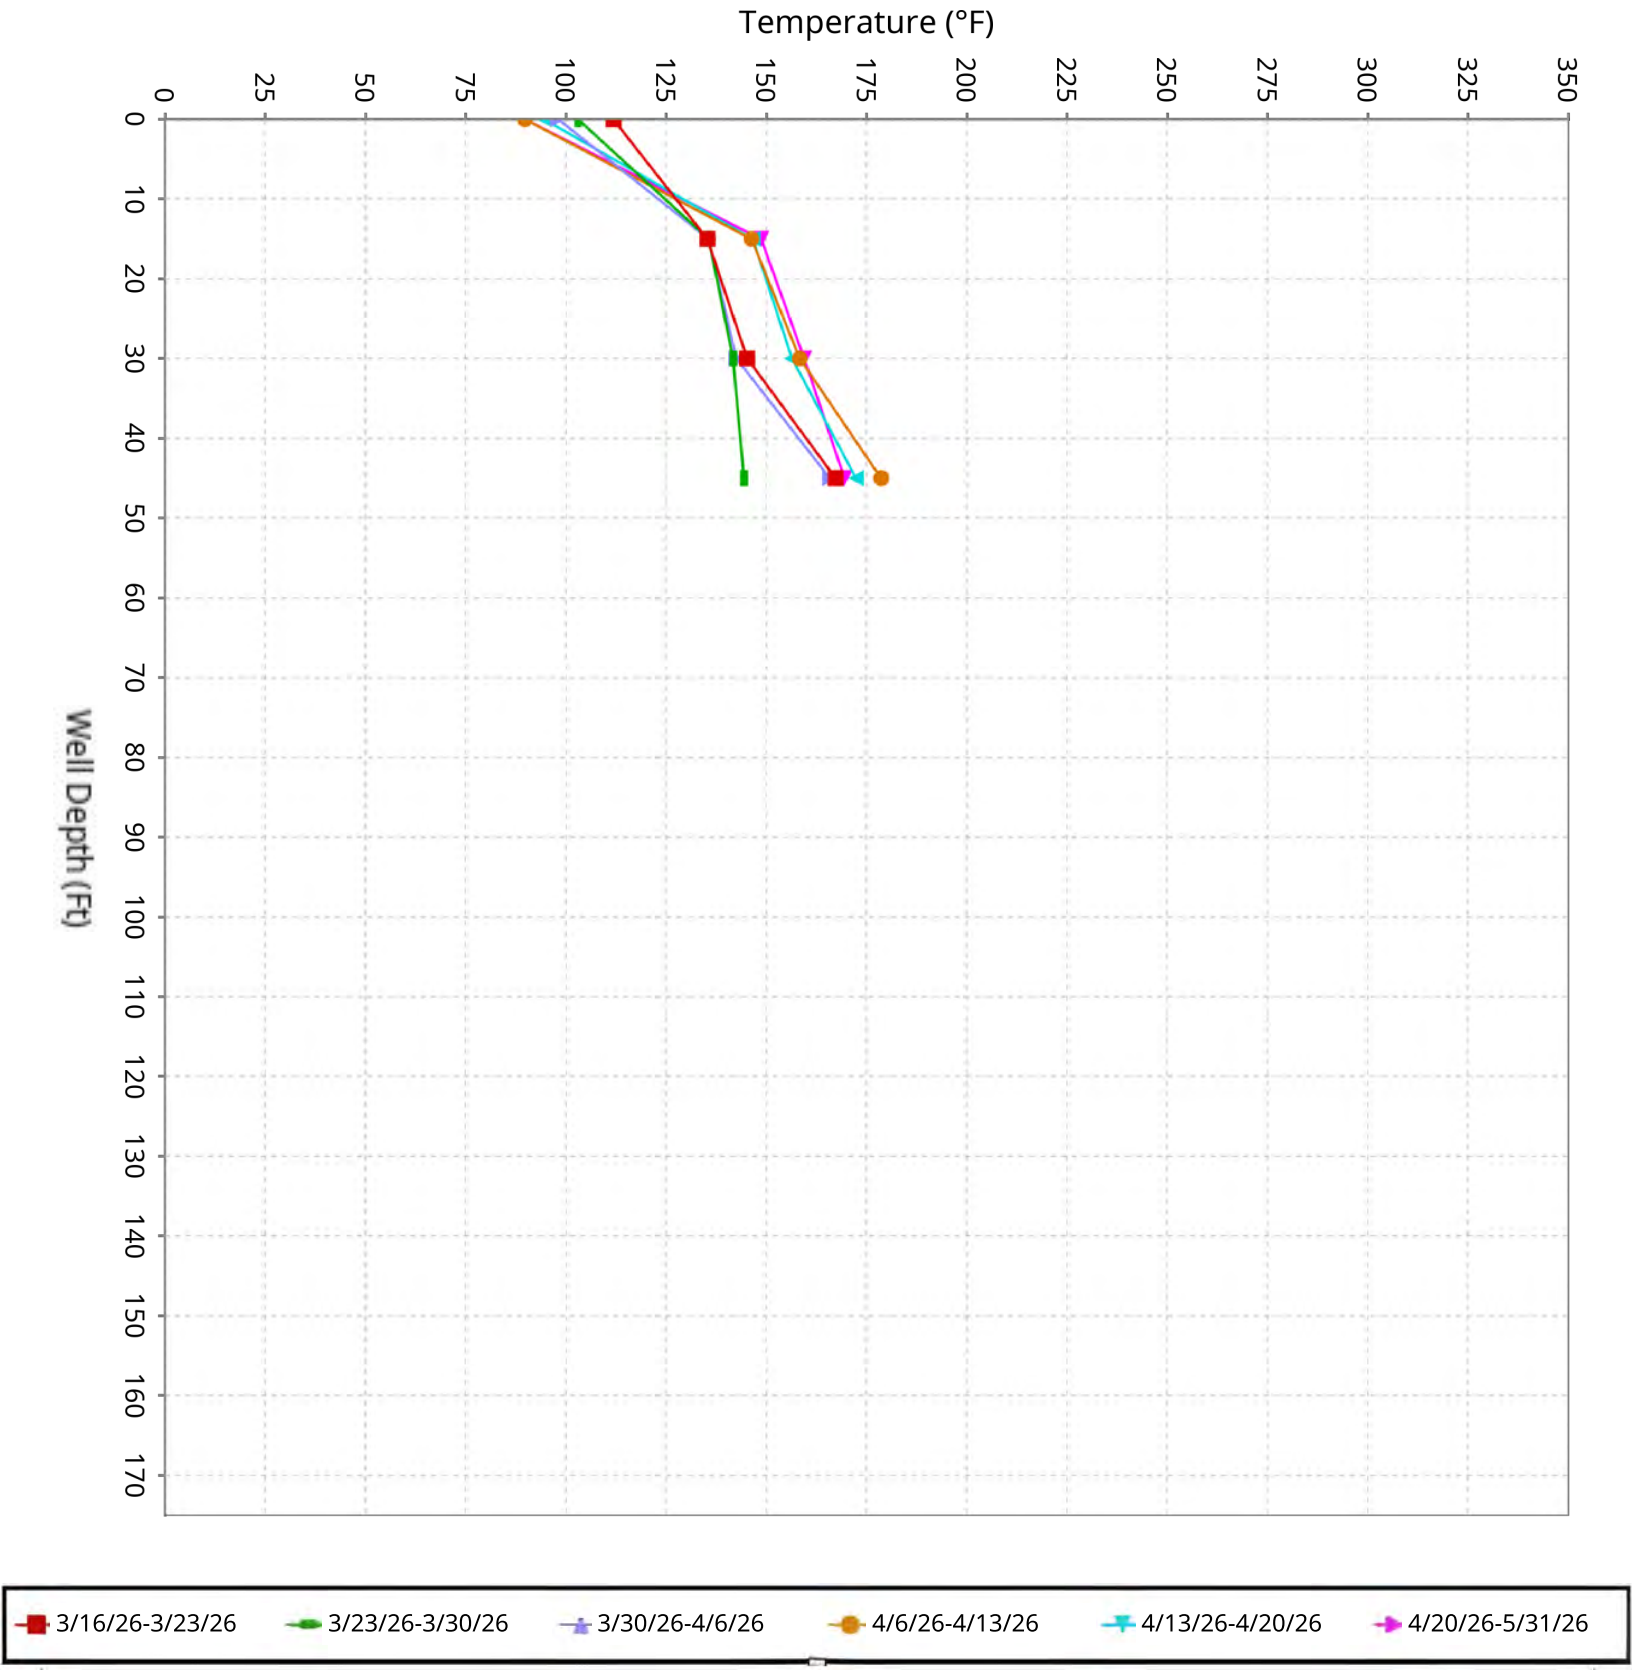
Vertical Temperature Profiles from Temperature Probes at Chiquita Landfill for TP-8

- TP-08
  - The 125-foot thermocouple went offline on March 3rd and TP-8 was offline between March 6th and March 9th for evaluation and maintenance. Upon removing the thermocouples, the casing for TP-08 was found to be damaged due to differential settlement beyond 45-feet, thus preventing the installation of the 100-foot, 125-foot, and 150-foot thermocouples. The 15-foot, 30-foot, and 45-foot thermocouples are active and reporting data.
  - The 45-foot thermocouple showed an increasein maximum temperature of 18°F from 139°F to 157°F from May 31st to June 3rd.
