Chiquita Canyon, LLC
Reaction Committee & South Coast Air Quality Management District
(SCAQMD) Staff Monthly Meeting
Wednesday, May 20, 2026 at 10:00 am PT

Chiquita Canyon Landfill (Facility ID 119219), Castaic, California, Modified Stipulated Order for Abatement (Case No. 6177-4) - Condition 27(e) Leachate Leaks and Spills

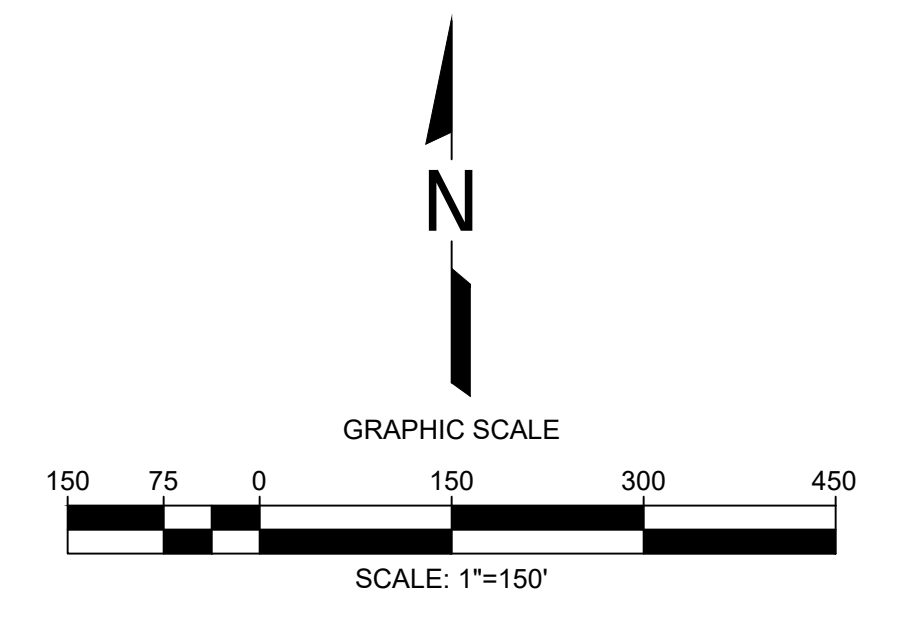
Attachment 2

- LEGEND**
- TOPOGRAPHIC CONTOUR
 - - - - EXISTING CELL LIMITS (APPROXIMATE)
 - CV-BD-P-XX EXISTING LFG VERTICAL EXTRACTION WELL - MAIN CANYON, CANYON B, CANYON D, PRIMARY CANYON

- CV-XX EXISTING LFG VERTICAL EXTRACTION WELL - PRESSURIZED LEACHATE RELEASE
 - BH-GB EXISTING GABION LFG COLLECTOR WELL
 - SW-XX EXISTING SOIL VAPOR EXTRACTION WELL
