## CHIQUITA CANYON

**Re: Chiquita Canyon, LLC Comments for July 14, 2026, Chiquita Canyon  
Landfill Community Advisory Committee Meeting**

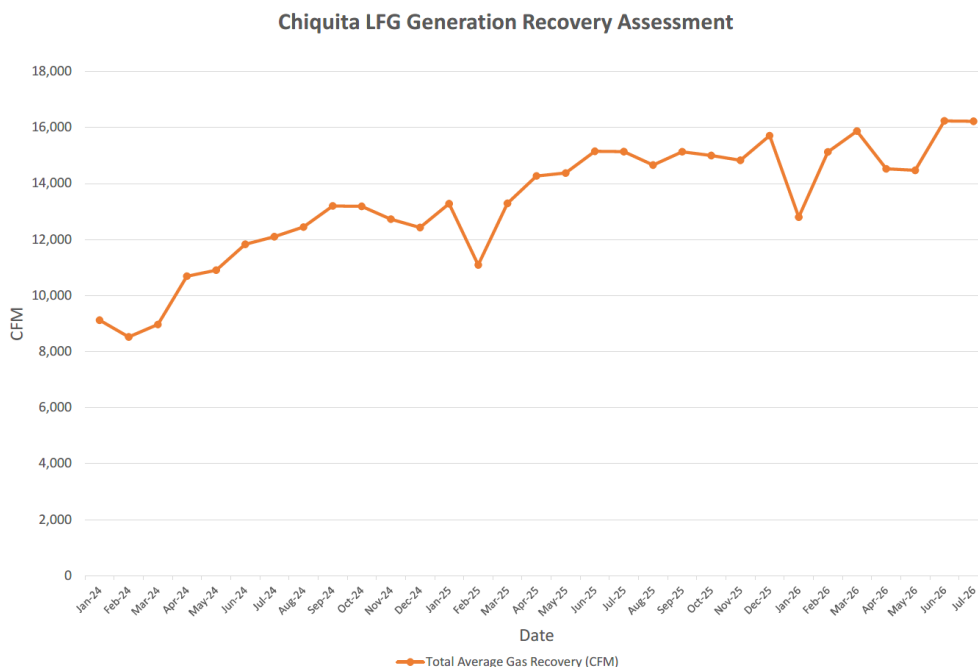
As previously noted, Chiquita has enhanced its on-site flaring capacity. In addition to Flares 1, 2, and 3, Chiquita now has 5 thermal oxidizers (“TOx”) units arranged in two TOx stations. Chiquita also has plans to install a fourth flare. Tuning and optimizing of the TOx stations has increased the total downtime in the flares. However, despite this downtime, Chiquita has consistently increased its overall destruction capacity (i.e., gas recovery). The below graph depicts the overall increase in total destruction capacity (i.e., total average gas recovery) at the site between January 2024 and June 2026.
