**Ref.: Comentarios de Chiquita Canyon, LLC para la Reunión del Comité Asesor de la Comunidad del Vertedero de Chiquita Canyon del 11 de Agosto de 2026**

**Proyecto de Apuntalamiento del Talud Oeste**

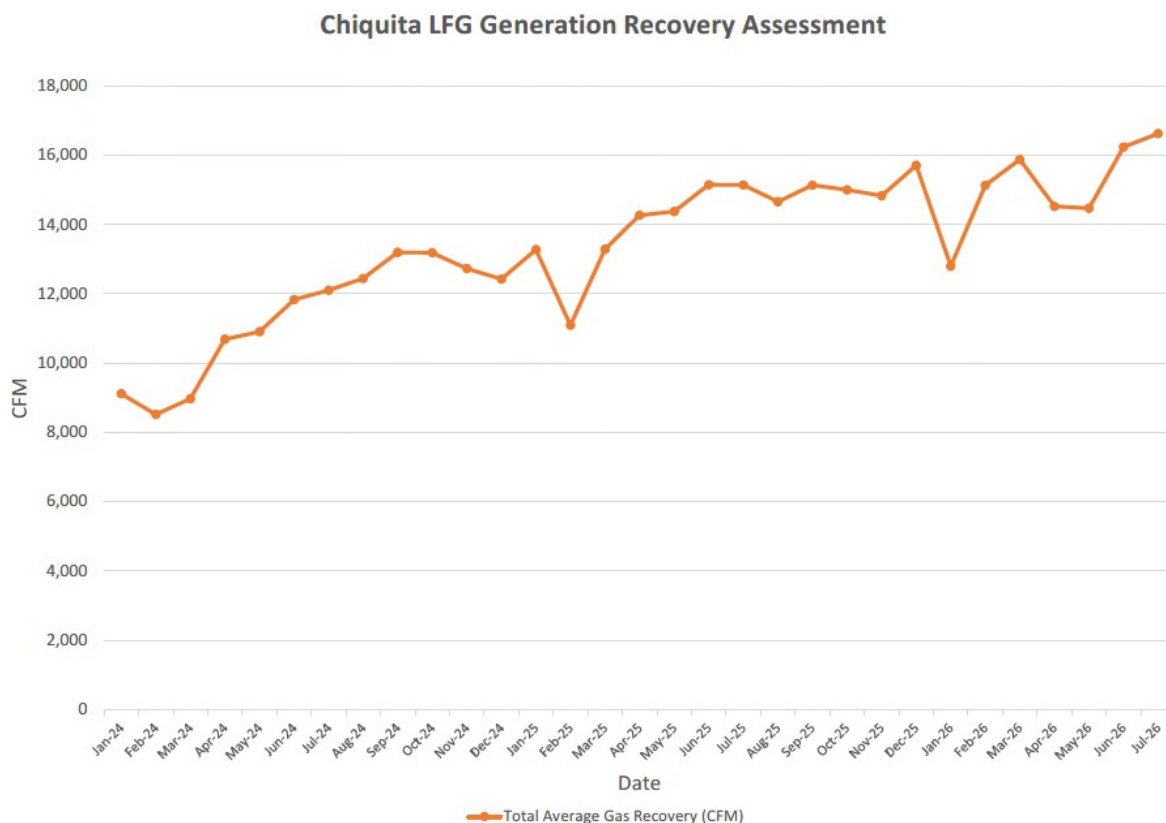
aumentado consistentemente su capacidad de destrucción global (es decir, la recuperación de gas). El gráfico a continuación exhibe el aumento global de destrucción total (es decir, la recuperación de gas total promedio) en el sitio entre enero de 2024 y julio de 2026.

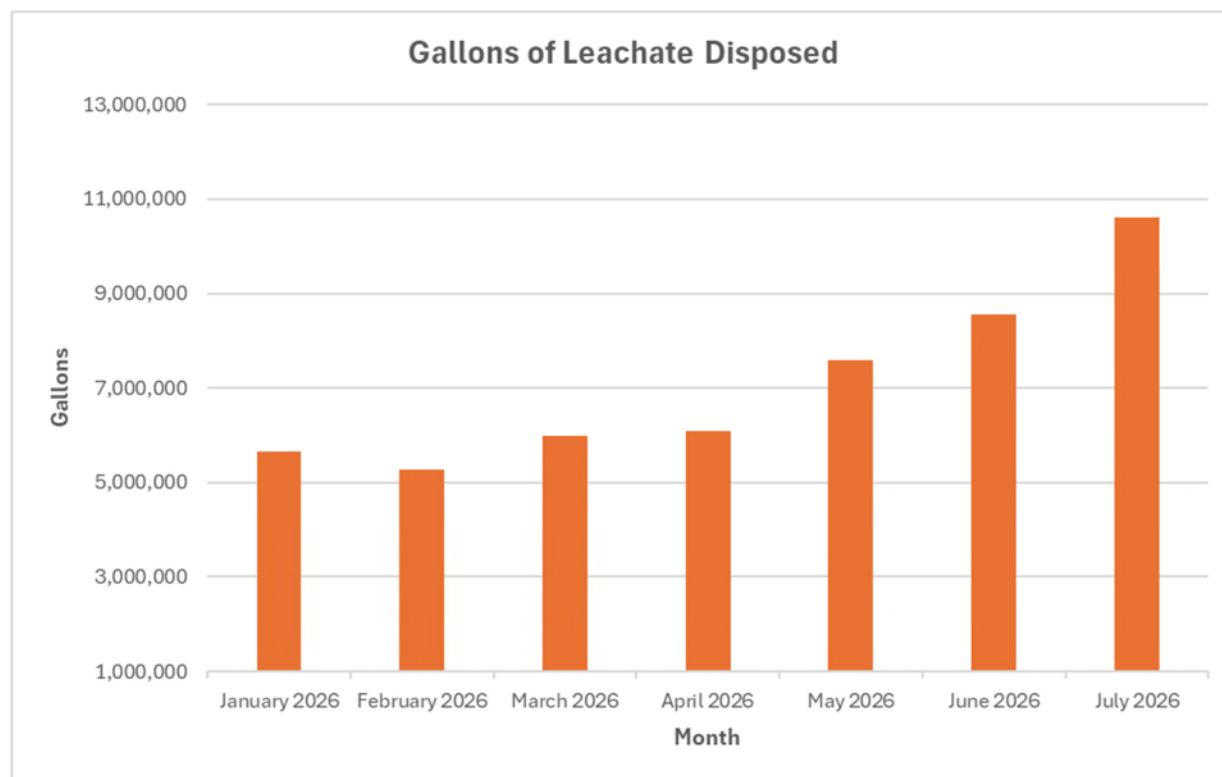
Como se indicó el mes pasado, Chiquita ya está bombeando en su capacidad total. La cantidad de lixiviados extraída y desechada ahora está por encima del nivel inicial de referencia establecido antes de que Chiquita haya perdido la capacidad de disposición en una salida clave en febrero de 2026. El gráfico a continuación exhibe el aumento global en la disposición de lixiviados en el sitio entre enero de 2026 y julio de 2026:
