SECTION 2 - CAUSES OF STREAM BANK EROSION

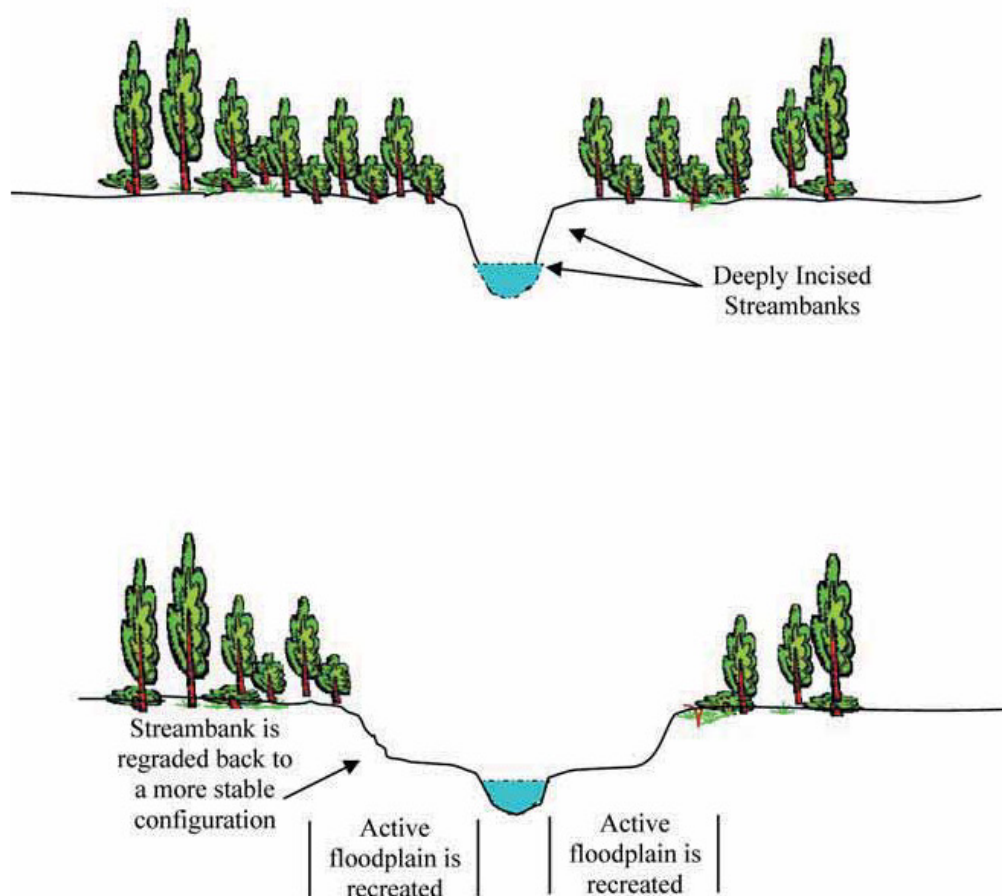
Associates in Collaboration with H. T. Harvey and Associates for the San Francisquito Creek Joint Powers Authority. They write, "The higher a bank is, the flatter the angle must be to prevent slumping. For example, most soils will support a three-foot high vertical bank, but if the river cuts a deeper channel (say five feet) the bank will collapse under its own weight. A five-foot tall bank would need to be graded to a lower gradient to be as stable as a three-foot vertical bank, and a ten-foot high bank would have to be excavated to an even lower gradient to be stable. The higher the bank, the lower the stable gradient becomes." The best remedy for this problem—the problem of an over-steepened bank experiencing both hydraulic and geotechnical failures—combines several steps. The first step involves regrading the slope to a more stable angle, which is why it is called "laying it back." The second step involves reinforcing the toe, where necessary, with biotechnical methods such as logs and rocks. The third step involves reducing erosive energy on the bank by planting the bank, so that it does not become over-steepened again. For an illustration, see figure 3 below.

Figure 3: Laying Back a Streambank to Increase Stability
