June 20, 2025  
File No. 01204123.42, Task 10

Subject: May 2025 Monthly Report for Modified Stipulated Order for Abatement (Case No. 6177-4), Chiquita Canyon Landfill (Facility ID 119219), Castaic, California

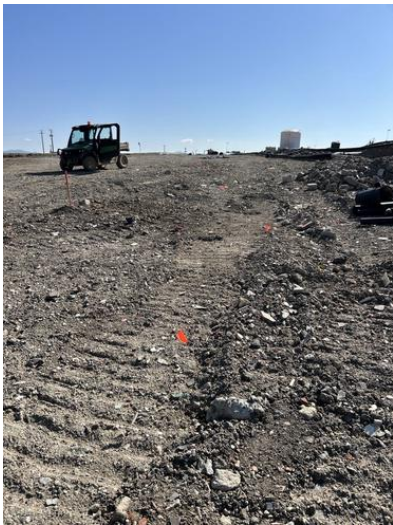
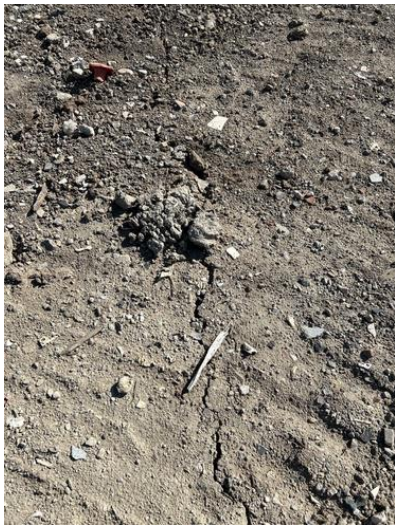
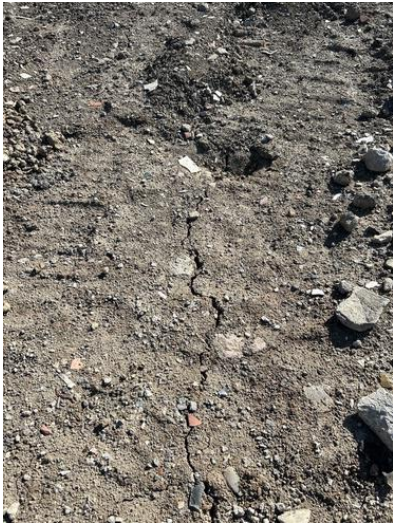
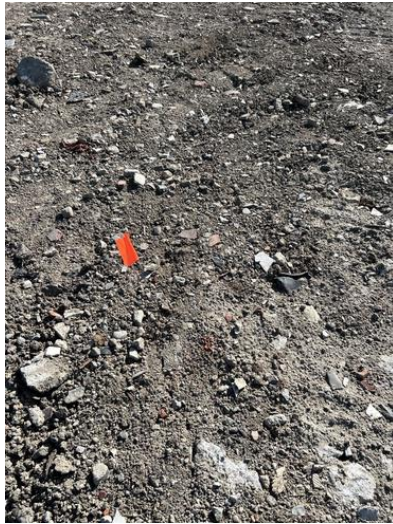
Using the Media link below, attach the before photo of the fissure of tension crack.

**Length of crack (ft) or area containing multiple cracks (ft x ft)** 45 ft

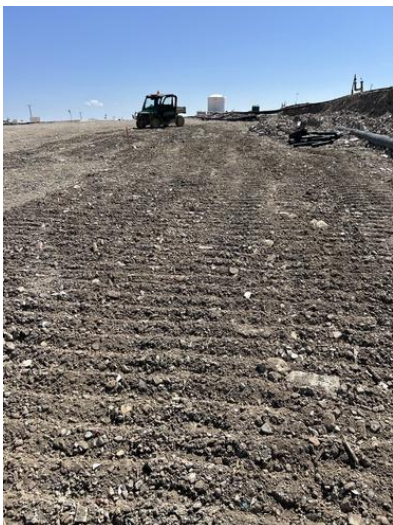
Photo 5

**Was Fissure or Crack fixed? If yes, add photo and description of repairs performed** Yes

**Date and time of repairs** 28 Apr 2025 9:38 AM PDT

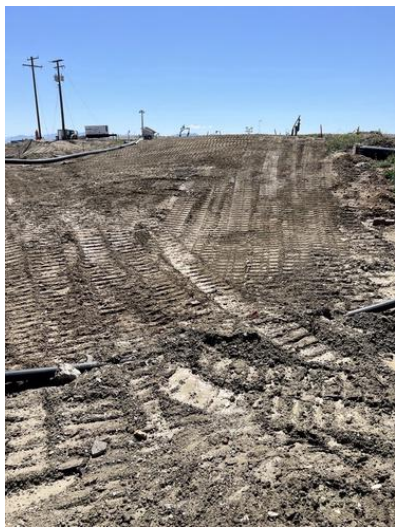
Photo 1

Grid 147

Instability

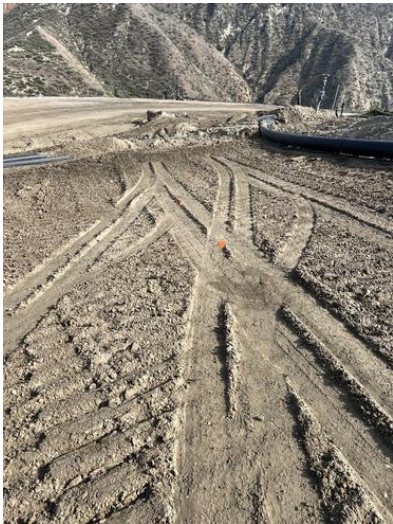
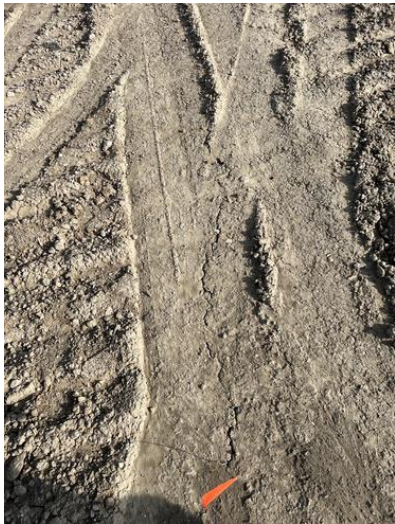
Using the Media link below, attach the before photo of the fissure of tension crack.

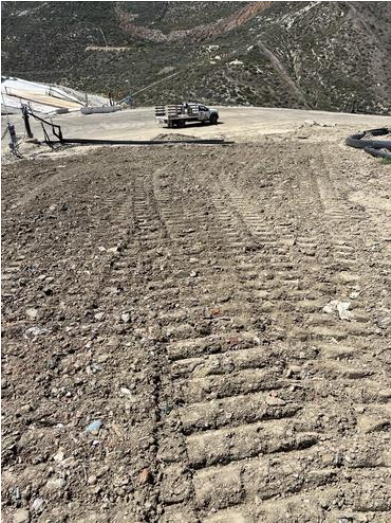
| Photo 3 | |

| Was Fissure or Crack fixed? If yes, add photo and description of repairs performed | Yes |

| Date and time of repairs | 30 Apr 2025 9:43 AM PDT |

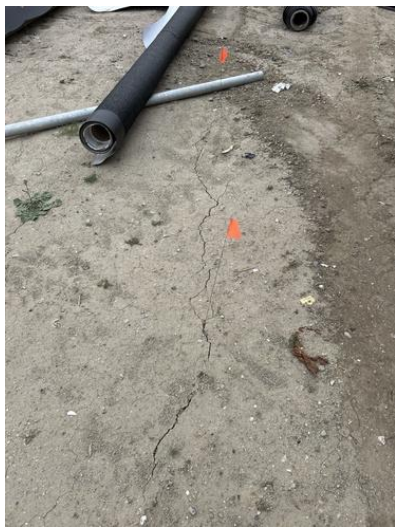
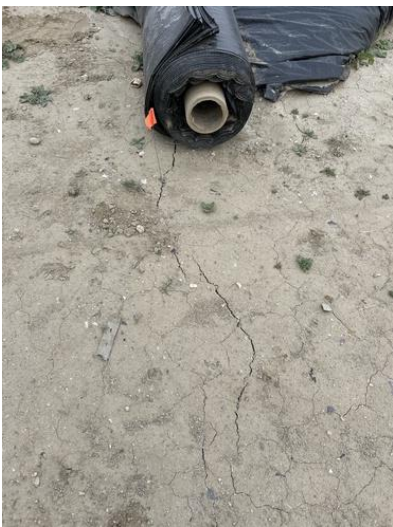
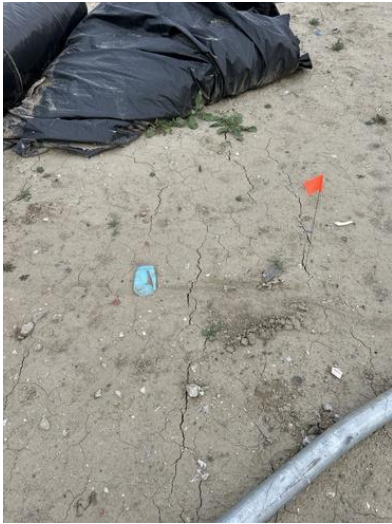
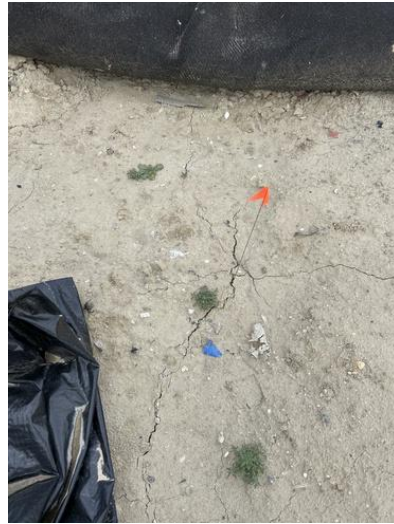
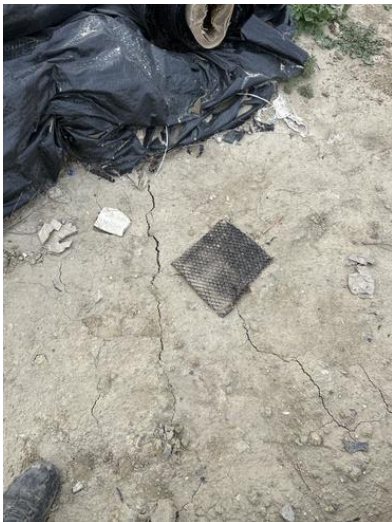
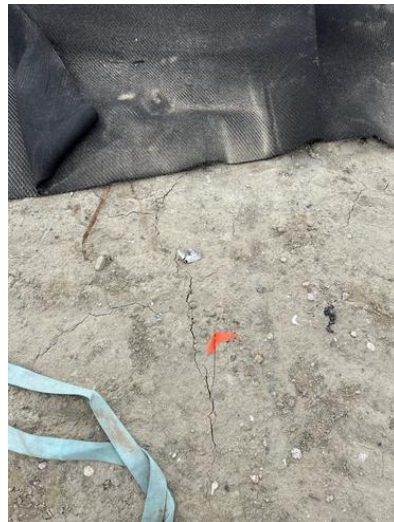
Using the Media link below, attach the before photo of the fissure or tension crack.

**Length of crack (ft) or area containing multiple cracks (ft x ft)**

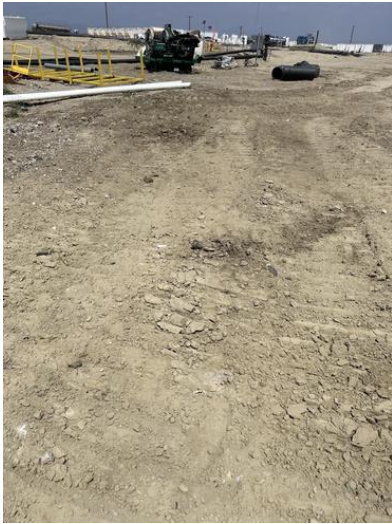
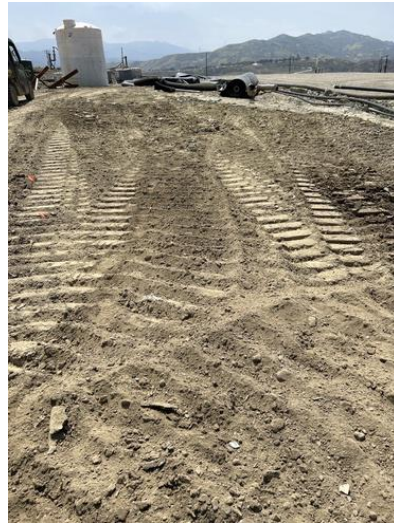
**Was Fissure or Crack fixed? If yes, add photo and description of repairs performed**

**Date and time of repairs**

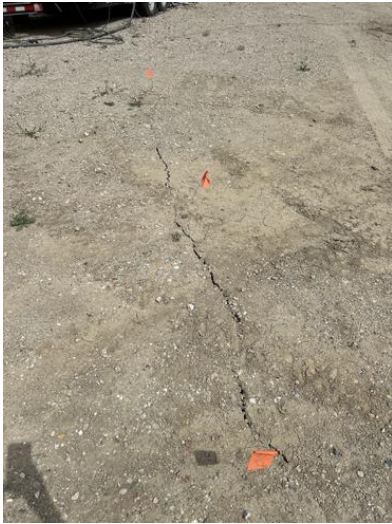
Photo 9

**Using the Media link below, attach the before photo of the fissure or tension crack.**

**Length of crack (ft) or area containing multiple cracks (ft x ft)** 7ft

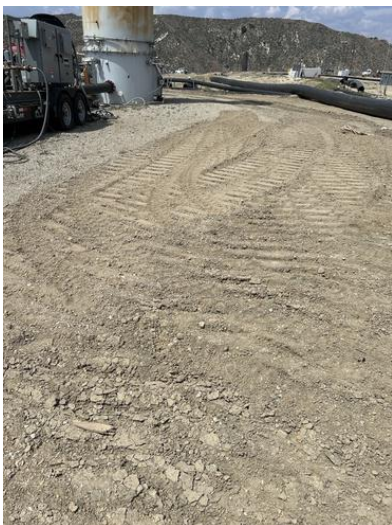
Photo 10

**Was Fissure or Crack fixed? If yes, add photo and description of repairs performed** Yes

**Date and time of repairs** 1 May 2025 12:04 PM PDT

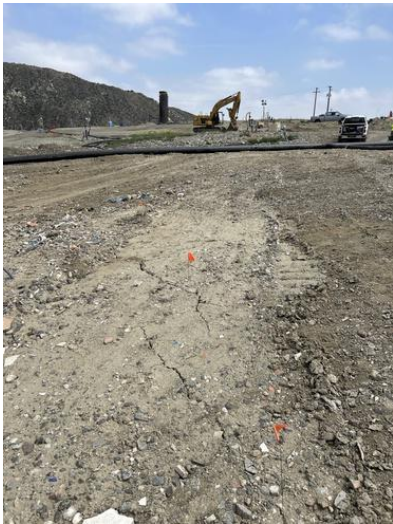
Photo 11

Using the Media link below, attach the before photo of the fissure or tension crack.

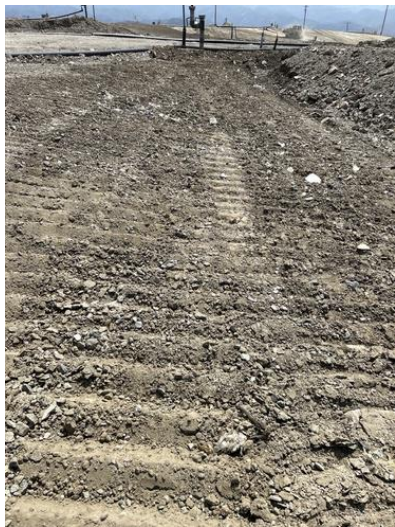
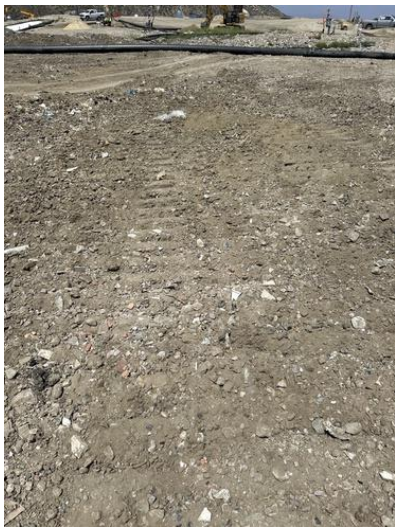
Was Fissure or Crack fixed? If yes, add photo and description of repairs performed

Date and time of repairs

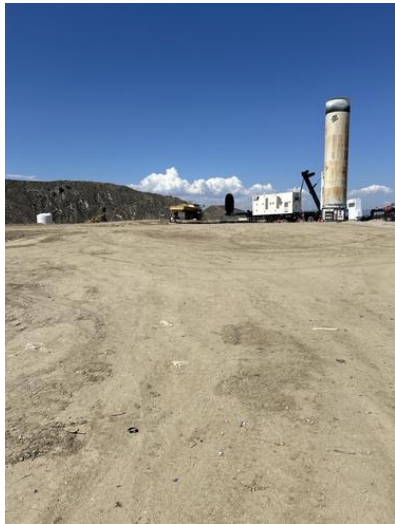
Photo 1

Grid 90

Instability

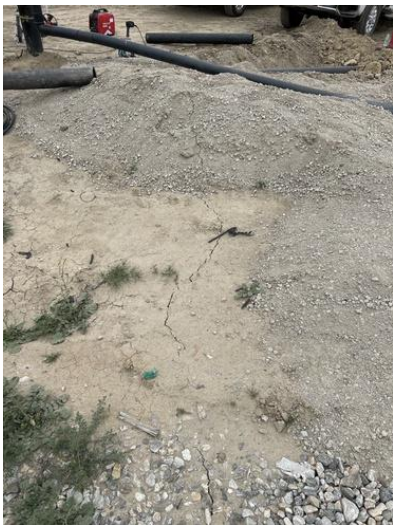
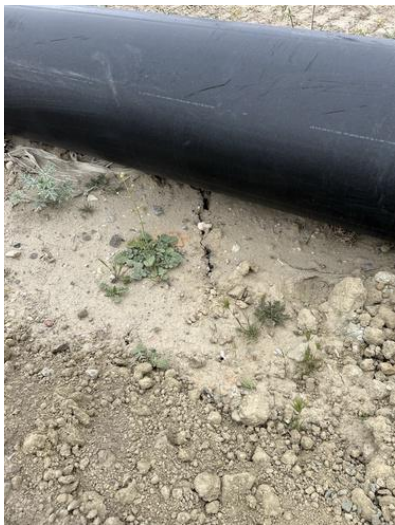
Using the Media link below, attach the before photo of the fissure of tension crack. 3 May 2025 10:42 AM PDT

Length of crack (ft) or area containing multiple cracks (ft x ft) 20ft x3ft area

| Horizontal Offset (width) | Small 0.5-2" in width |

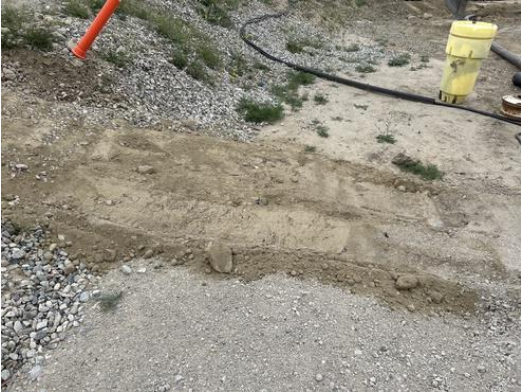
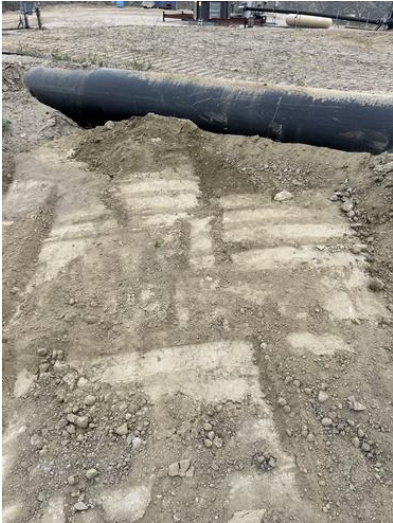
| Was Fissure or Crack fixed? If yes, add photo and description of repairs performed | Yes |

| Date and time of repairs | 3 May 2025 11:04 AM PDT |
| Description of repairs | Other (please describe) |

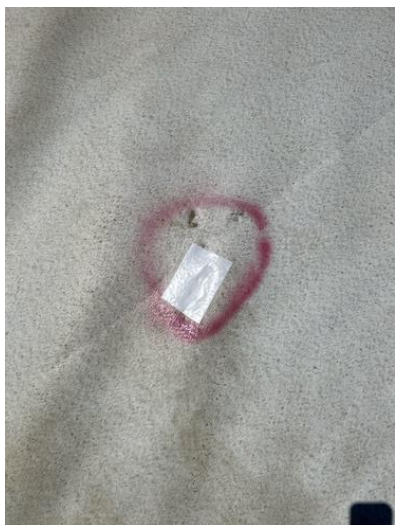
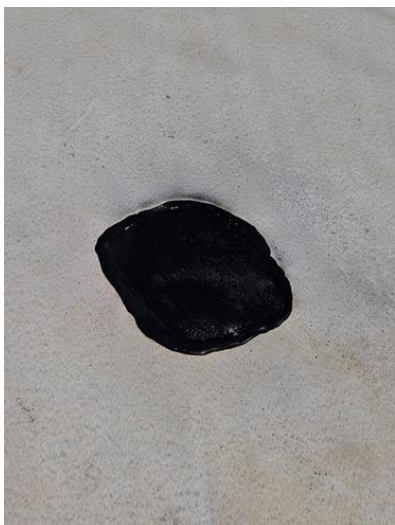
Puncture in cover needs to be extrusion welded.

Take photo of repair

Description of repair work

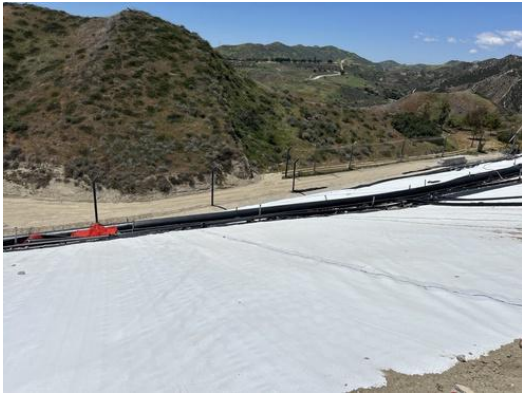
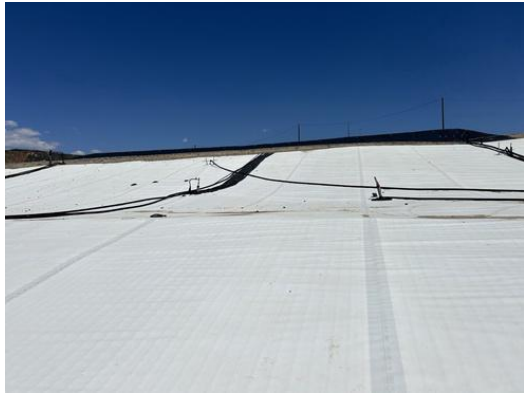
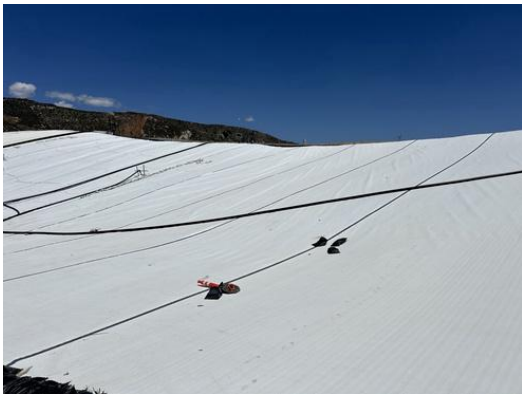
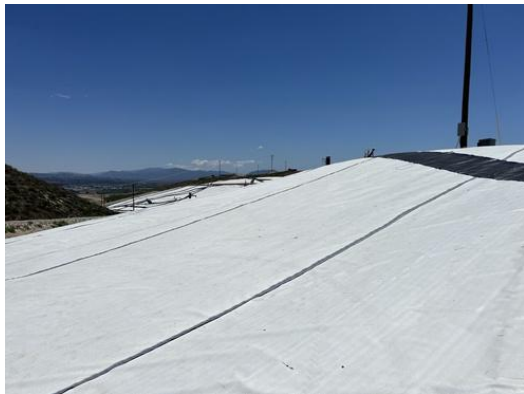
Instability under the cover

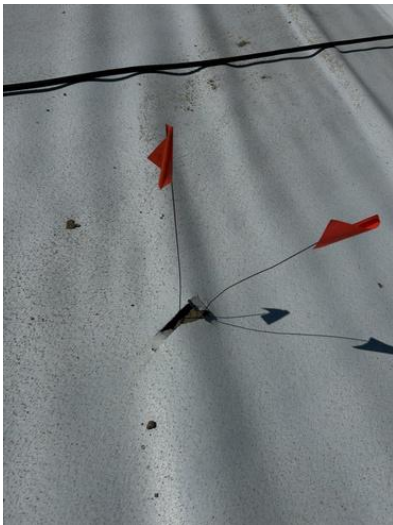
Photo 1

Found 5/2/25 at 12:15. Grid 181

Tear in liner. Needs to be patched

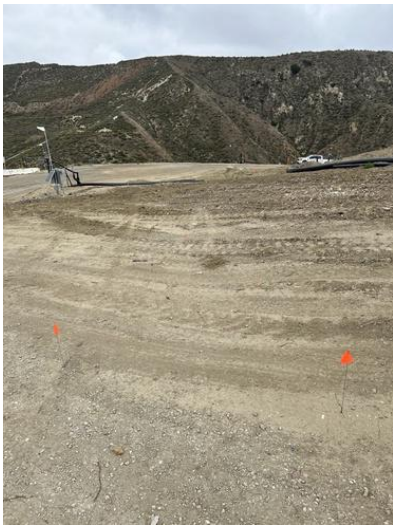
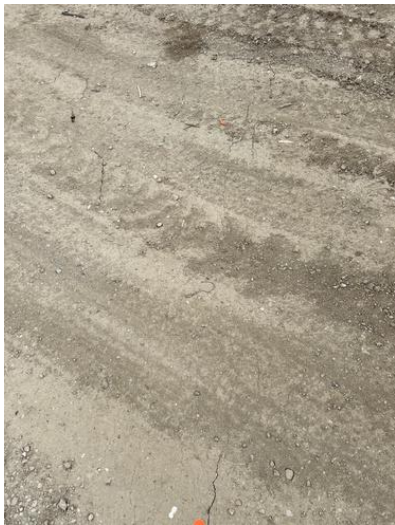
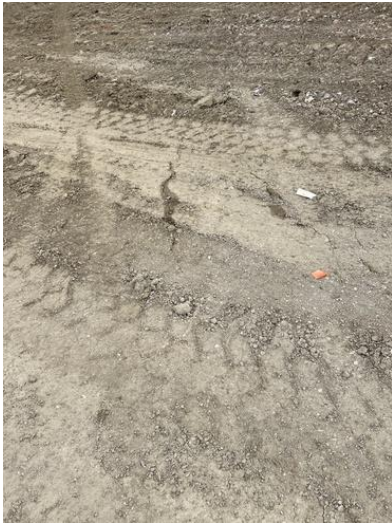
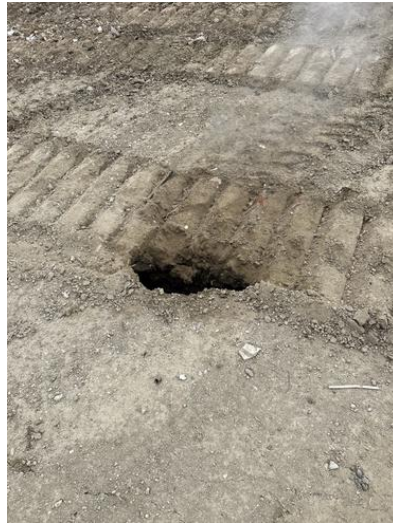
Grid Location

146

5 May 2025 8:35 AM PDT

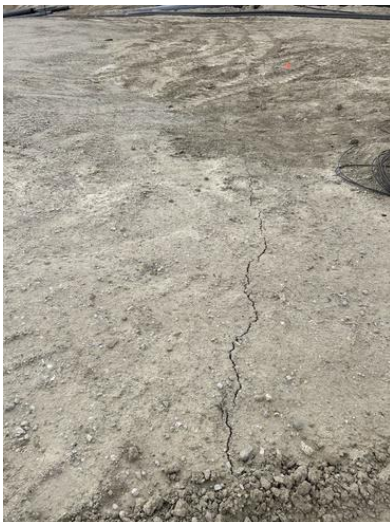
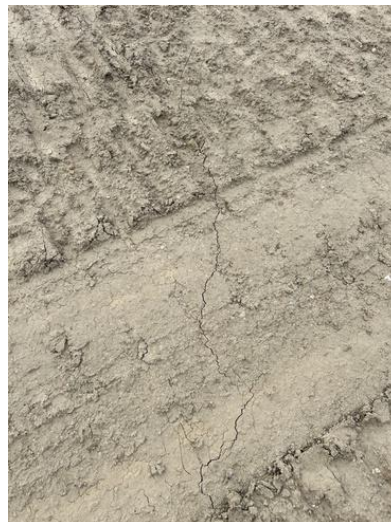
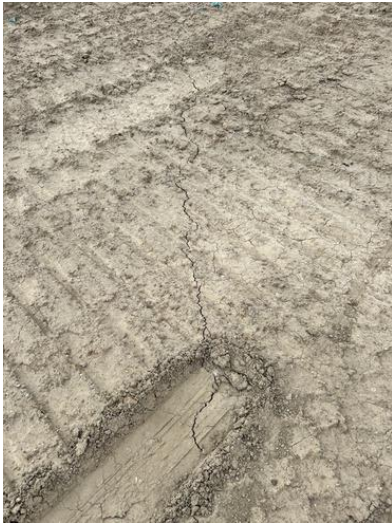
147

5 May 2025 8:47 AM PDT

**Length of crack (ft) or area containing multiple cracks (ft x ft)** 35ft x 30ft

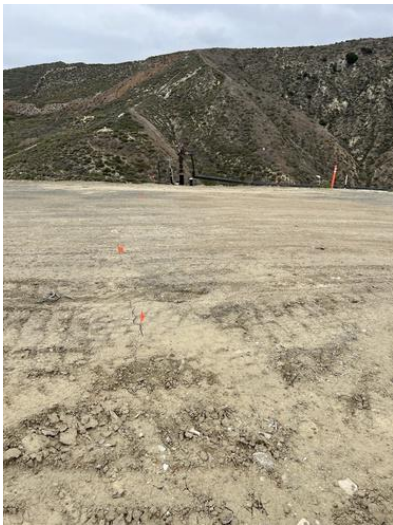
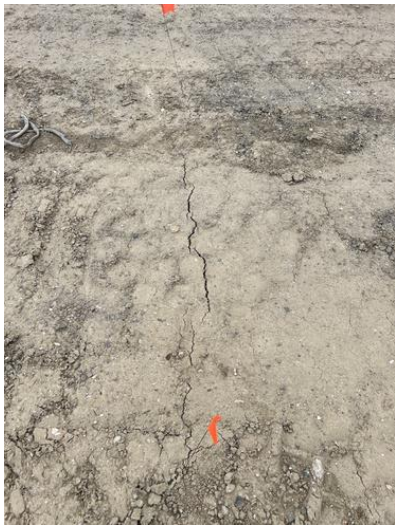
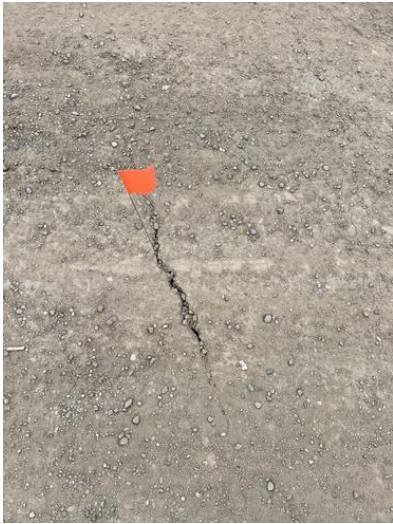
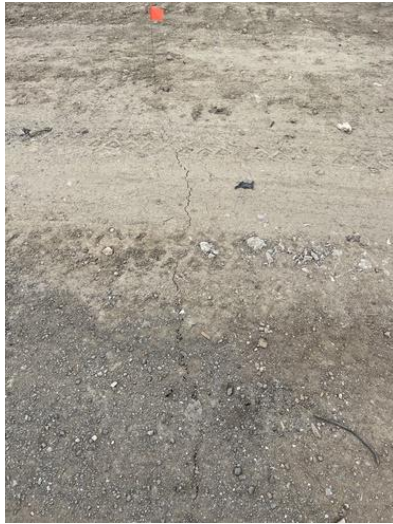
146

6 May 2025 10:28 AM PDT

**Length of crack (ft) or area containing multiple cracks (ft x ft)** 15ft x 40ft

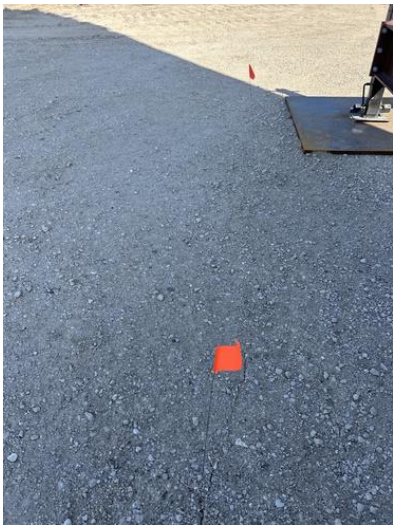
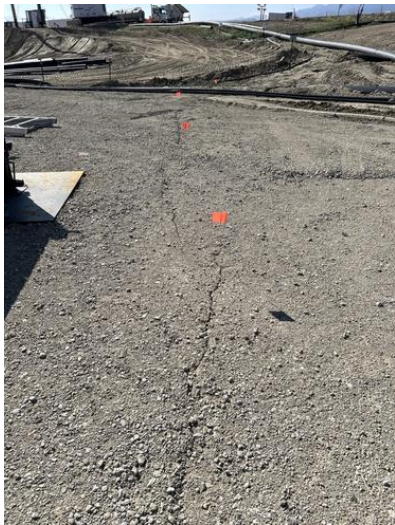
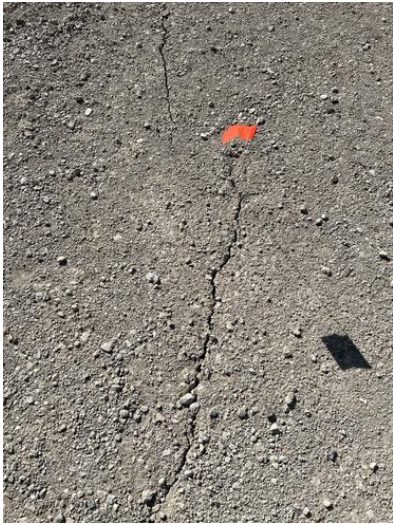
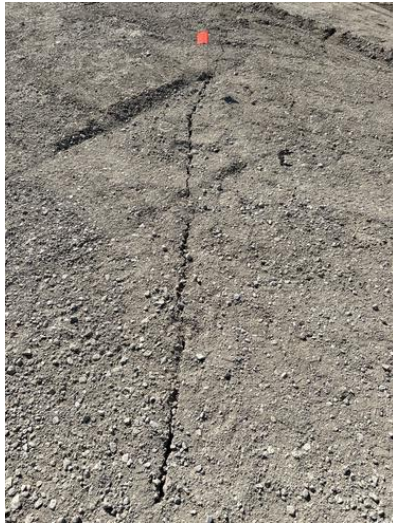
147

7 May 2025 9:12 AM PDT

**Length of crack (ft) or area containing multiple cracks (ft x ft)** 40ft

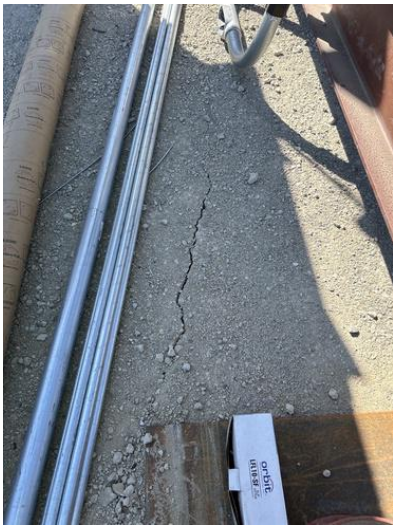
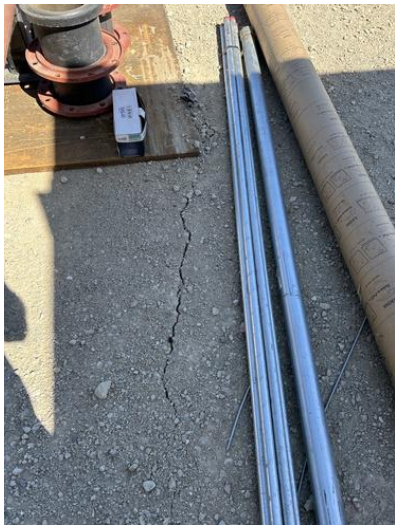
147

8 May 2025 9:40 AM PDT

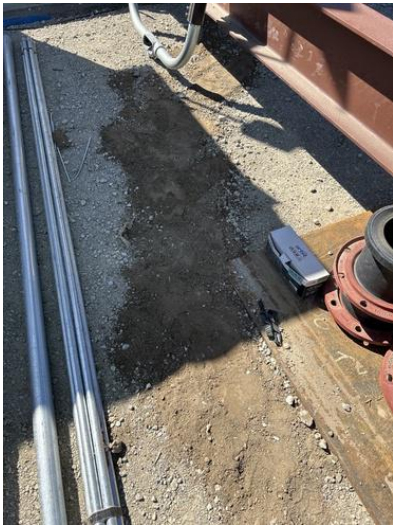
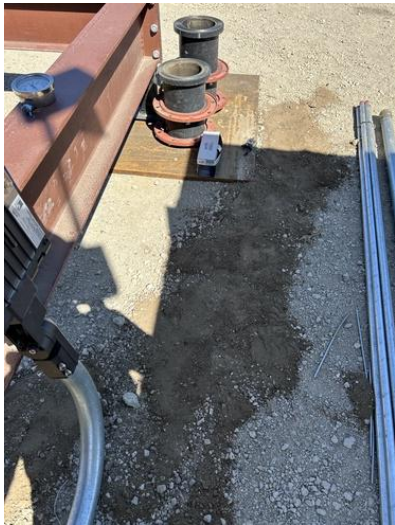
| Was Fissure or Crack fixed? If yes, add photo and description of repairs performed | Yes |

| Date and time of repairs | 8 May 2025 11:04 AM PDT |

| Description of repairs | Other (please describe) |

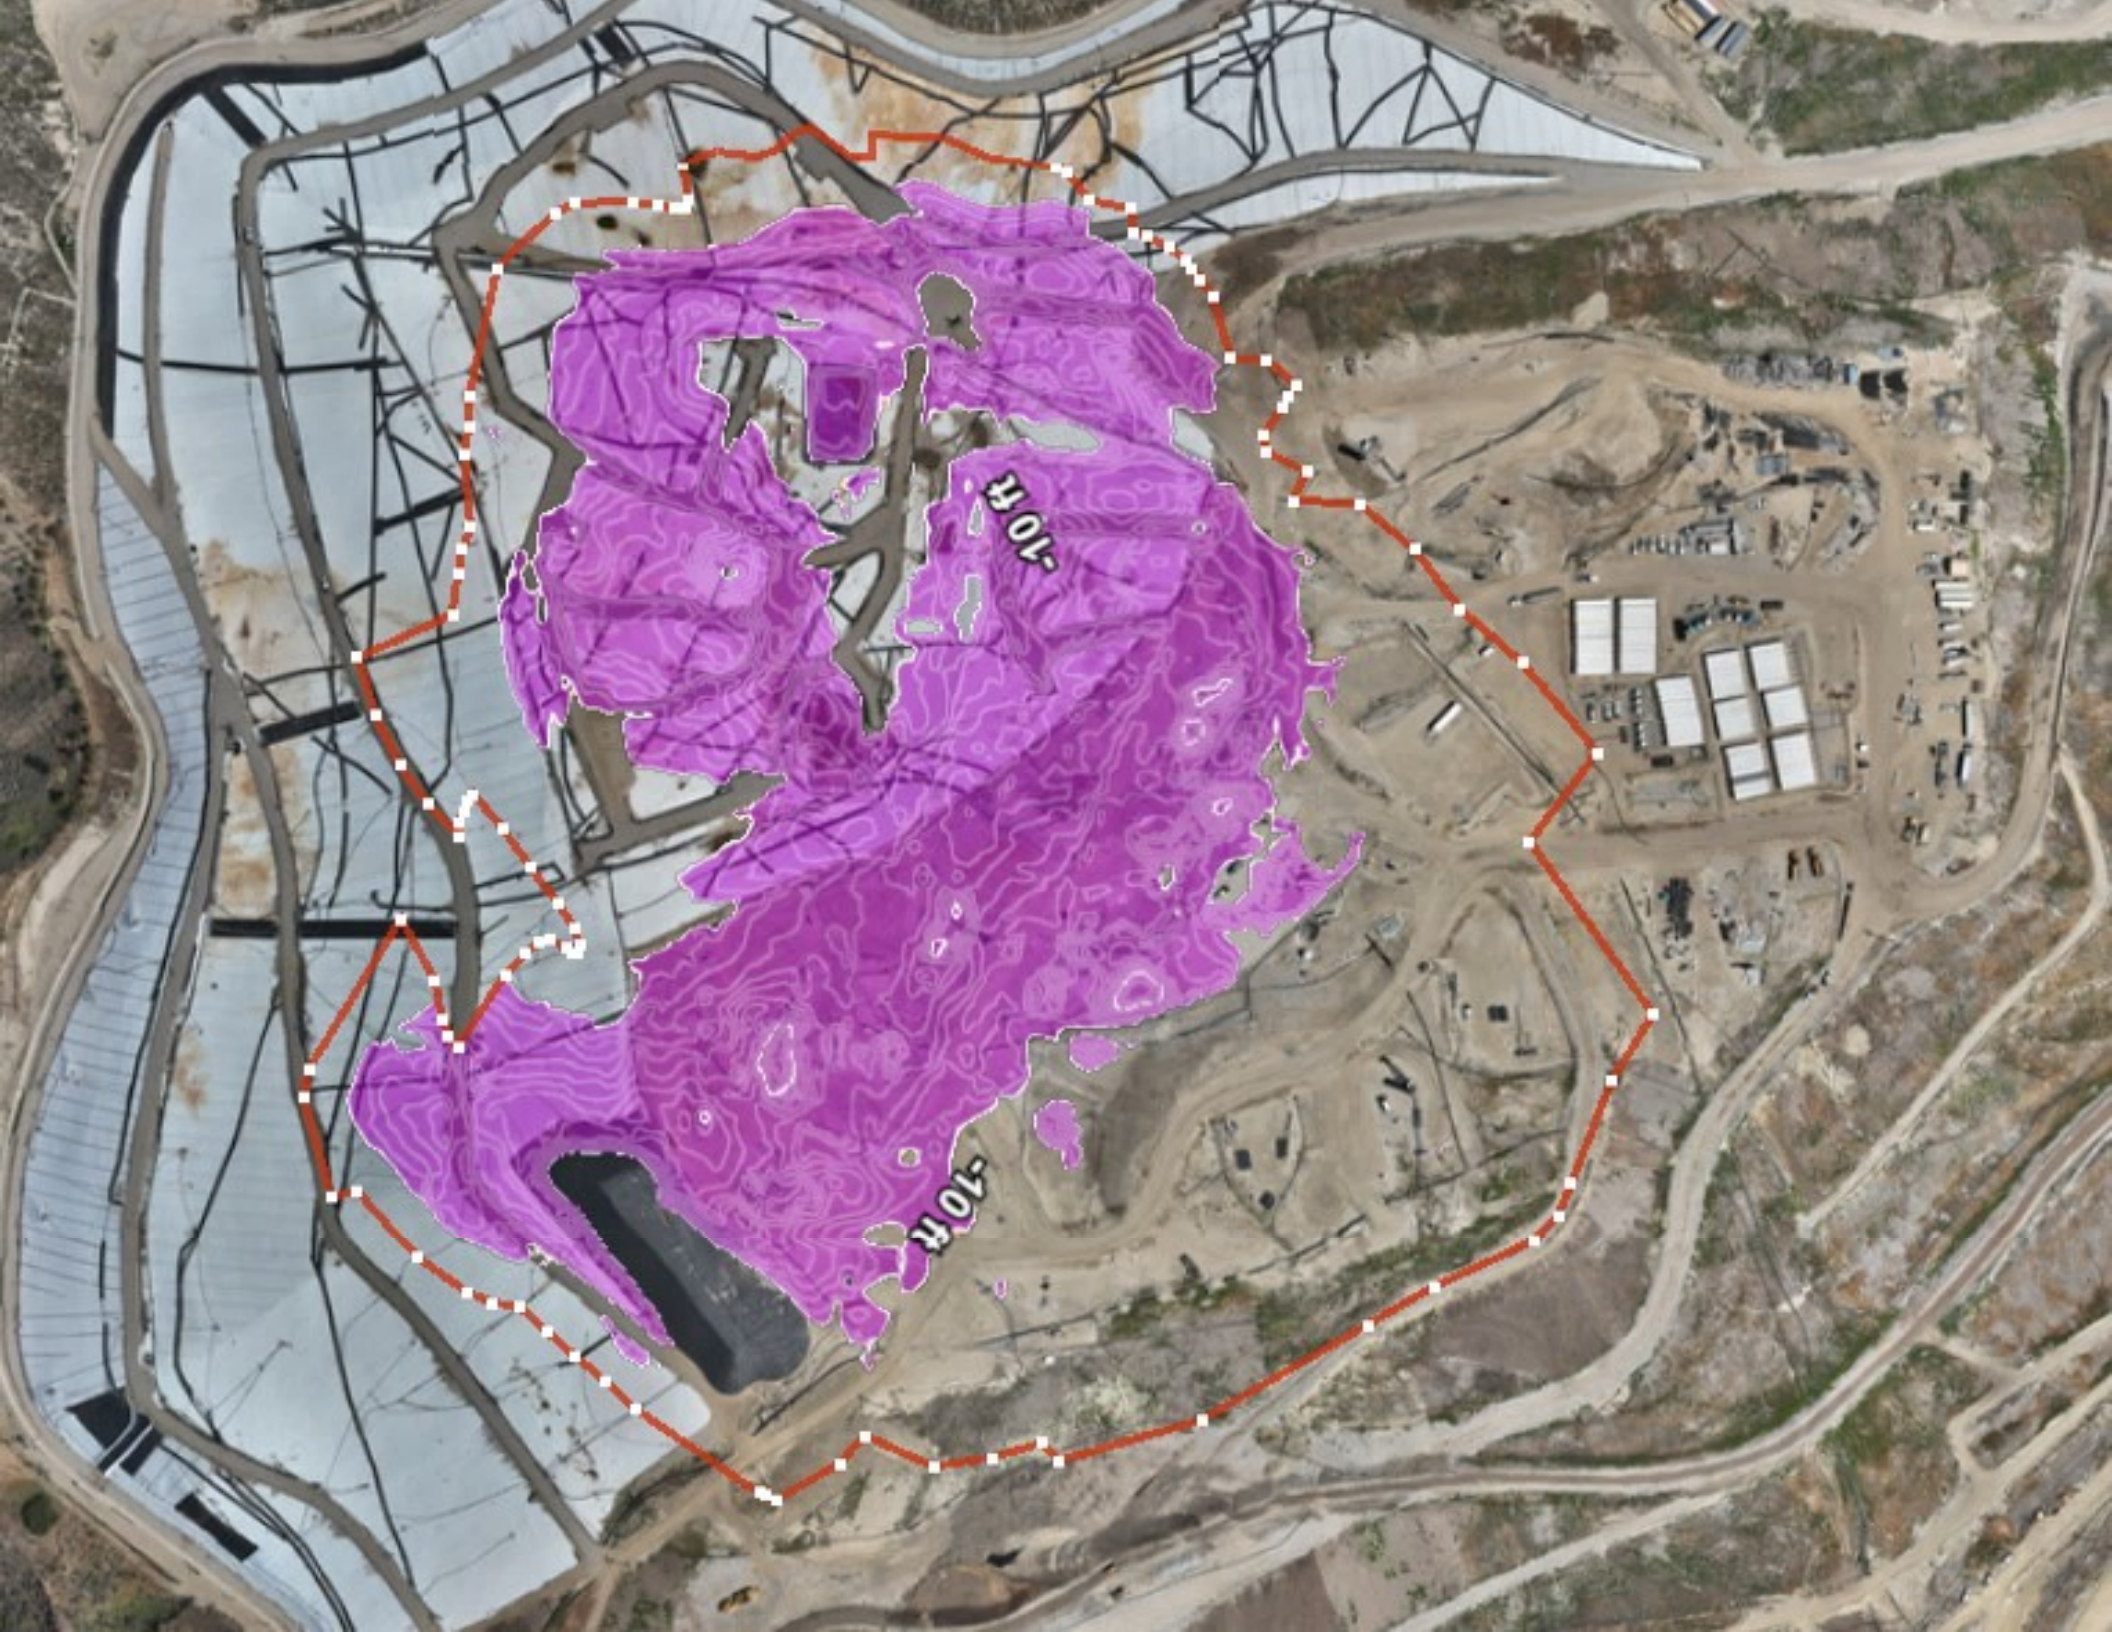
Settlement area between 4/24/2024 and  
4/23/2025, submitted on 4/29/2025, and  
provided again herein for comparison

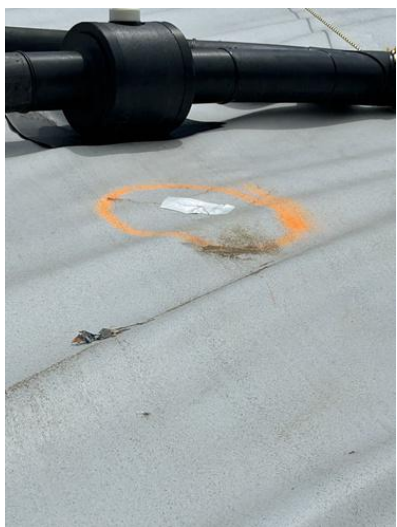
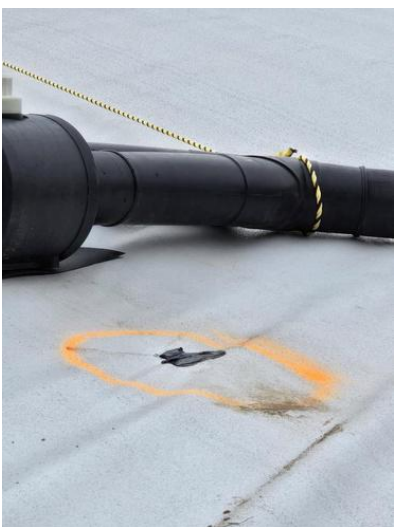
Found 5/5/25 1:09pm Grid 201

Puncture in cover needs to be extrusion welded.

Taped with flex seal upon discovery on 5/5/25. Permanent repairs were completed by

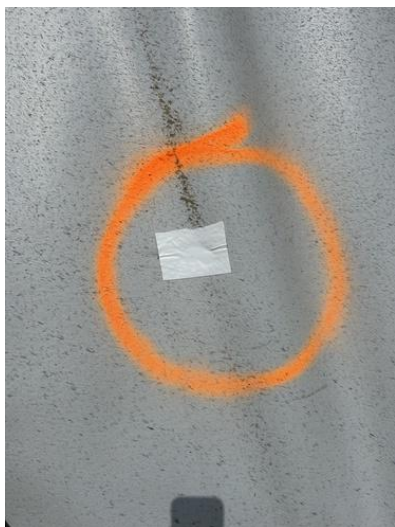
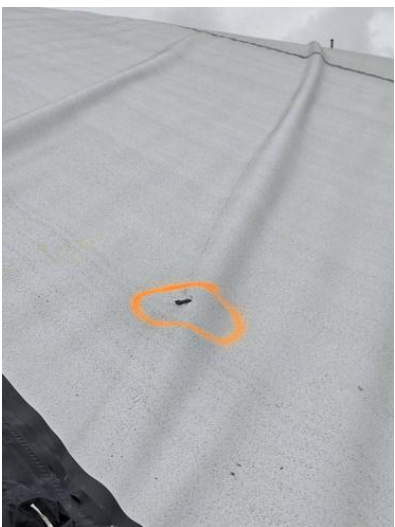
Found 5/5/25 1:15pm Grid 201

Puncture in cover needs to be extrusion welded.

discovery on 5/5/25. Permanent repairs were completed by extrusion welding on 5/6/25.

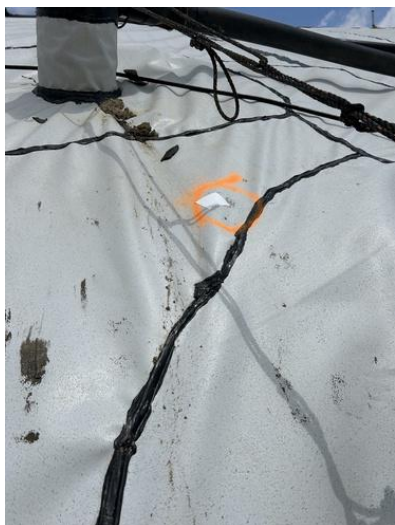
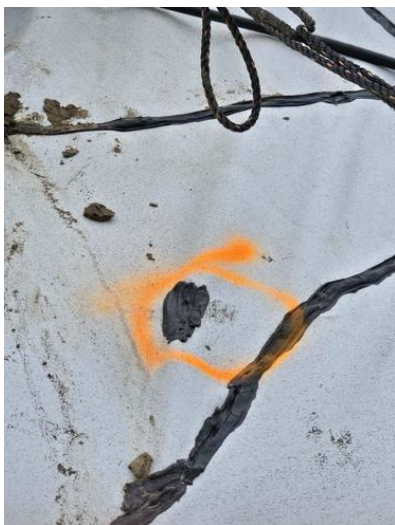
Found 5/5/25 1:20pm Grid 201

**Notate what the issue is and what needs to be repaired** Puncture in cover needs to be extrusion welded.

Taped with flex seal upon discovery on 5/5/25. Permanent repairs were completed by extrusion welding on 5/6/25.

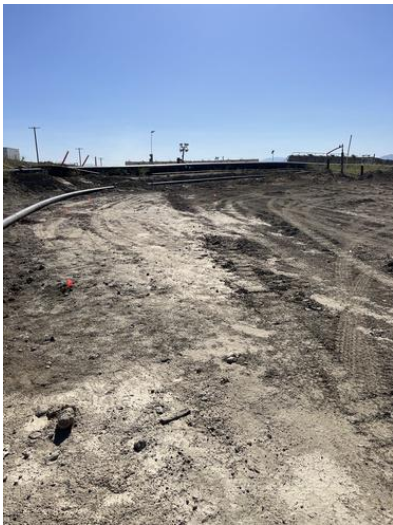
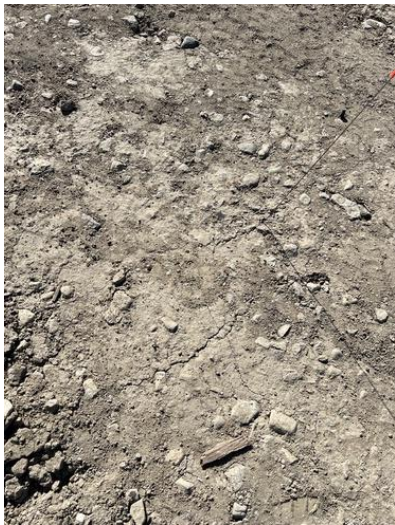
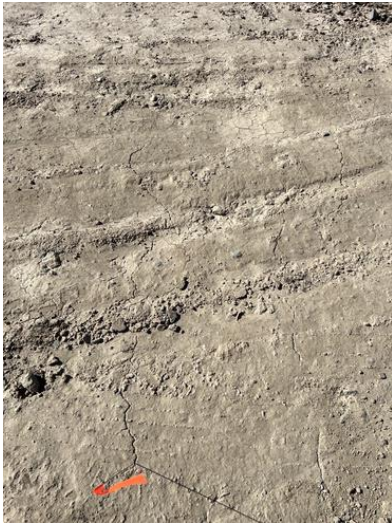
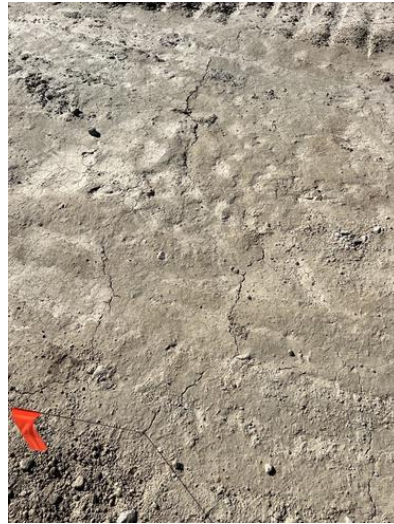
Yes

148

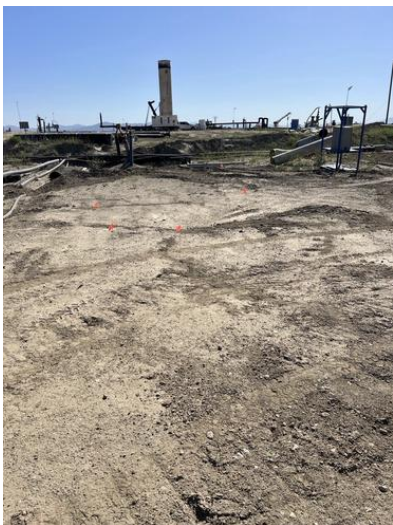
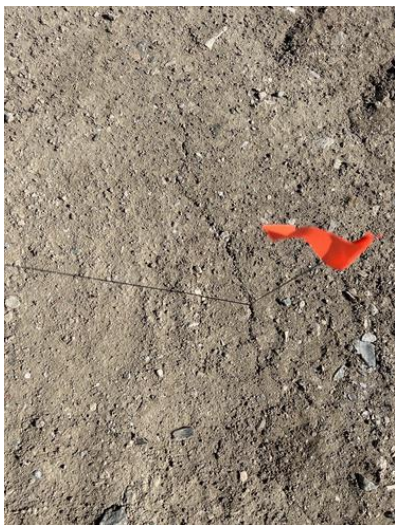
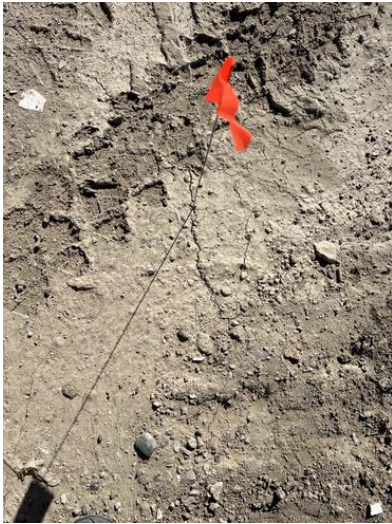
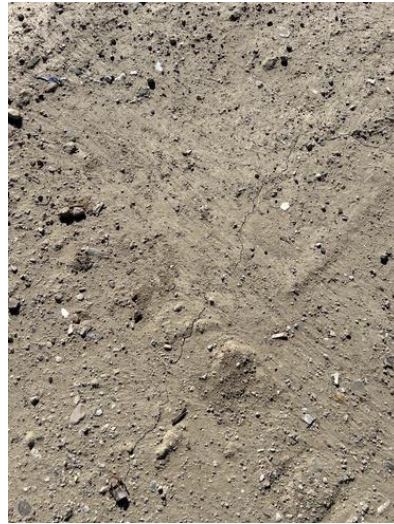
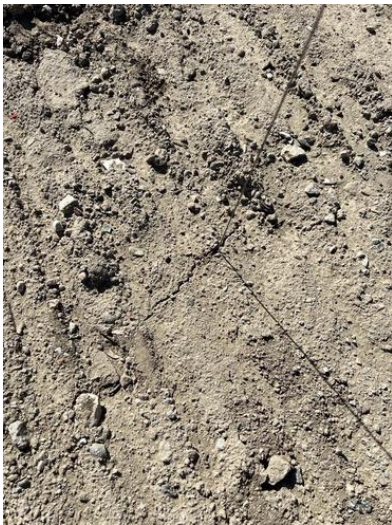
Yes

160

| <b>Length of crack (ft) or area containing multiple cracks (ft x ft)</b> | 25ft x 35ft |

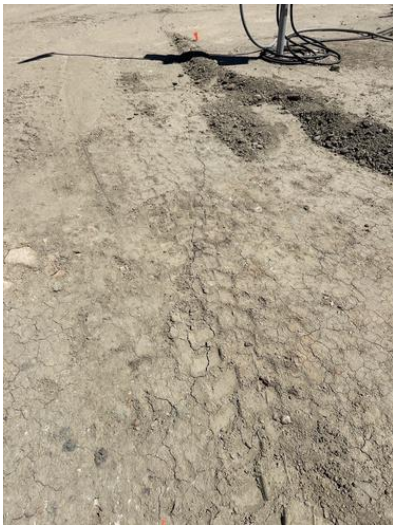
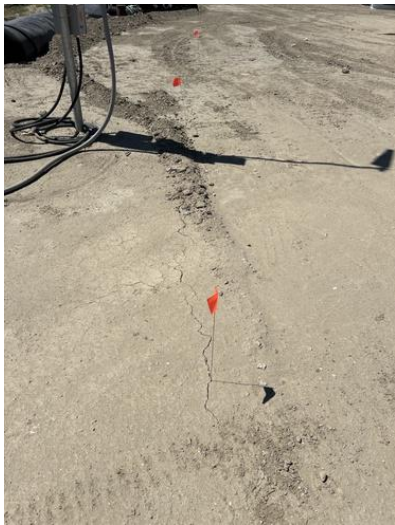
Yes

160

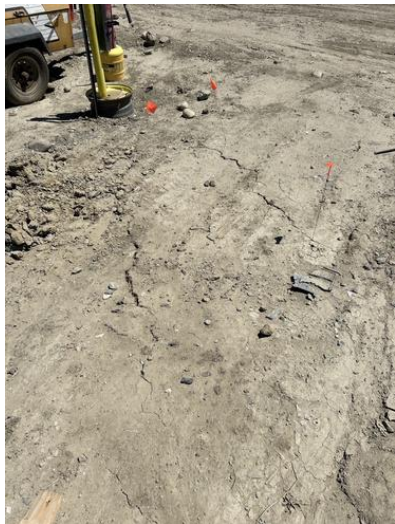
Photo 4

| Fissure or Tension Crack Found? | Yes |

149

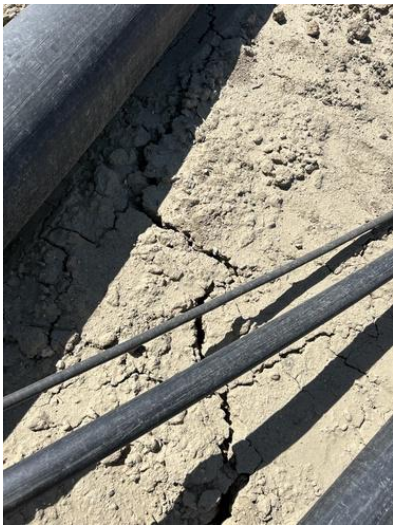
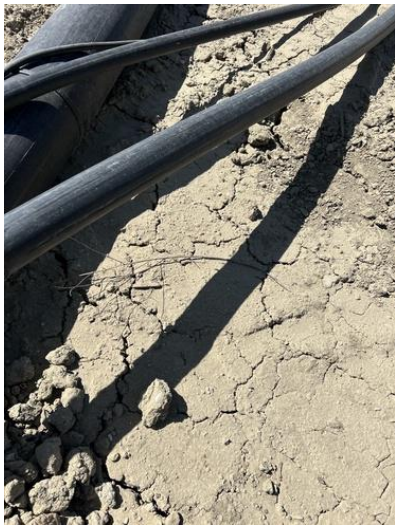
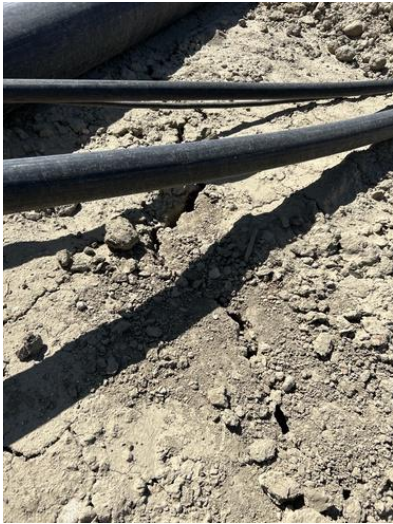
**Length of crack (ft) or area containing multiple cracks (ft x ft)** 6ft x 4ft area

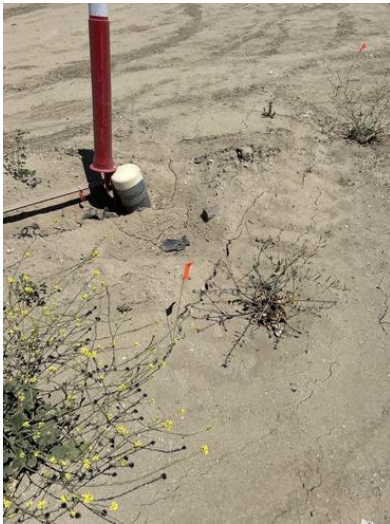
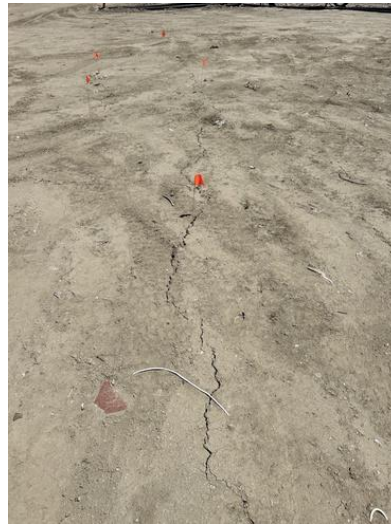
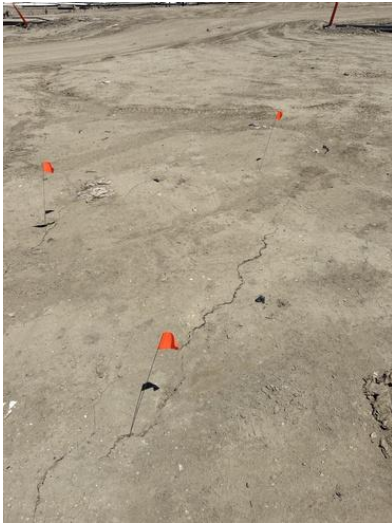
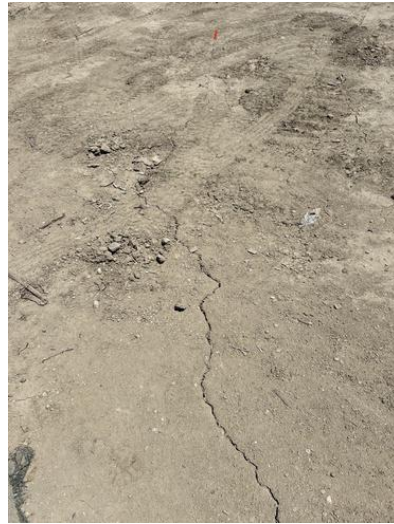
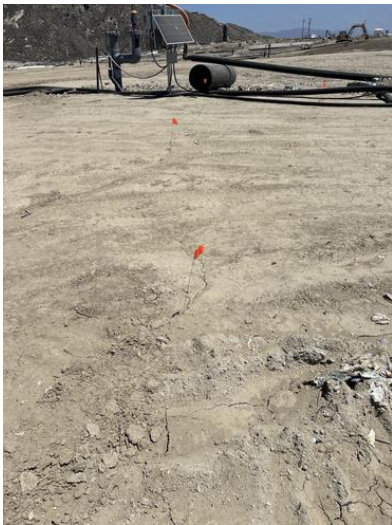
164

| <b>Length of crack (ft) or area containing multiple cracks (ft x ft)</b> | 20ft x 25ft area |
