June 20, 2025  
File No. 01204123.42, Task 10

Subject: May 2025 Monthly Report for Modified Stipulated Order for Abatement (Case No. 6177-4), Chiquita Canyon Landfill (Facility ID 119219), Castaic, California

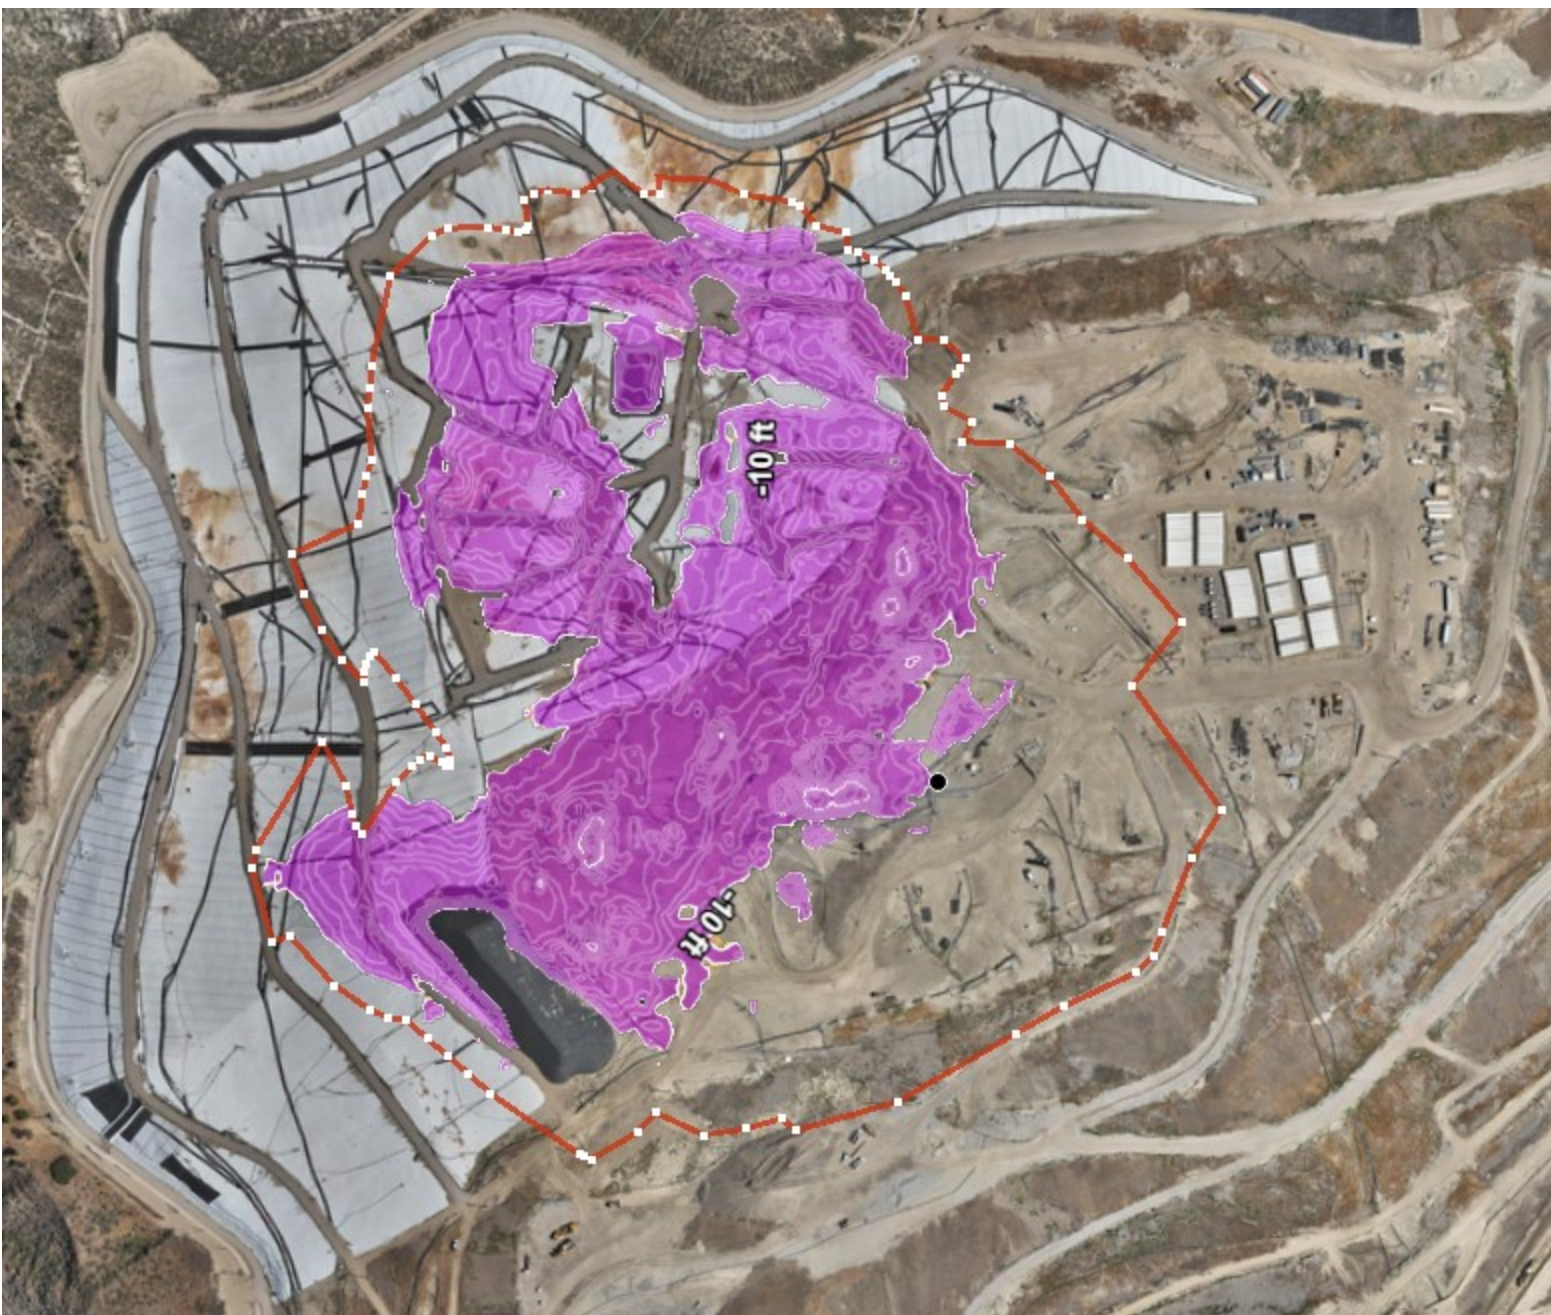
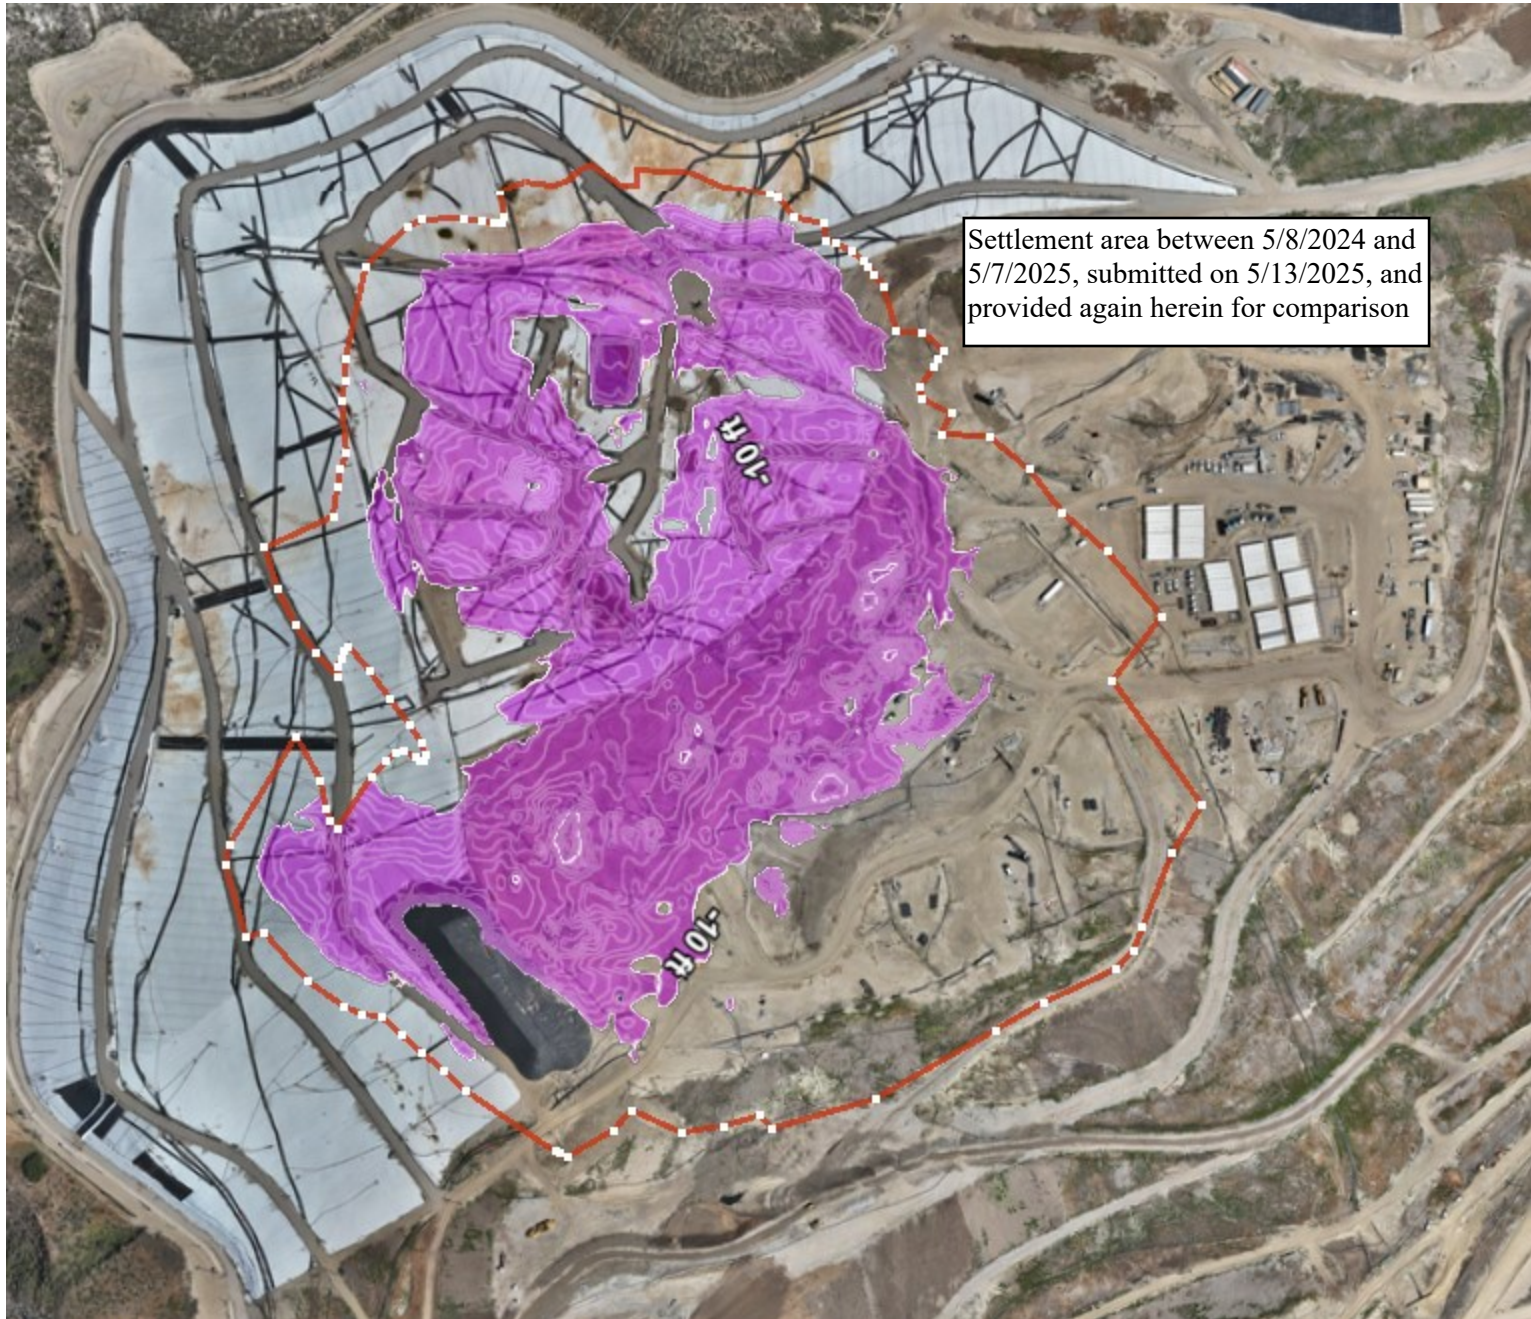
Settlement area between 5/8/2024 and 5/7/2025, submitted on 5/13/2025, and provided again herein for comparison

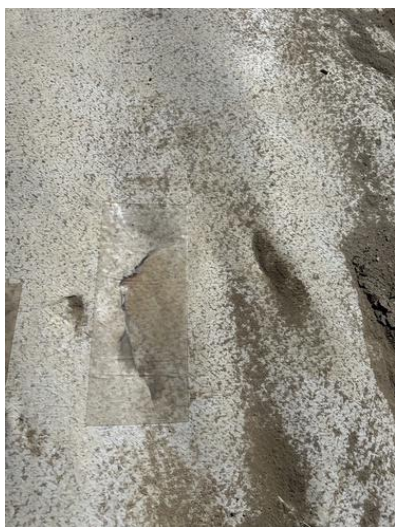
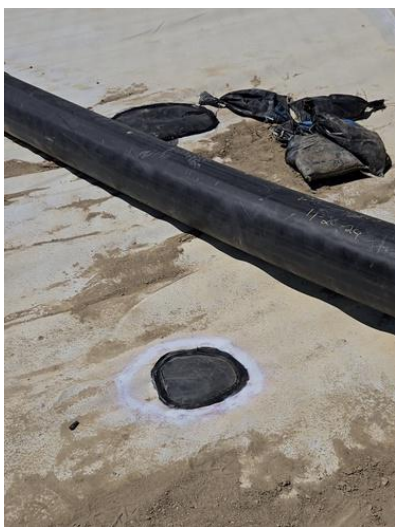
Found 5/19 at 9:29 am in grid 78.

Tear in cover, needs to be patched/extrusion welded.

Tear was taped with flex seal tape on 5/19 upon discovery. Final repair was completed by patching

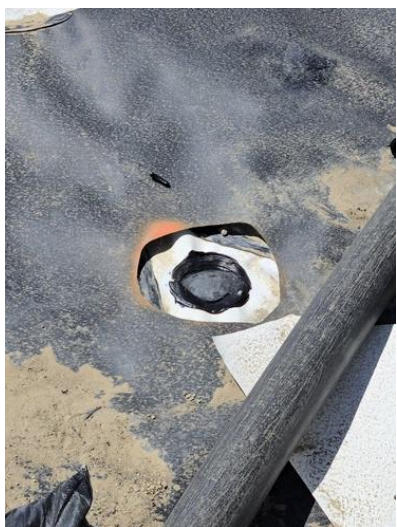
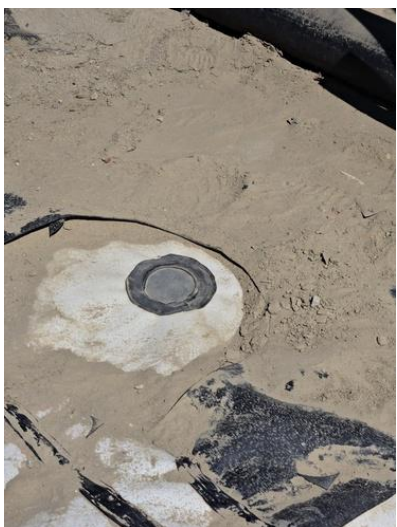
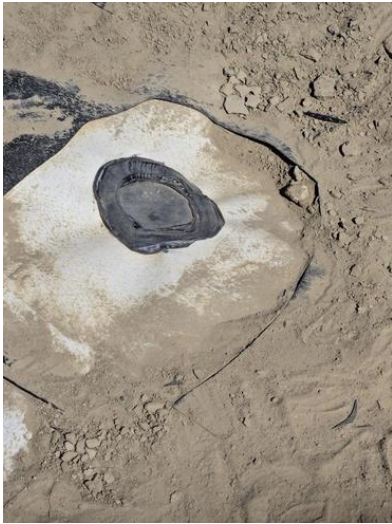
Found on 5/20/25 at 7:45am. Grid 75/76

3 holes from posts that were moved need to be patched and extrusion welded.

| Description of repair work | Holes were patched and extrusion welded. |

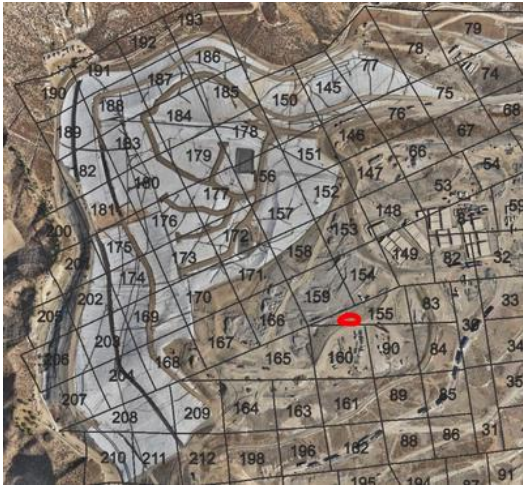
Using the attached image, annotate all areas where inspectors identified a fissure or tension crack.

155

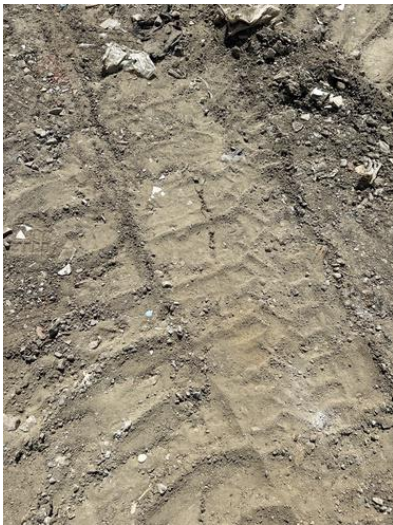
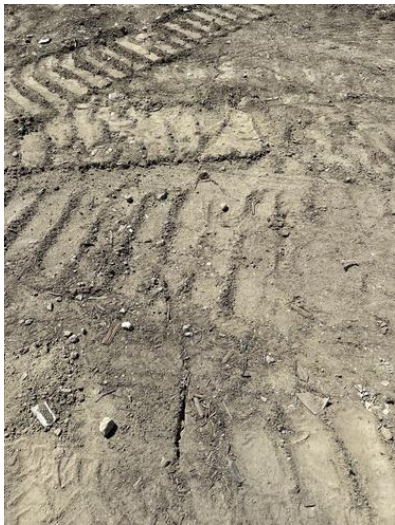
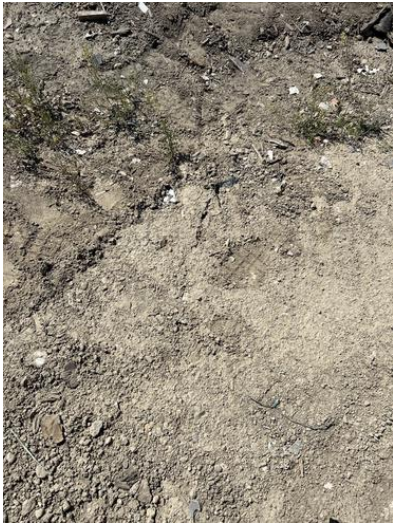
**Length of crack (ft) or area containing multiple cracks (ft x ft)** 20ft x 30ft

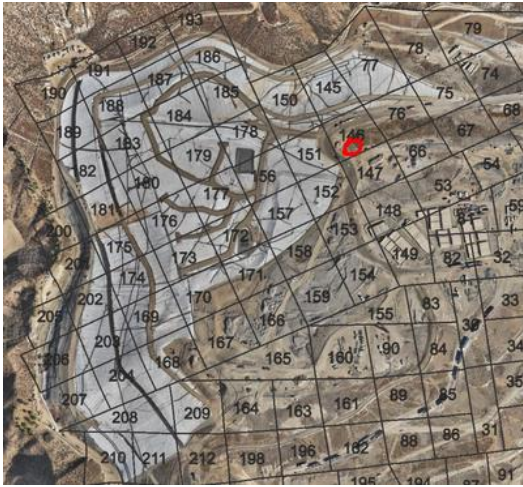
Using the attached image, annotate all areas where inspectors identified a fissure or tension crack.

146

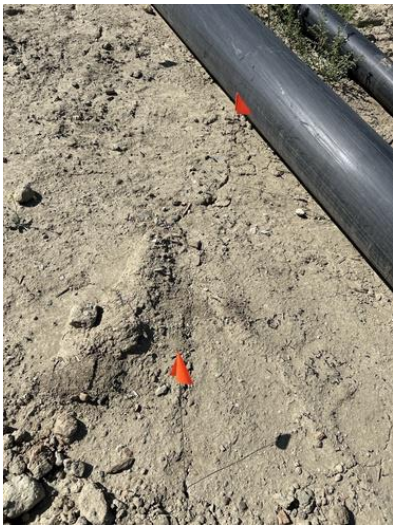
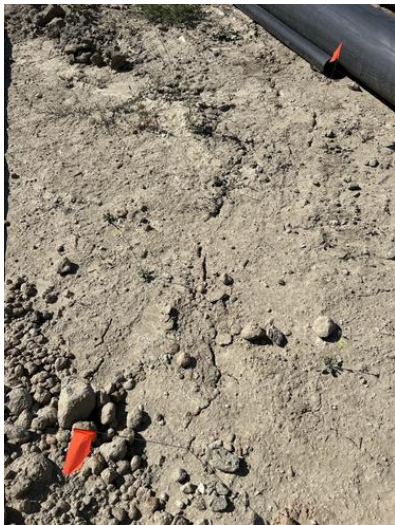
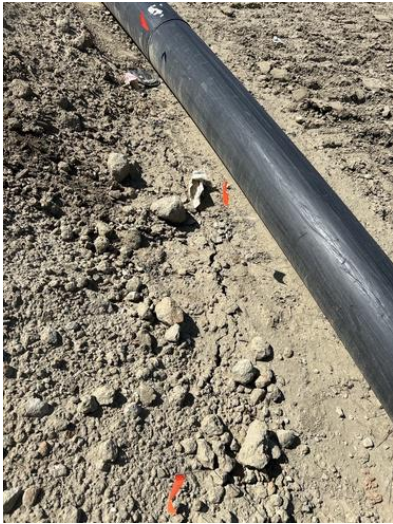
**Length of crack (ft) or area containing multiple cracks (ft x ft)** 4ft x 10ft area

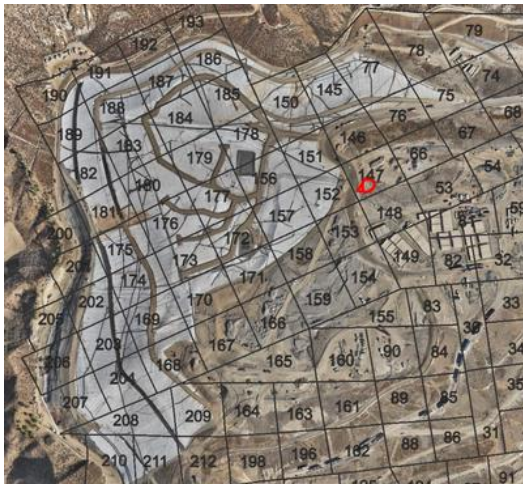
**Using the attached image, annotate all areas where inspectors identified a fissure or tension crack.**

147

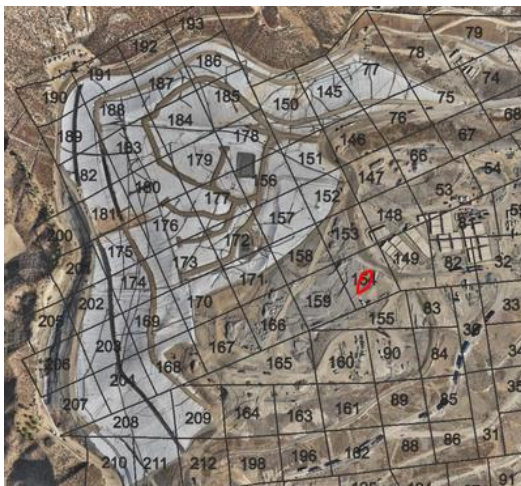
**Using the attached image, annotate all areas where inspectors identified a fissure or tension crack.**

154

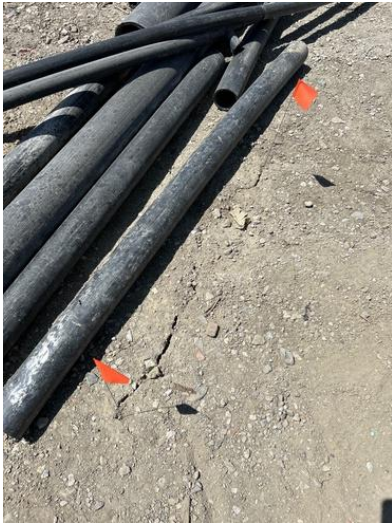
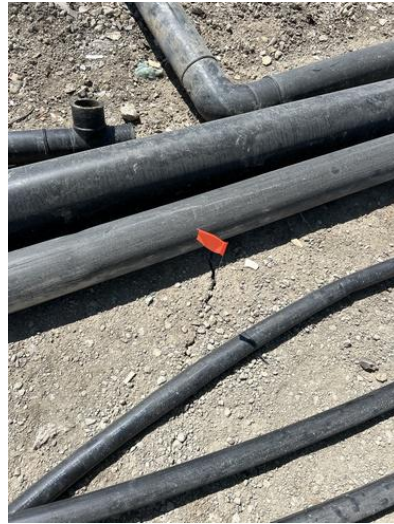
| <b>Length of crack (ft) or area containing multiple cracks (ft x ft)</b> | 10ft x 10 ft area |

**Description of repairs** Cracks were track walked.

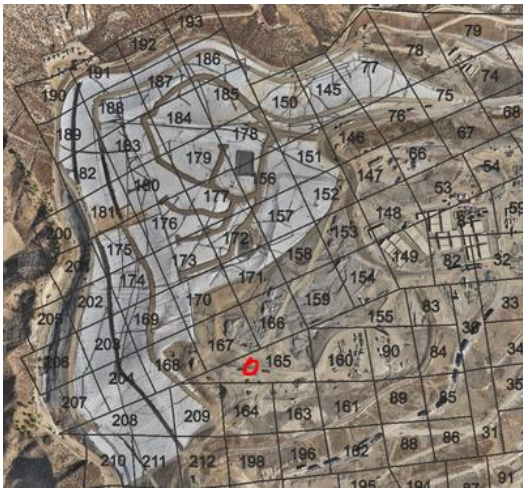
**Grid Location** 165

**Fissure or Tension Crack Found?** Yes

Using the attached image, annotate all areas where inspectors identified a fissure or tension crack.

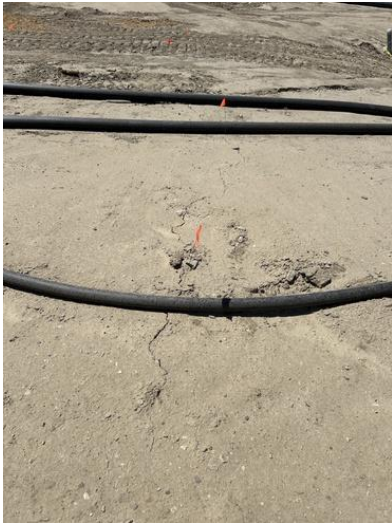
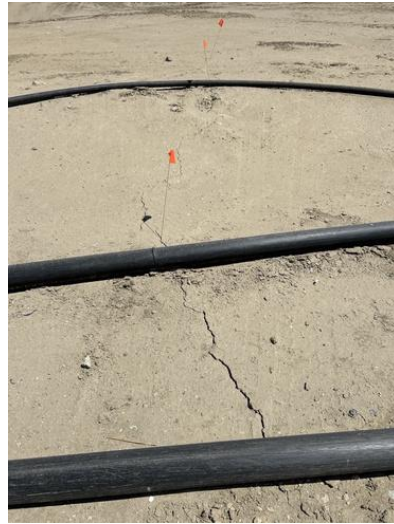
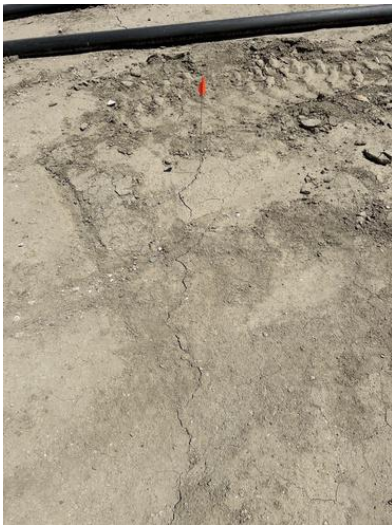
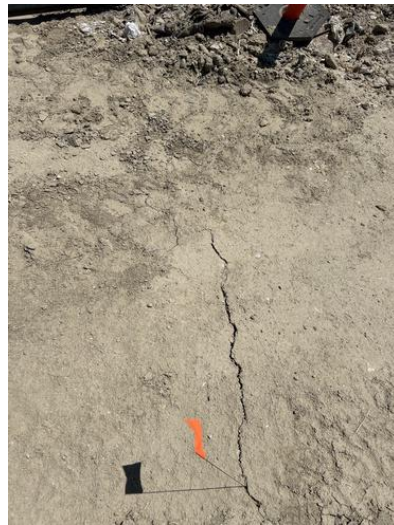
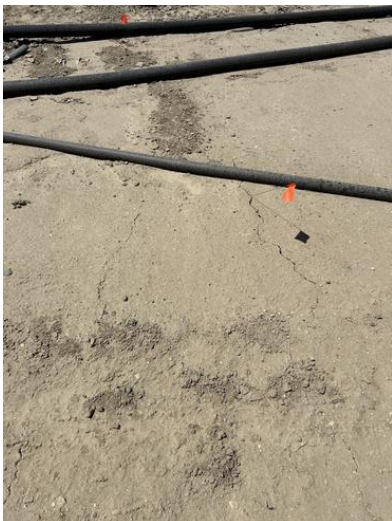
**Using the Media link below, attach the before photo of the fissure of tension crack.** 29 May 2025 11:30 AM PDT

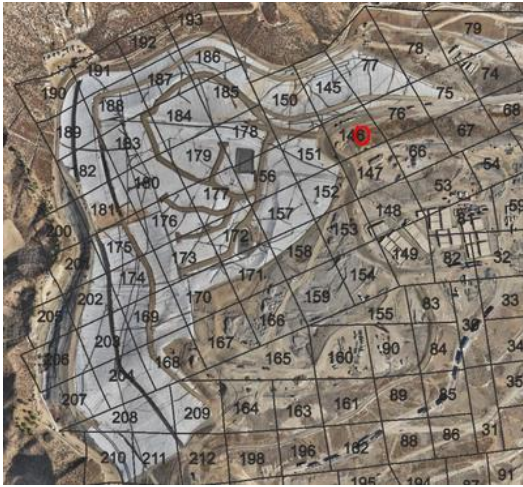
146

Fissure or Tension Crack Found?

Yes

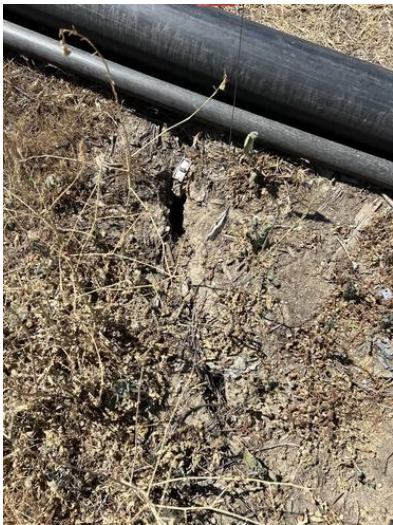
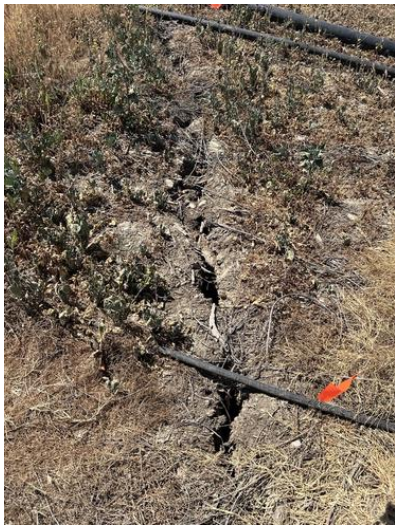
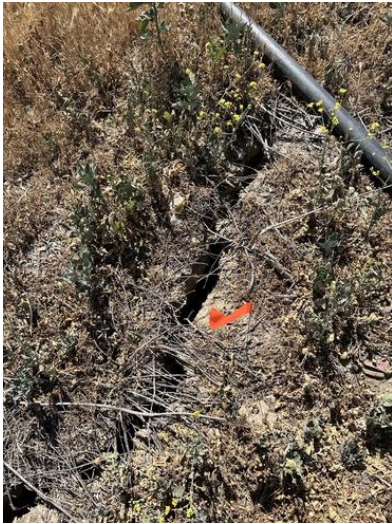
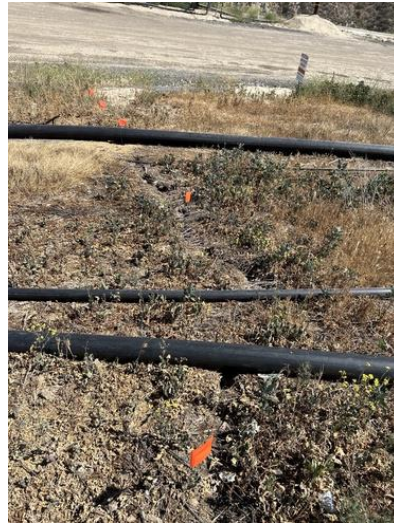
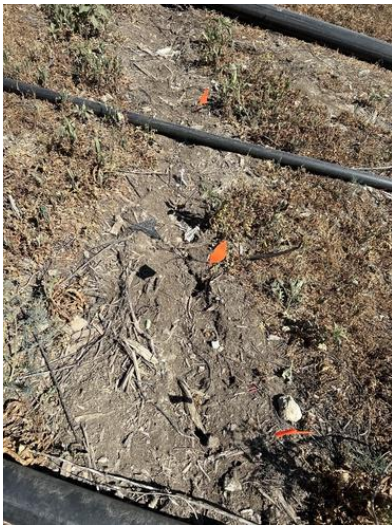
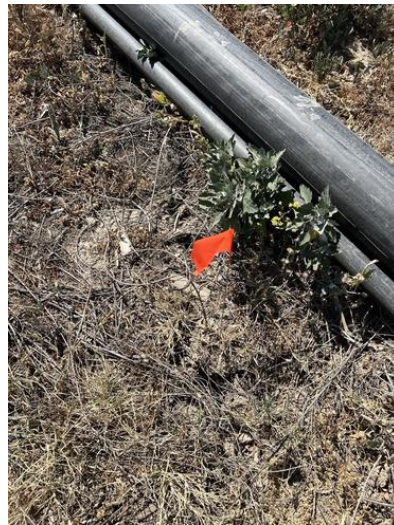
30 May 2025 10:32 AM PDT

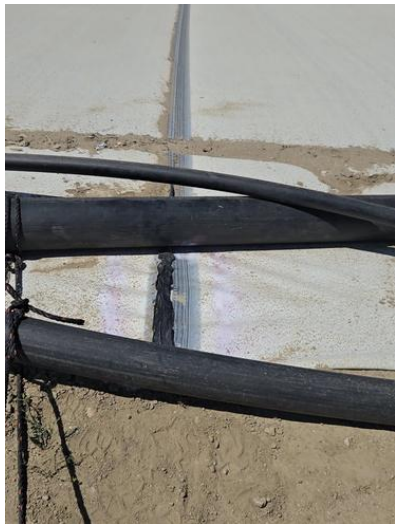
Photo 2

Separation at seam in the liner.
