CHIQUITA CANYON
A Waste Connections Company

**Re: Chiquita Canyon, LLC's Weekly Report on the Documentation and
Tracking of Cover Issues, Monthly Summary and Monthly Isopach Map**

4050 - Chiquita Reaction Area Tracking of Fissures and Tension Cracks

**AUGUST 2025 FISSURE AND TENSION CRACK MONITORING SUMMARY
CHIQUITA CANYON LANDFILL
CASTAIC, CALIFORNIA**

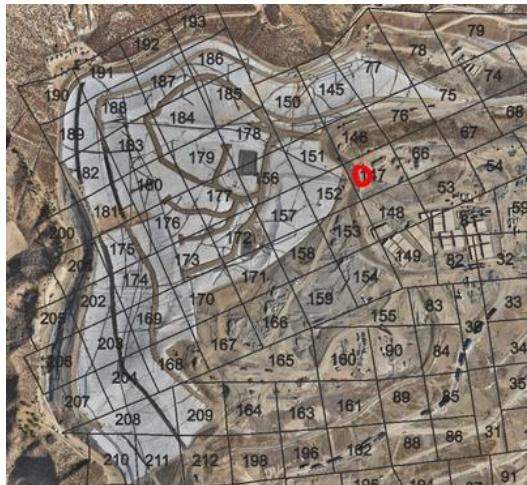
Grid Location

Not continuous crack over 50ft.

Cracks were track walked.
