CHIQUITA CANYON
A Waste Connections Company

Re: Chiquita Canyon, LLC's Weekly Report on the Documentation and Tracking of Cover Issues

Attachment: May 19, 2025 Weekly Cover Issues Report

4050 - Chiquita Reaction Area Tracking of Fissures and Tension Cracks

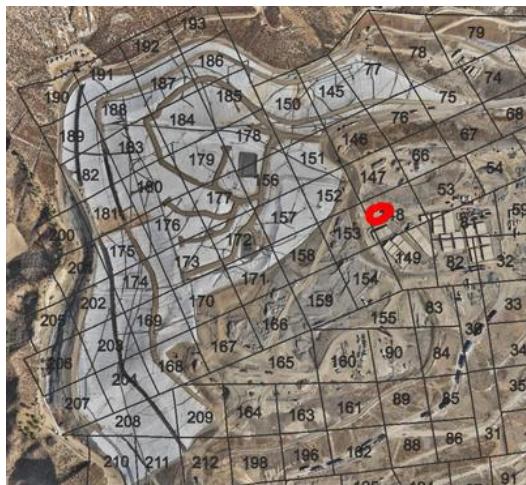
148

Yes

Cracks were track walked.

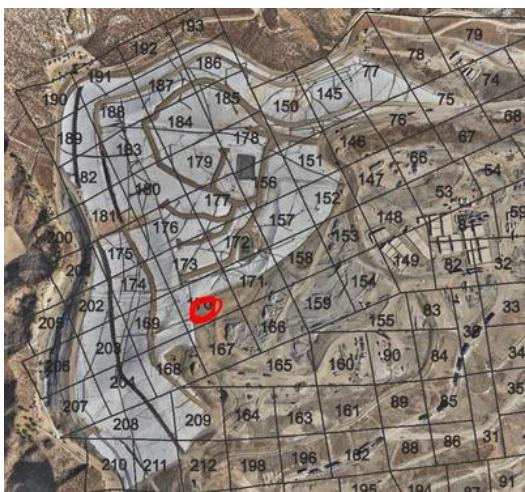
170

Yes
