# CHIQUITA CANYON

**Ref.: Informe Semanal de Chiquita Canyon, LLC sobre la Documentación y el Seguimiento de Problemas con las Cubiertas y Resumen Mensual**

# 4050 - Chiquita Reaction Area Tracking of Fissures and Tension Cracks

**MAY 2025 FISSURE AND TENSION CRACK MONITORING SUMMARY  
CHIQUITA CANYON LANDFILL  
CASTAIC, CALIFORNIA**

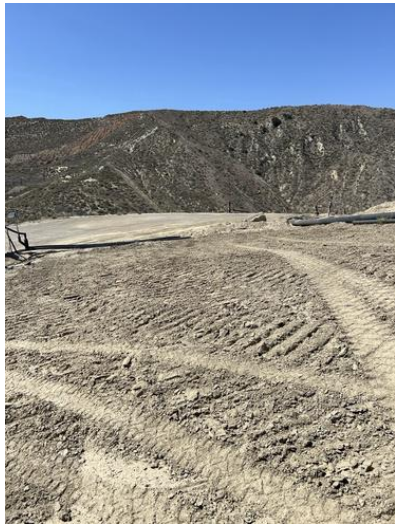
Grid 146

No

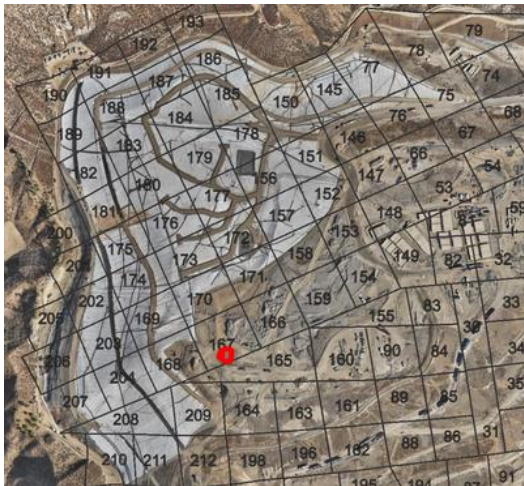
167

Fissure or Tension Crack Found?

Yes

**Length of crack (ft) or area containing multiple cracks (ft x ft)** 20ft x 30ft

**Date and time of repairs** 3 Jun 2025 10:15 AM PDT

**Description of repairs** Cracks were track walked.

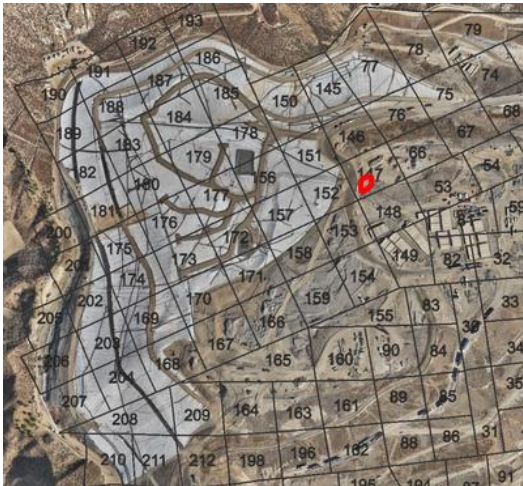
147

Fissure or Tension Crack Found?

Yes

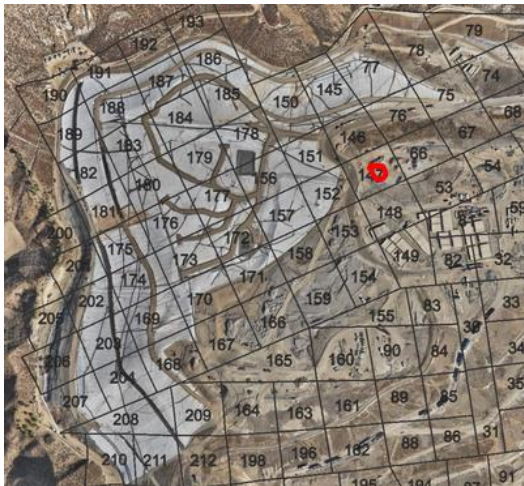
147

Fissure or Tension Crack Found?

Yes

**Length of crack (ft) or area containing multiple cracks (ft x ft)** 25ft x 45ft

**Date and time of repairs** 4 Jun 2025 12:28 PM PDT

**Description of repairs** Other (please describe)

Dirt was added and cracks were track walked.

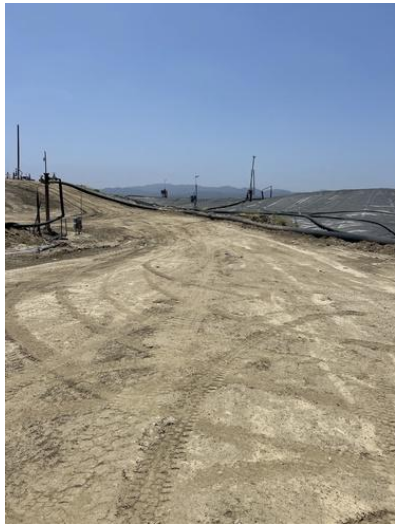
Grid 167

**Fissure or Tension Crack Found?**

No

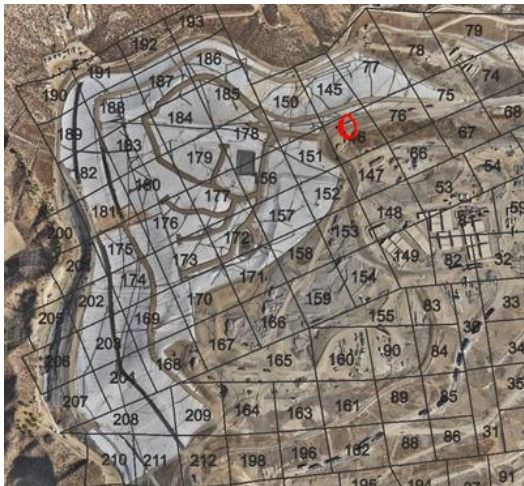
146

Fissure or Tension Crack Found?

Yes

| Date and time of repairs | 6 Jun 2025 12:04 PM PDT |
| Description of repairs | Cracks were track walked. |

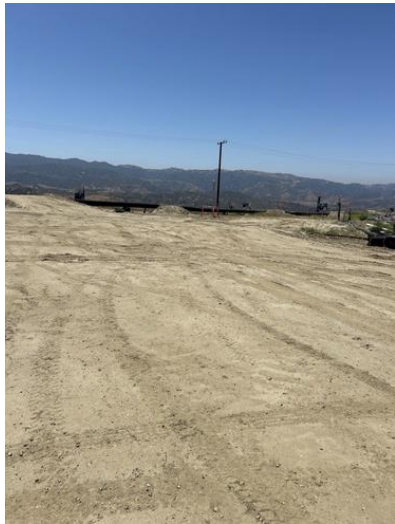
Grid 90

**Fissure or Tension Crack Found?**

No
