CHIQUITA CANYON
A Waste Connections Company

Re: Chiquita Canyon, LLC's Weekly Report on the Documentation and Tracking of Cover Issues

Attachment: June 24, 2025 Weekly Cover Issues Report

4050 - Chiquita Reaction Area Tracking of Fissures and Tension Cracks

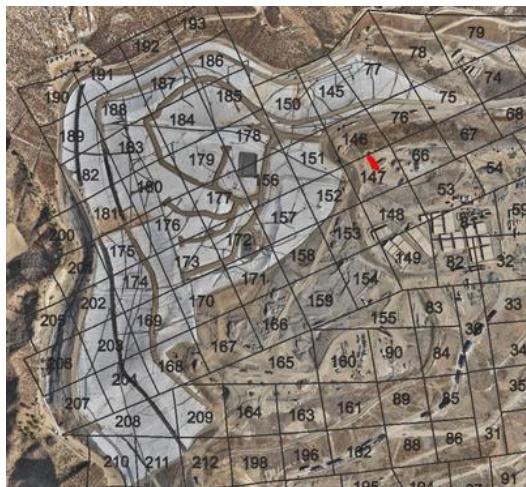
147

Yes

Cracks were track walked.

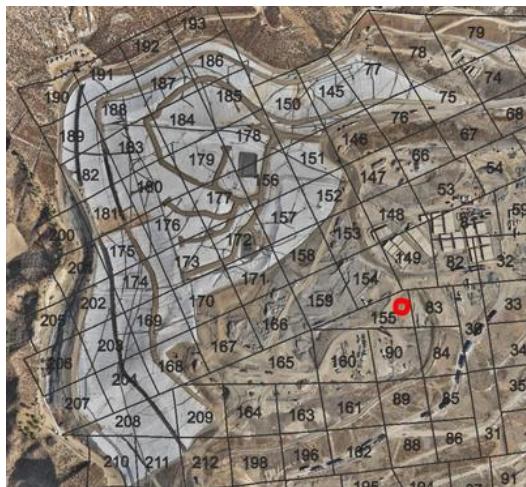
155

Yes

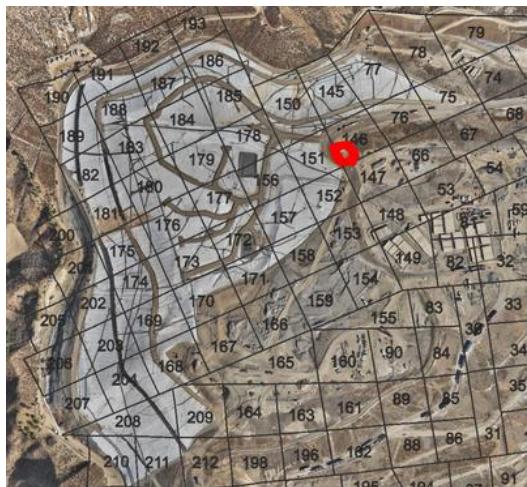
146

Yes

Cracks were track walked.

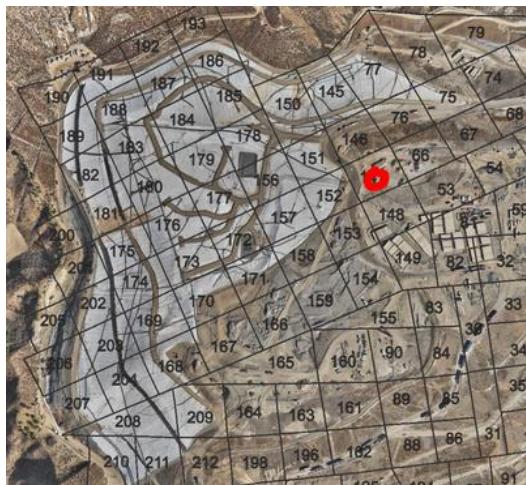
147

Yes

Description of repairs	Other (please describe)
------------------------	-------------------------

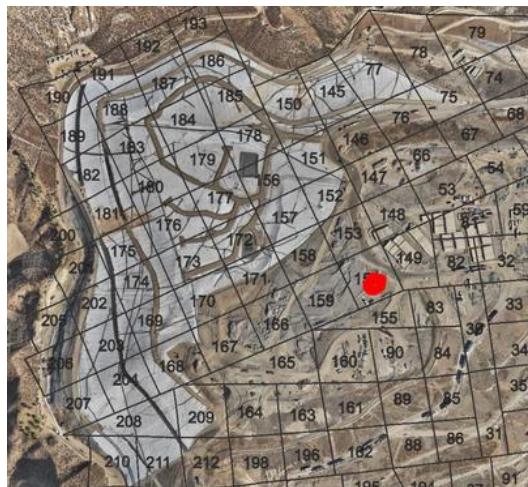
154

Fissure or Tension Crack Found?	Yes
---------------------------------	-----

Cracks were track walked.
