Re: Chiquita Canyon, LLC's Weekly Report on the Documentation and Tracking of Cover Issues

4050 - Chiquita Reaction Area Tracking of Fissures and Tension Cracks

4050 - Geosynthetic Cover Inspection

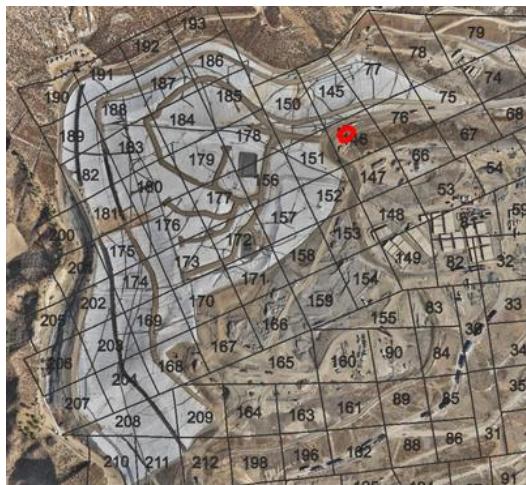
146

Yes

Description of repairs	Cracks were track walked.
------------------------	---------------------------

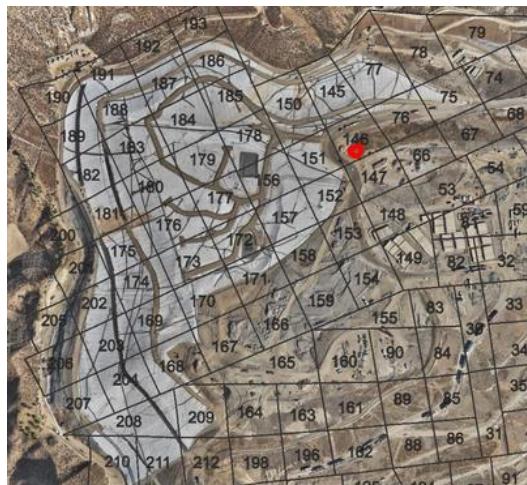
146

Yes

Cracks were track walked.

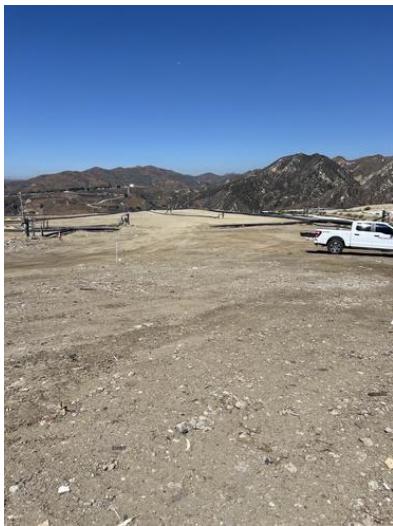
Photo 1

Instability

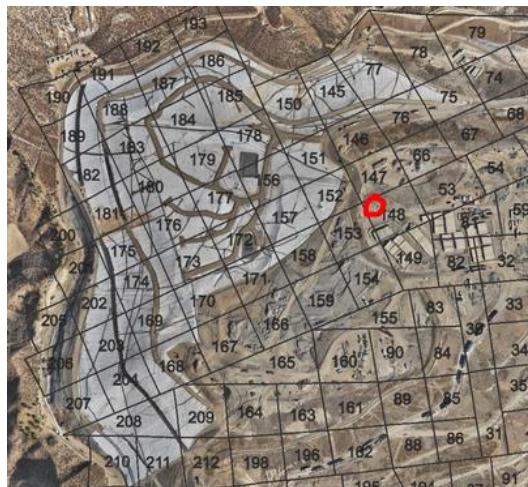
148

Yes

Cracks were compacted with excavator

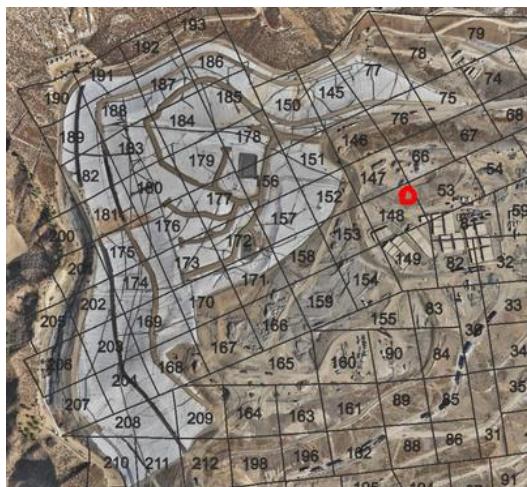
148

Yes

Cracks were track walked.

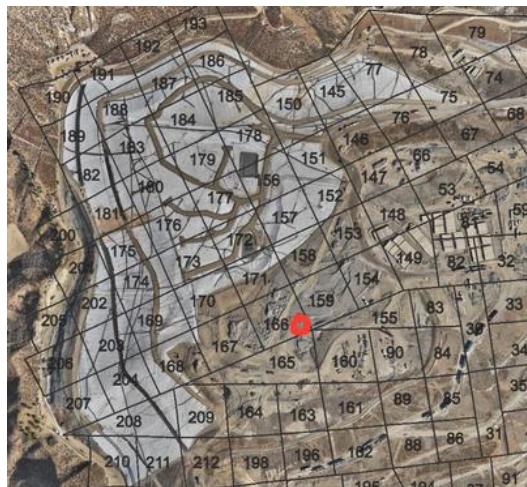
166

Yes

Cracks were track walked.

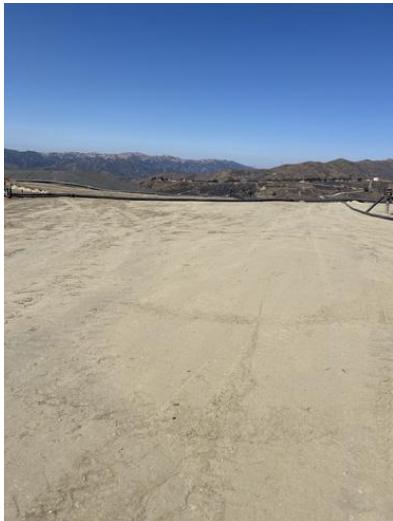
Photo 1

Instability

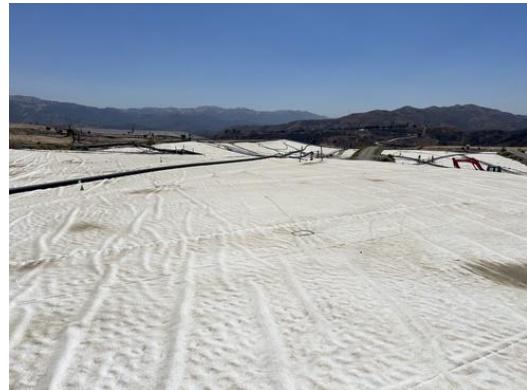
Photo 4

Instability under the cover

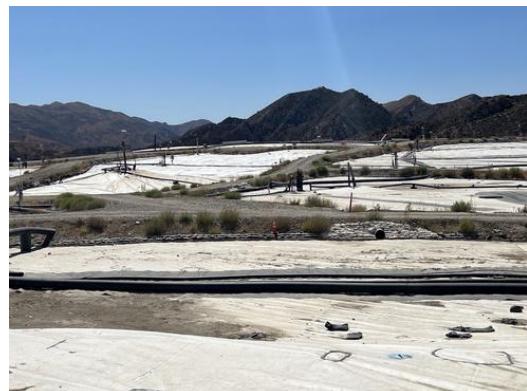
Photo 4

Instability under the cover

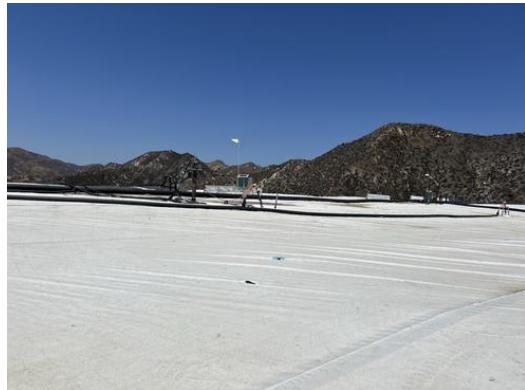
Photo 4

Instability under the cover

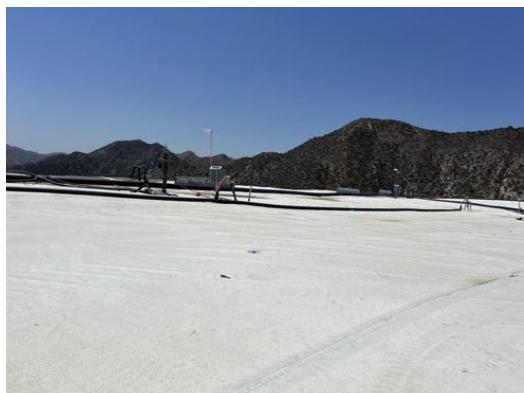
Photo 5

Instability under the cover
