Re: Chiquita Canyon, LLC's Weekly Report on the Documentation and Tracking of Cover Issues

Attachment: September 30, 2025 Weekly Cover Issues Report

4050 - Chiquita Reaction Area Tracking of Fissures and Tension Cracks

4050 - Geosynthetic Cover Inspection

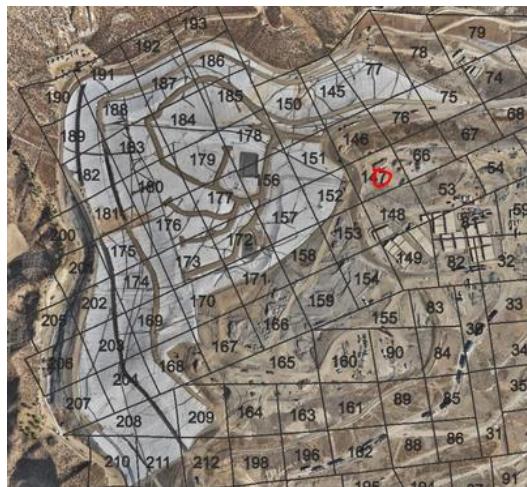
147

Yes

Cracks were track walked.
