**Re: Chiquita Canyon, LLC's Weekly Report on the Documentation and
Tracking of Cover Issues, Monthly Summary and Monthly Isopach Map**

4050 - Chiquita Reaction Area Tracking of Fissures and Tension Cracks

4050 - Geosynthetic Cover Inspection

**SEPTEMBER 2025 FISSURE AND TENSION CRACK MONITORING SUMMARY
CHIQUITA CANYON LANDFILL
CASTAIC, CALIFORNIA**

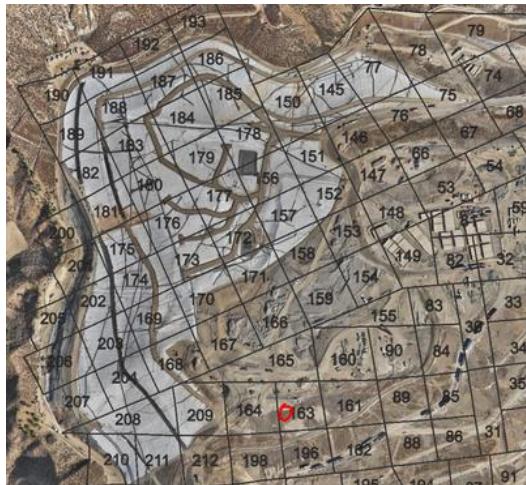
163

Longest individual crack about 15ft

Cracks were track walked.

Dirt added over cracks between piping

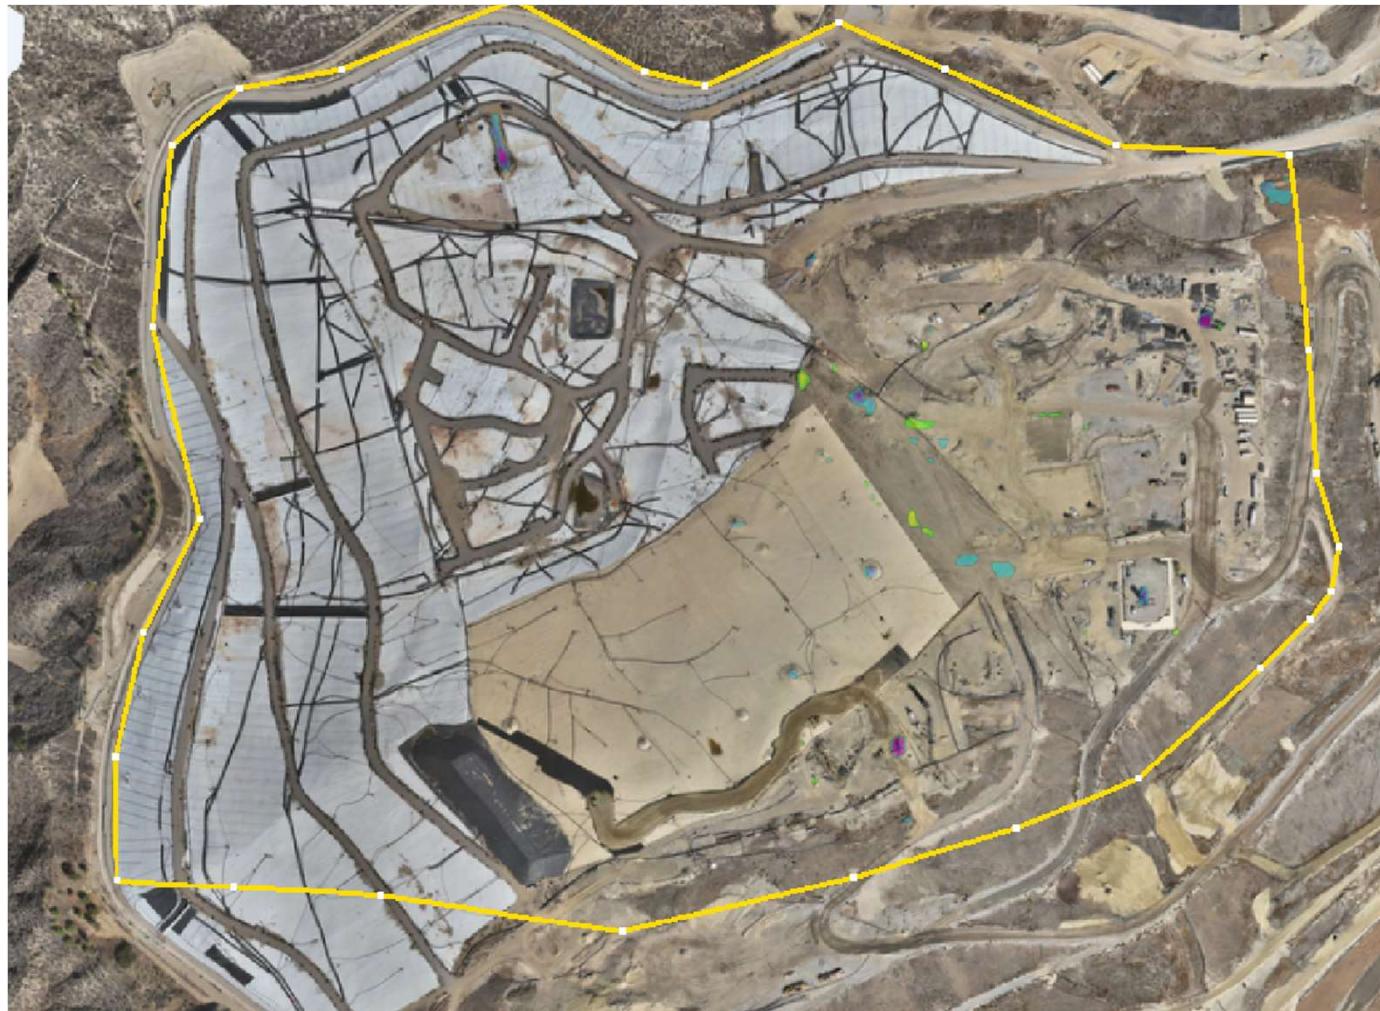
Chiquita Canyon Landfill - Isopach

October 1, 2025 Survey Image. August 27, 2025 vs October 1, 2025
