CHIQUITA CANYON
A Waste Connections Company

Re: Chiquita Canyon, LLC's Weekly Report on the Documentation and Tracking of Cover Issues, Monthly Summary, and Monthly Isopach Map

4050 - Chiquita Reaction Area Tracking of Fissures and Tension Cracks

**OCTOBER 2025 FISSURE AND TENSION CRACK MONITORING SUMMARY
CHIQUITA CANYON LANDFILL
CASTAIC, CALIFORNIA**

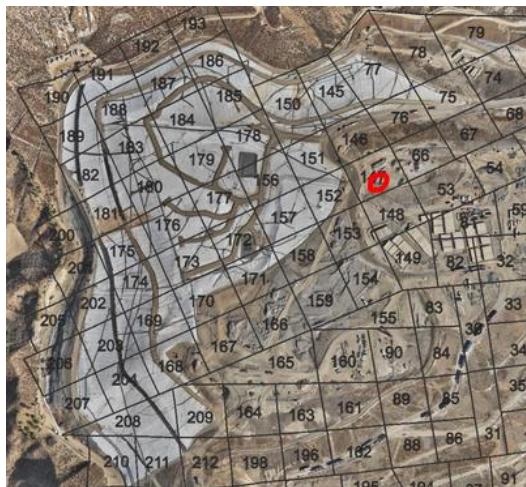
147

Using the attached image, annotate all areas where inspectors identified a fissure or tension crack.

Cracks were track walked.

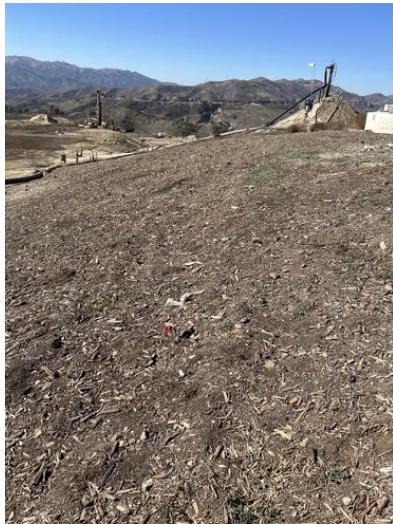
Photo 1

Grid 163

Instability

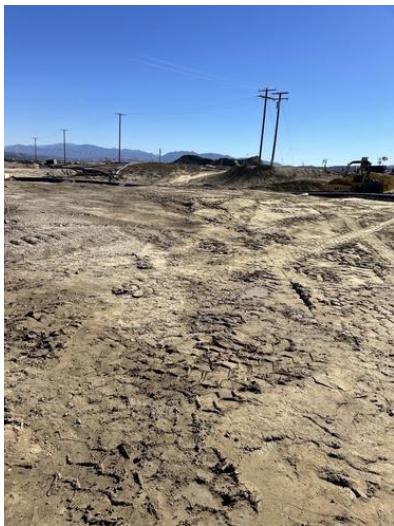
Photo 1

Grid 147

Instability

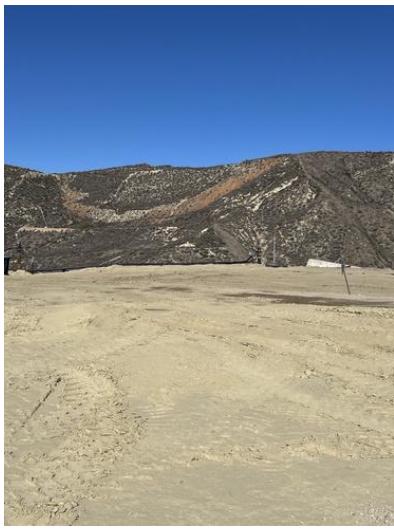
Photo 1

Grid 147

Instability

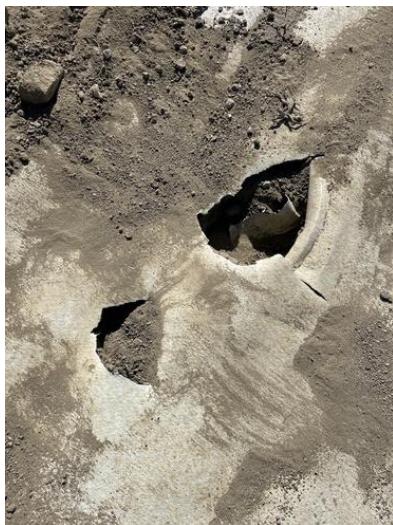
Grid 202

Liner torn, needs to be patched/extrusion welded.
