CHIQUITA CANYON
A Waste Connections Company

**Re: Chiquita Canyon, LLC's Weekly Report on the Documentation and
Tracking of Cover Issues, Monthly Summary, and Monthly Isopach Map**

4050 - Chiquita Reaction Area Tracking of Fissures and Tension Cracks

**NOVEMBER 2025 FISSURE AND TENSION CRACK MONITORING SUMMARY
CHIQUITA CANYON LANDFILL
CASTAIC, CALIFORNIA**

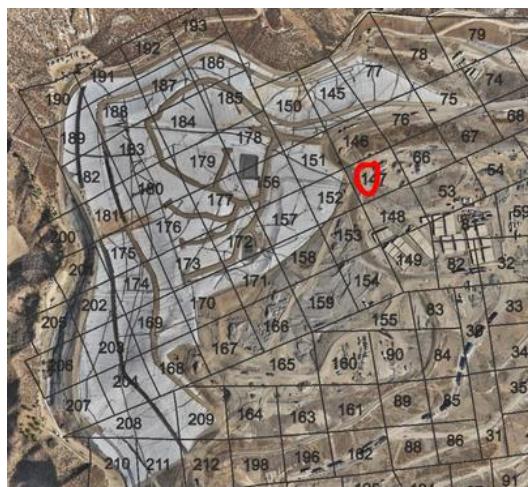
147

Longest crack approximately 25ft

Cracks were track walked.

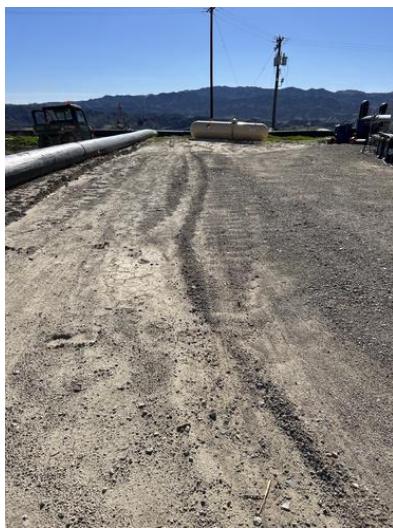
Grid 90

No

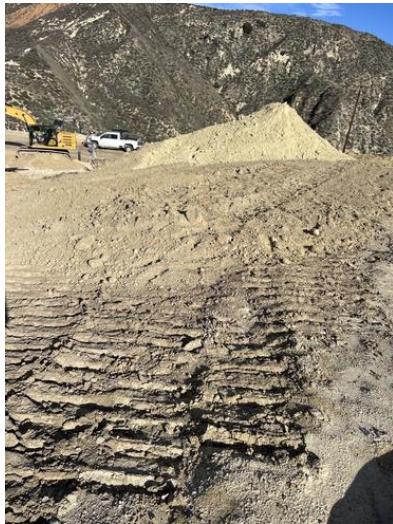
Grid 146

No

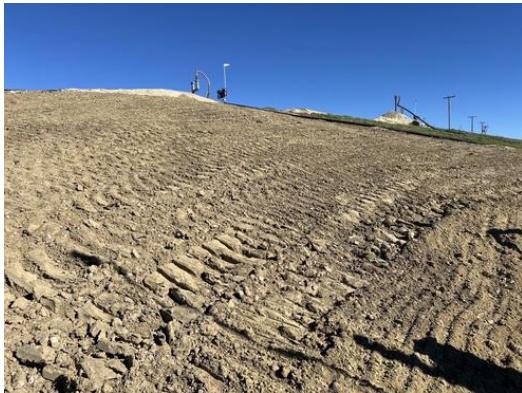
Grid 164

No

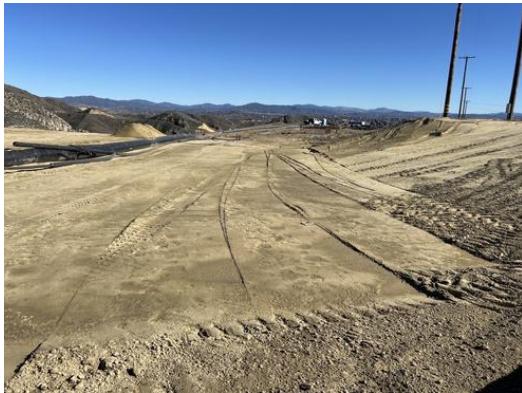
Grid 148

No
