CHIQUITA CANYON
A Waste Connections Company

Re: Chiquita Canyon, LLC's Weekly Report on the Documentation and Tracking of Cover Issues

4050 - Chiquita Reaction Area Tracking of Fissures and Tension Cracks

4050 - Geosynthetic Cover Inspection

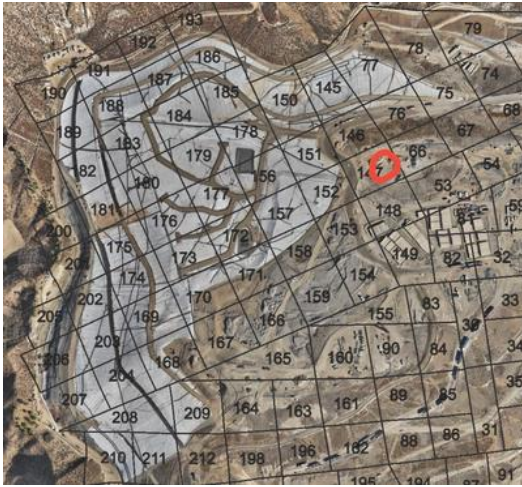
147

Using the attached image, annotate all areas where inspectors identified a fissure or tension crack.

Length of crack (ft) or area containing multiple cracks (ft x ft) 20ft x 35ft

Description of repairs Cracks were track walked.

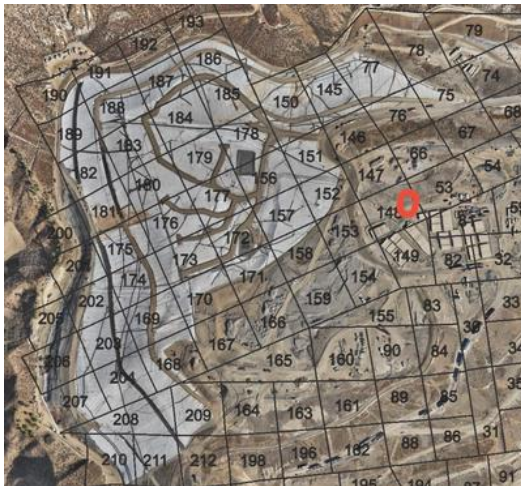
148

No individual crack over 50 ft.

Cracks were track walked.

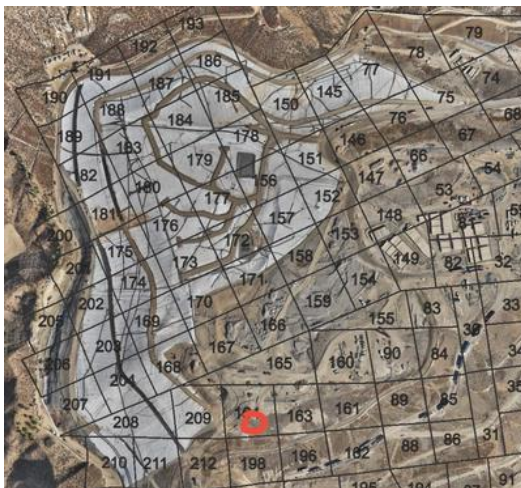
164

Length of crack (ft) or area containing multiple cracks (ft x ft)	40ft x 6ft
Horizontal Offset (width)	Extra Small <0.5 in width
Vertical Offset (height)	Extra small <0.5" in height
Orientation (direction)	E to W
Location	Castaic CA 91384 United States (34.43252671347615, -118.64837630125139)
Was Fissure or Crack fixed? If yes, add photo and description of repairs performed	Yes

Date and time of repairs	20 Jan 2026 12:08 PM PST
Description of repairs	Cracks were track walked.
Instability	
Are there any indications of slope stability concerns?	No

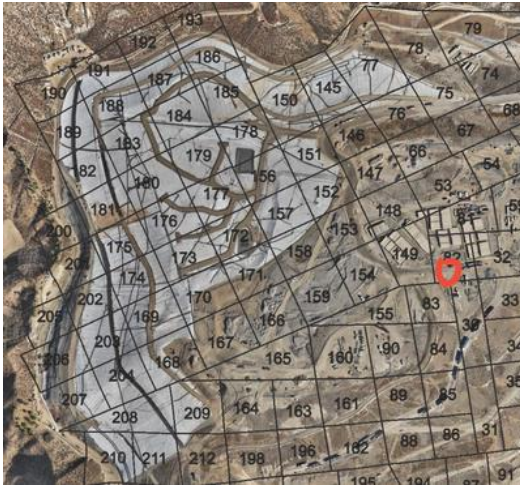
82

Horizontal Offset (width)	Extra Small <0.5 in width
Vertical Offset (height)	Extra small <0.5" in height
Orientation (direction)	NE to SW
Location	Castaic CA 91384 United States (34.43437523960082, -118.64572449211354)
Was Fissure or Crack fixed? If yes, add photo and description of repairs performed	Yes

Photo 3	
Date and time of repairs	21 Jan 2026 11:28 AM PST
Description of repairs	Cracks were track walked.
Instability	
Are there any indications of slope stability concerns?	No

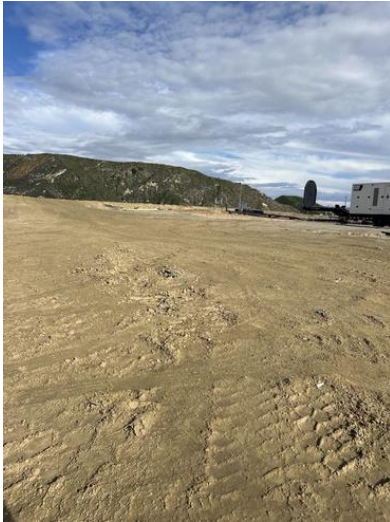
Grid 90

No

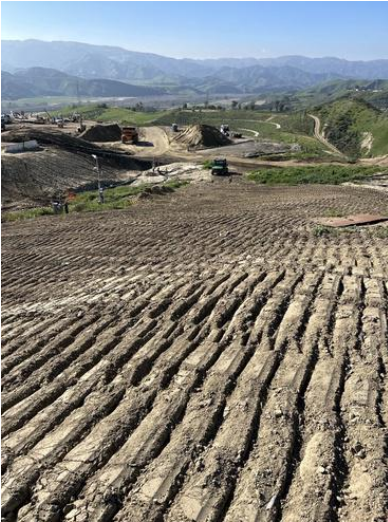
Grid 164

No

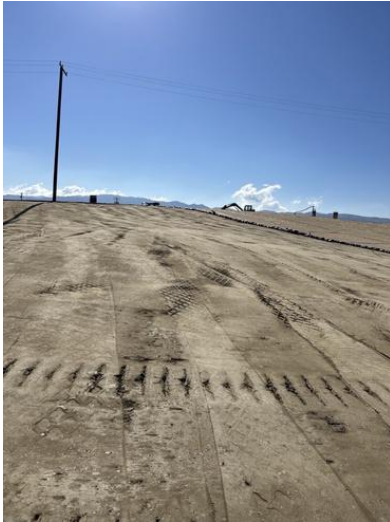
Grid 53

No
