**Re: Chiquita Canyon, LLC's Weekly Report on the Documentation and Tracking of Cover Issues, Monthly Summary and Monthly Isopach Map**

# 4050 - Chiquita Reaction Area Tracking of Fissures and Tension Cracks

**JANUARY 2026 FISSURE AND TENSION CRACK MONITORING SUMMARY  
CHIQUITA CANYON LANDFILL  
CASTAIC, CALIFORNIA**

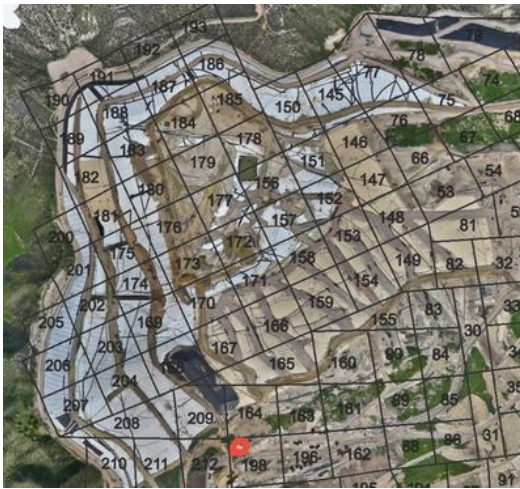
198

Yes

**Length of crack (ft) or area containing multiple cracks (ft x ft)** 4ft

**Date and time of repairs** 5 Feb 2026 11:34 AM PST

**Description of repairs** Cracks were track walked.

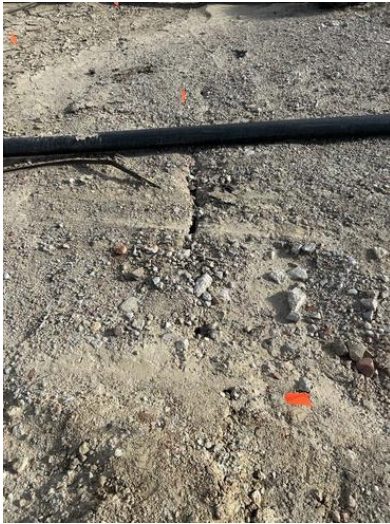
83

Multiple cracks in a 11ft x 16ft area

Cracks were track walked.
