Re: Chiquita Canyon, LLC's Weekly Report on the Documentation and Tracking of Cover Issues, Monthly Summary and Monthly Isopach Map

4050 - Chiquita Reaction Area Tracking of Fissures and Tension Cracks

**APRIL 2026 FISSURE AND TENSION CRACK MONITORING SUMMARY
CHIQUITA CANYON LANDFILL
CASTAIC, CALIFORNIA**

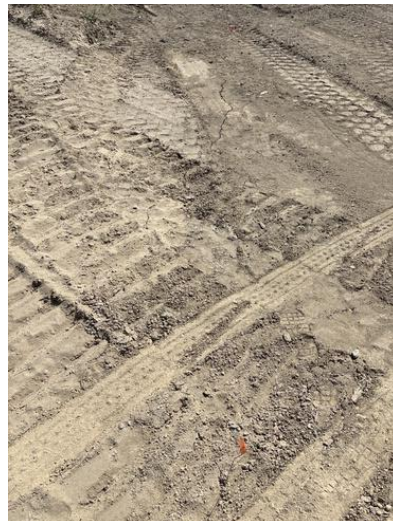
Photo 2

Length of crack (ft) or area containing multiple cracks (ft x ft) 35ft x 15ft

Description of repairs Cracks were track walked.

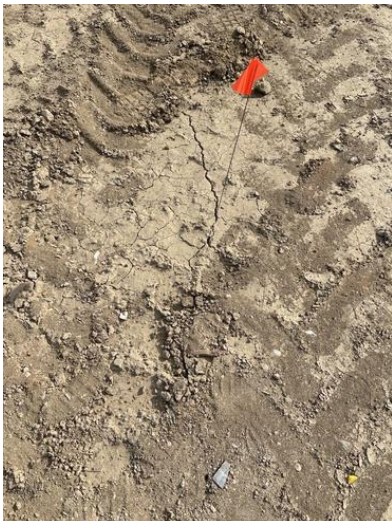
Photo 1

No individual crack 50ft or longer.

Cracks were track walked.

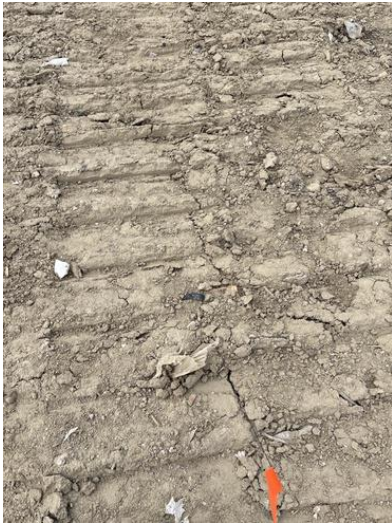
Photo 7

No individual crack 50ft or longer.

Horizontal Offset (width)	Small 0.5-2" in width
Vertical Offset (height)	Extra small <0.5" in height
Orientation (direction)	NE to SW
Location	Castaic CA 91384 United States (34.43232910860781, -118.64881009154321)
Was Fissure or Crack fixed? If yes, add photo and description of repairs performed	Yes

Photo 12	
Date and time of repairs	5 May 2026 10:32 AM PDT
Description of repairs	Other (please describe)
Soil was added and track walked.	
Instability	
Are there any indications of slope stability concerns?	No

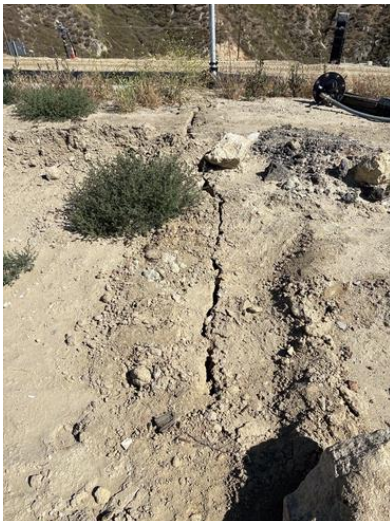
Photo 1

Length of crack (ft) or area containing multiple cracks (ft x ft) 20ft x 15ft

Description of repairs Cracks were track walked.

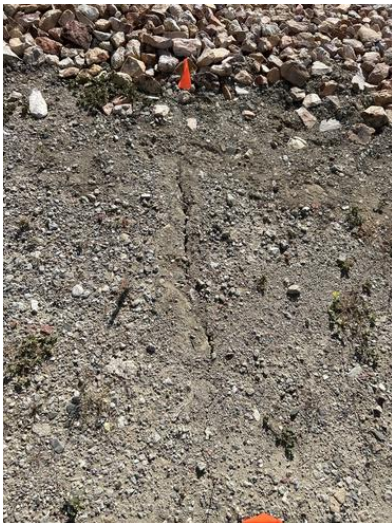
Photo 1

Length of crack (ft) or area containing multiple cracks (ft x ft) 17ft

Description of repairs Cracks were track walked.

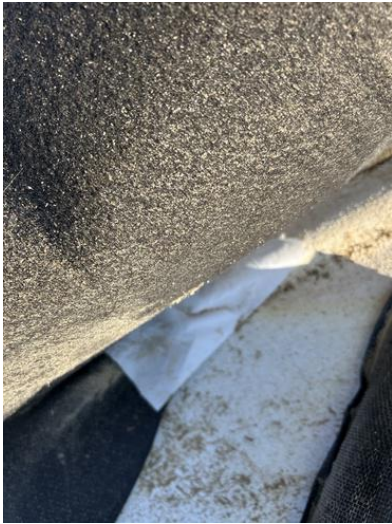
Photo 2

181

Small tear in liner, needs to be patched and extrusion welded

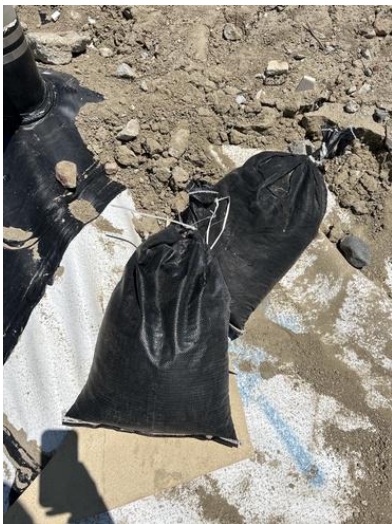
Photo 4

204

Liner torn, needs to be patched and extrusion welded

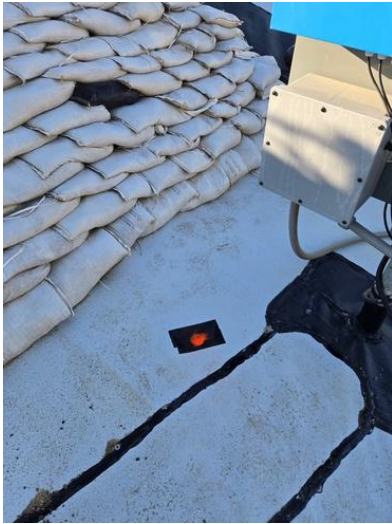
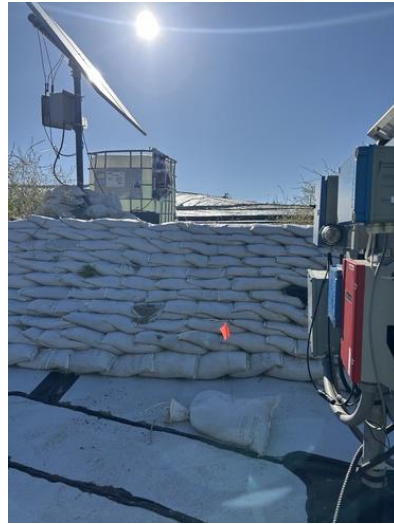
206

Liner torn, needs to be patched and extrusion welded

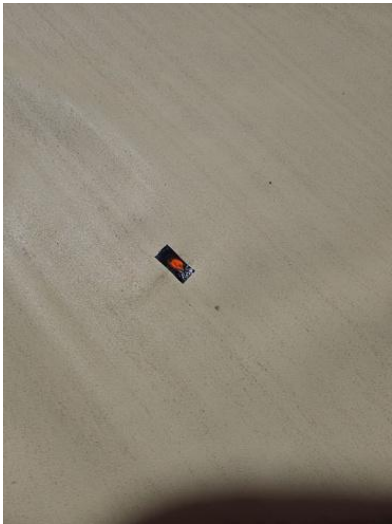
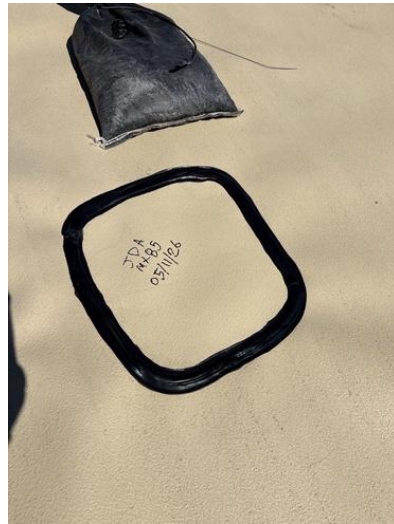
184

Liner torn, needs to be patched and extrusion welded
