CHIQUITA CANYON
A Waste Connections Company

Re: Chiquita Canyon, LLC's Weekly Report on the Documentation and Tracking of Cover Issues, Monthly Summary, and Monthly Isopach Map

4050 - Chiquita Reaction Area Tracking of Fissures and Tension Cracks

MAY 2026 FISSURE AND TENSION CRACK MONITORING SUMMARY
CHIQUITA CANYON LANDFILL
CASTAIC, CALIFORNIA

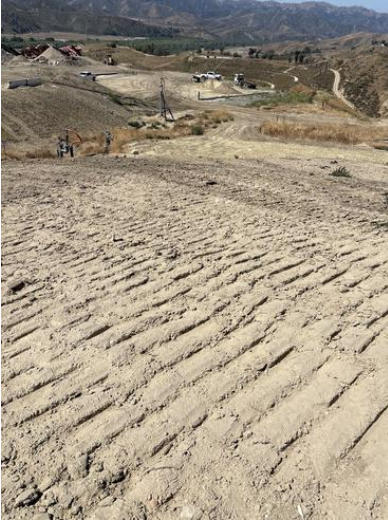
Grid 164

Fissure or Tension Crack Found?

No

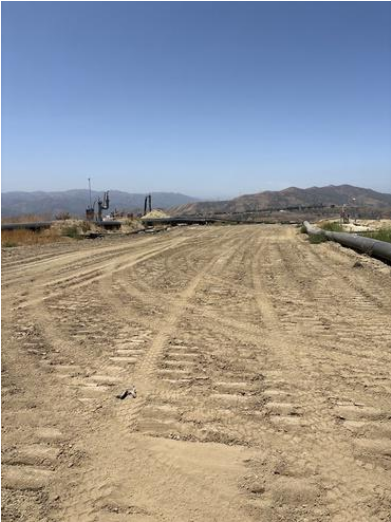
Grid 163

Fissure or Tension Crack Found?

No

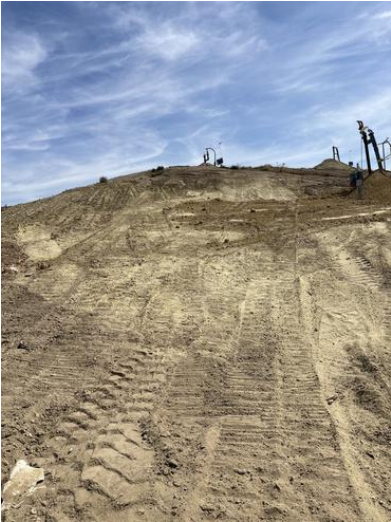
Grid 164

Fissure or Tension Crack Found?

No

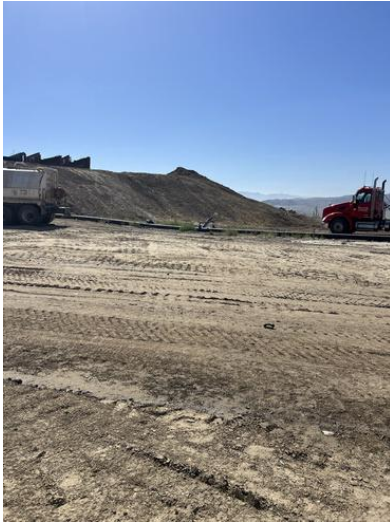
Grid 212

Fissure or Tension Crack Found?

No

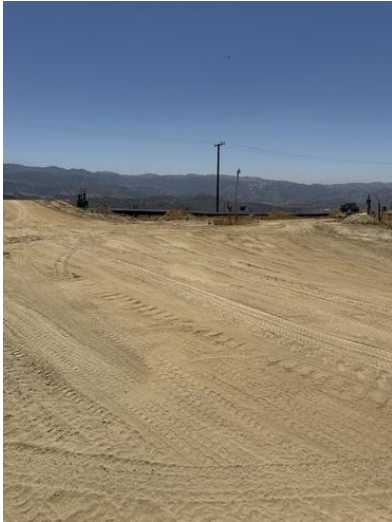
Grid 90

Fissure or Tension Crack Found?

No

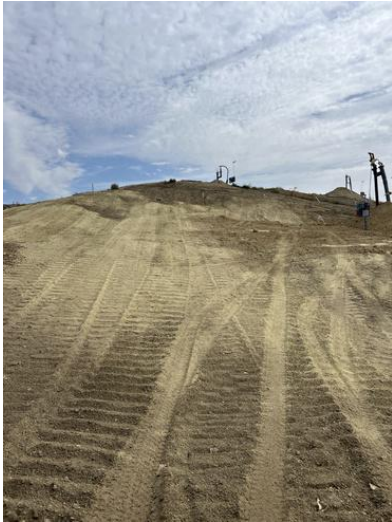
Grid 164

Fissure or Tension Crack Found?

No

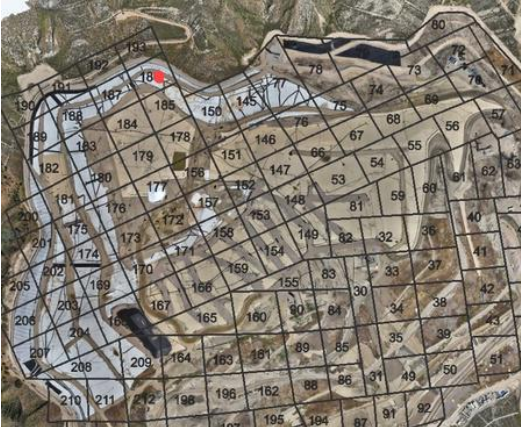
186

Tear in liner needs to be patched/extrusion welded.

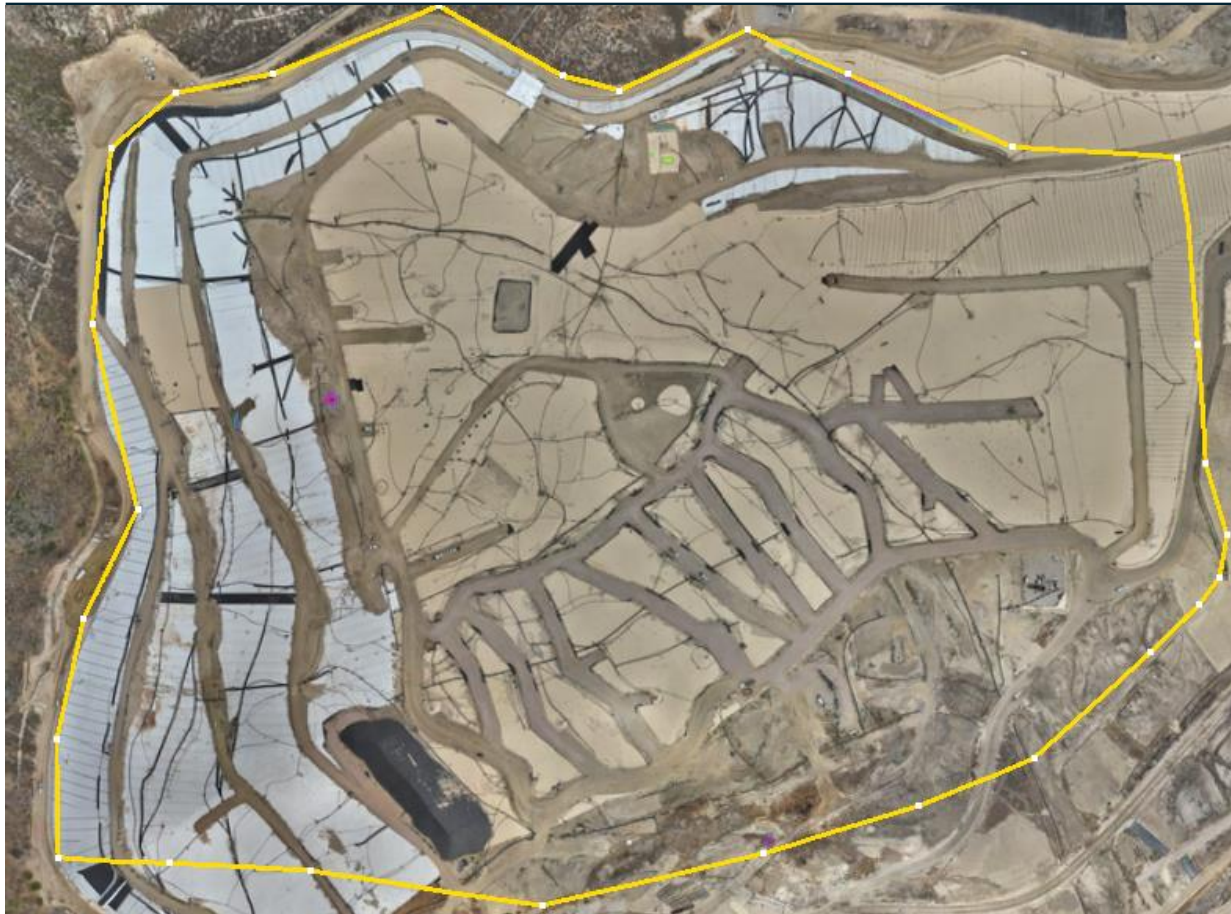
Chiquita Canyon Landfill -Isopach

May 27, 2026 Survey Image. May 6, 2026 vs May 27, 2026
