**CHIQUITA CANYON**  
*A Waste Connections Company*

**Re: Chiquita Canyon, LLC's Weekly Report on the Documentation and Tracking of Cover Issues**

Attachment: October 20, 2026 Weekly Cover Issues Report

# 4050 - Chiquita Reaction Area Tracking of Fissures and Tension Cracks

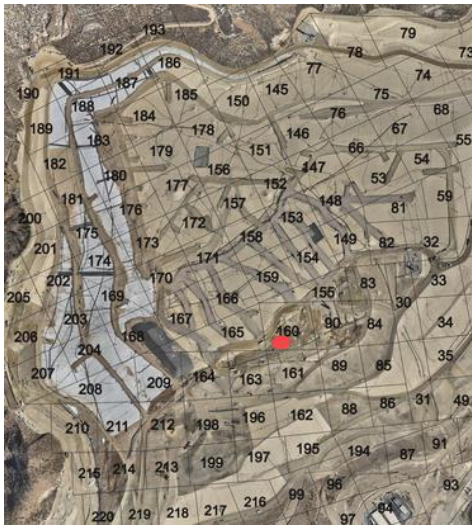
160

Using the attached image, annotate all areas where inspectors identified a fissure or tension crack.

No individual crack 50ft or longer

| Description of repairs | Cracks were track walked. |

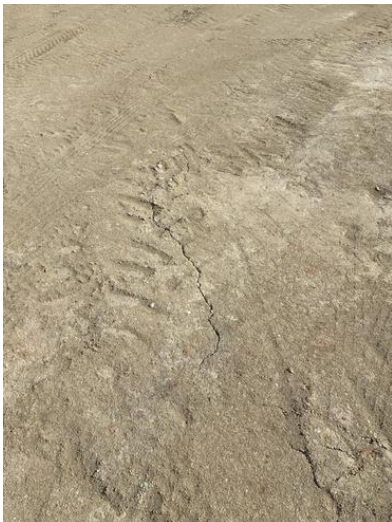
Photo 5

Image of Fissure/Tension Crack

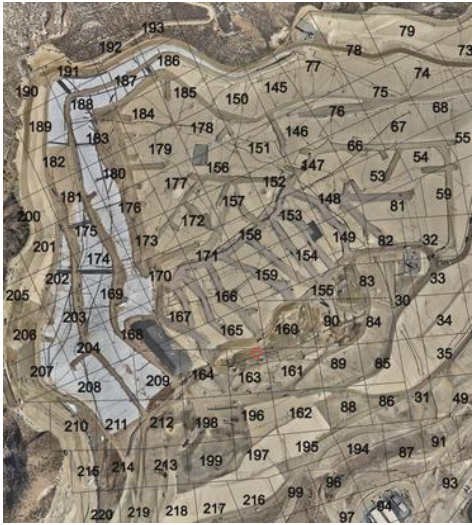
163

Using the attached image, annotate all areas where inspectors identified a fissure or tension crack.

Cracks were track walked.

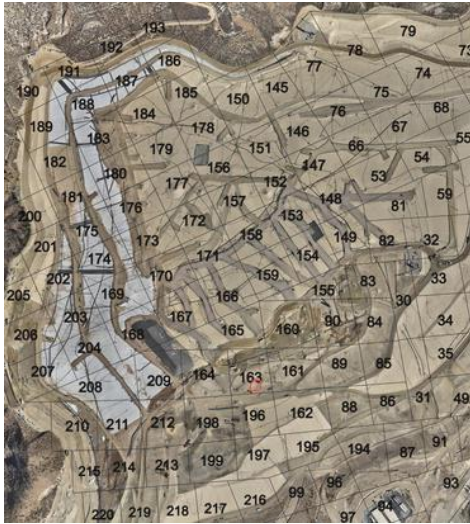
Using the attached image, annotate all areas where inspectors identified a fissure or tension crack.

| <b>Length of crack (ft) or area containing multiple cracks (ft x ft)</b> | 20ft |

| <b>Description of repairs</b> | Cracks were track walked. |

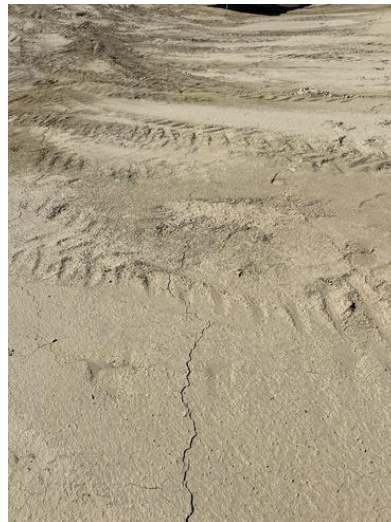
Photo 5

**Image of Fissure/Tension Crack**

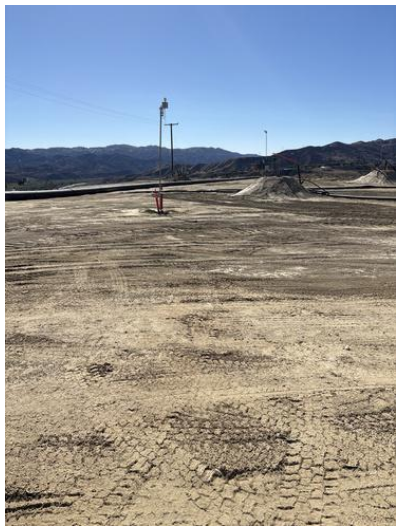
Photo 1

Fissure or Tension Crack Found?

Grid number of area in photo where there is no fissure or tension crack

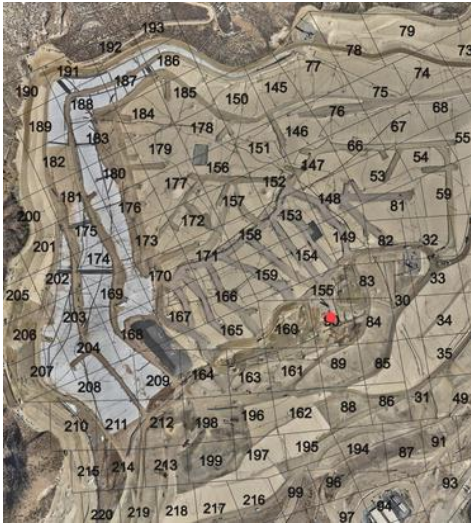
90

Using the attached image, annotate all areas where inspectors identified a fissure or tension crack.

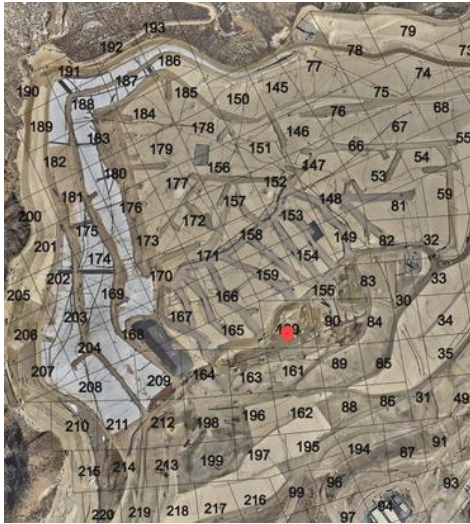
Using the attached image, annotate all areas where inspectors identified a fissure or tension crack.

| Length of crack (ft) or area containing multiple cracks (ft x ft) | 30ft x 25ft |

| Description of repairs | Cracks were track walked. |

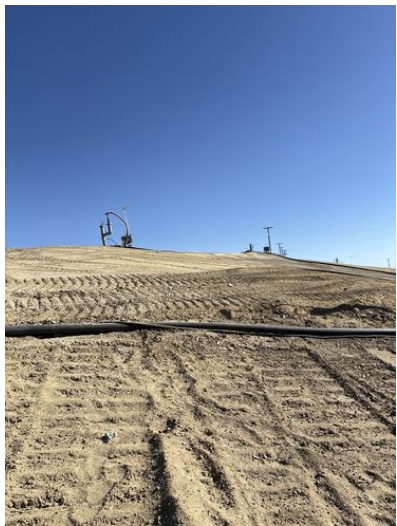
Photo 1

No

**Grid number of area in photo where there is no fissure or tension crack**

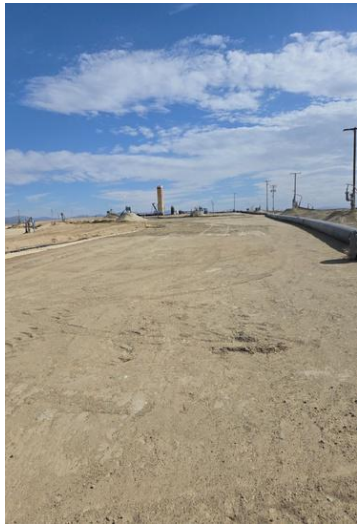
Photo 1

No

Grid number of area in photo where there is no fissure or tension crack
