***Phase I Environmental
Site Assessment Report***

**Selected Parcels along Upper Llagas Creek
Reaches 4, 5, 6 and 7B
Morgan Hill, California
Volume No. 1**

December 2003

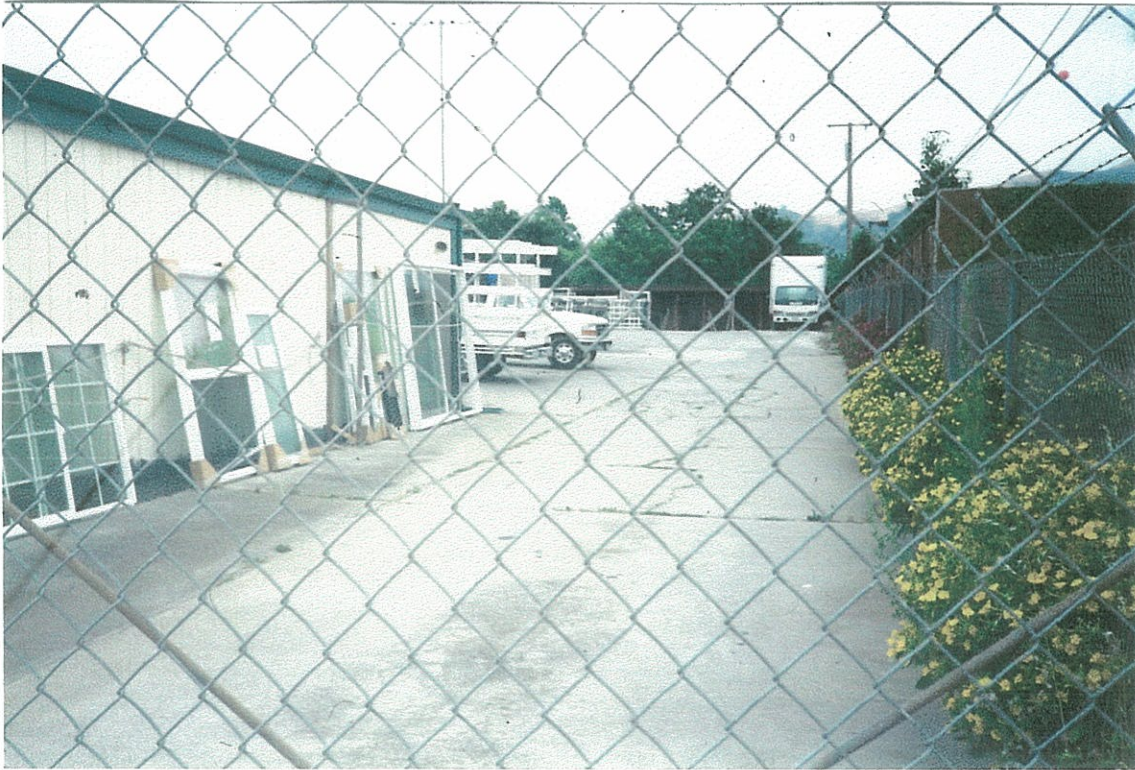
Photo #1: 16845 Monterey Street, Morgan Hill (APN 767-10-001, Reach 7B), view towards creek.

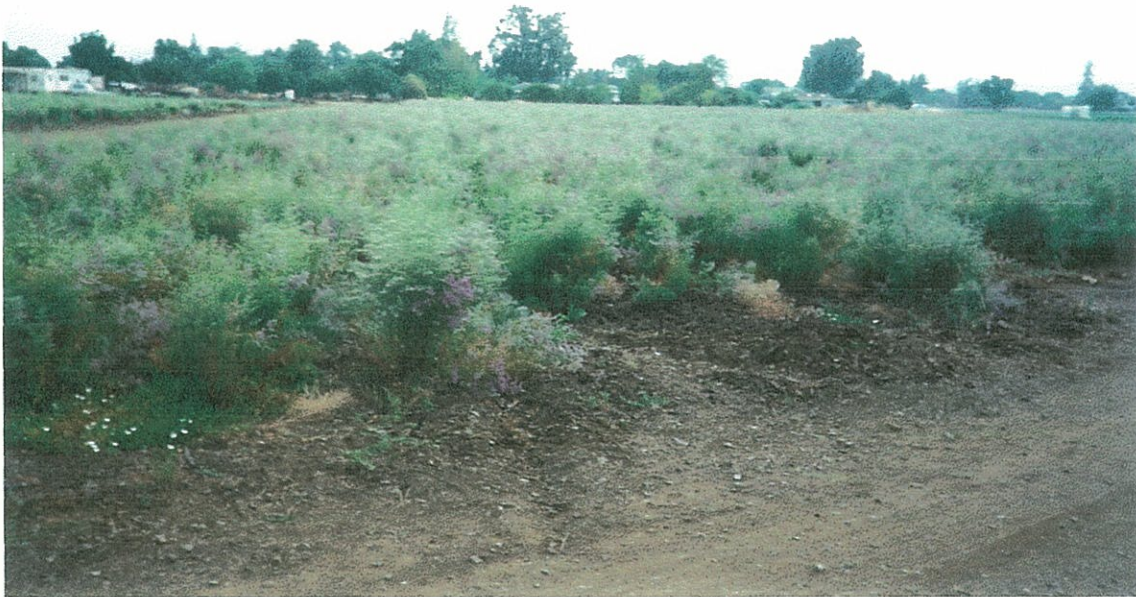
Photo #2: 14425 Monterey (APN 779-05-011, Reach 6), view from near creek looking northeast.

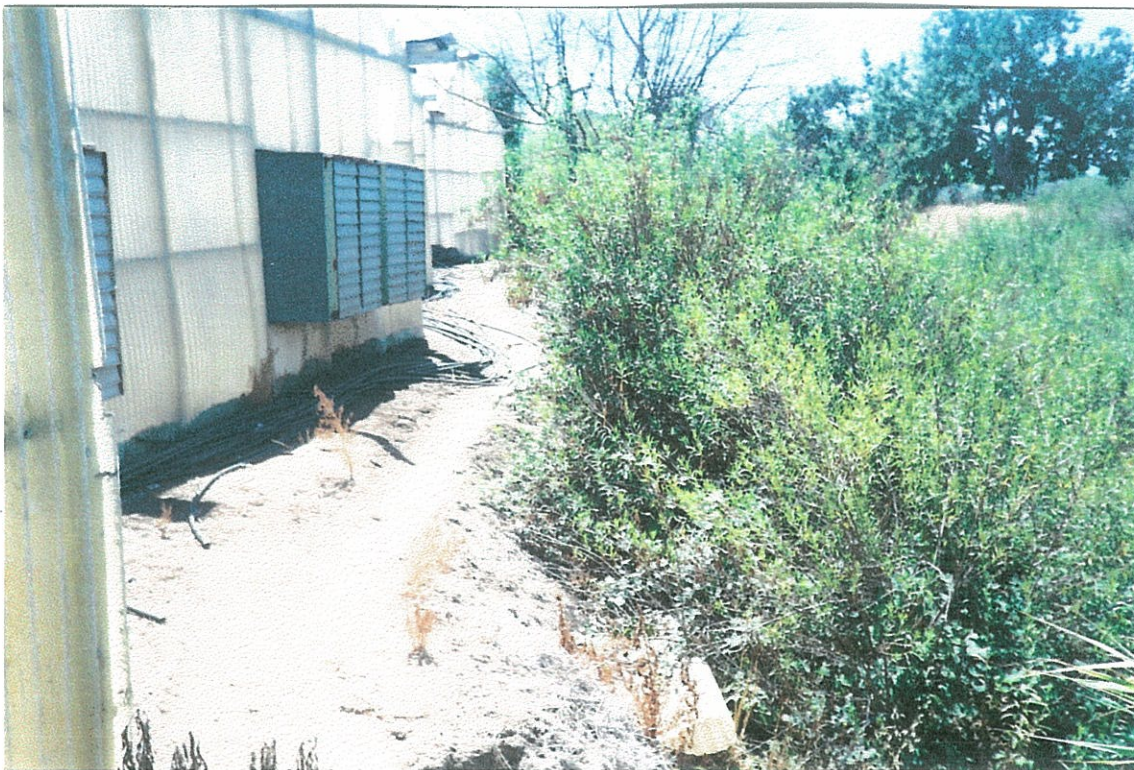
Photo #4: 13792 Llagas Ave. (APN 825-09-007), view southeast from creek bank.

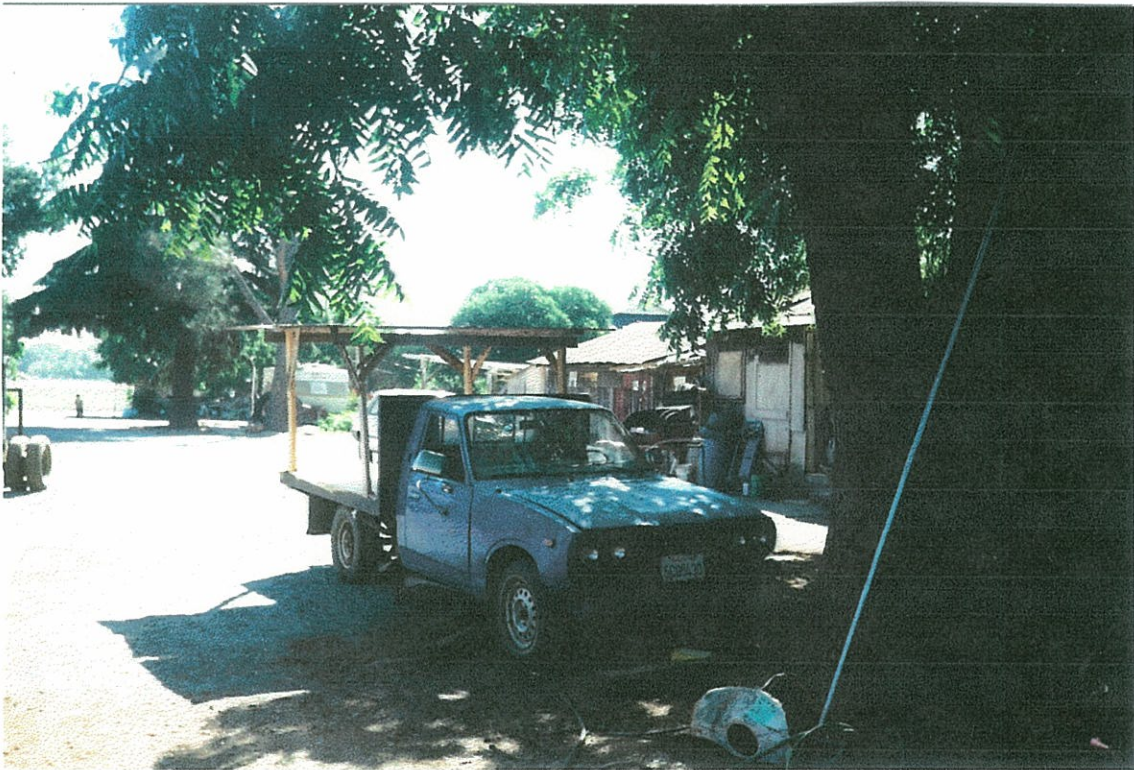
Photo #5: 13795 Murphy Avenue (APN 825-09-008), view towards creek.

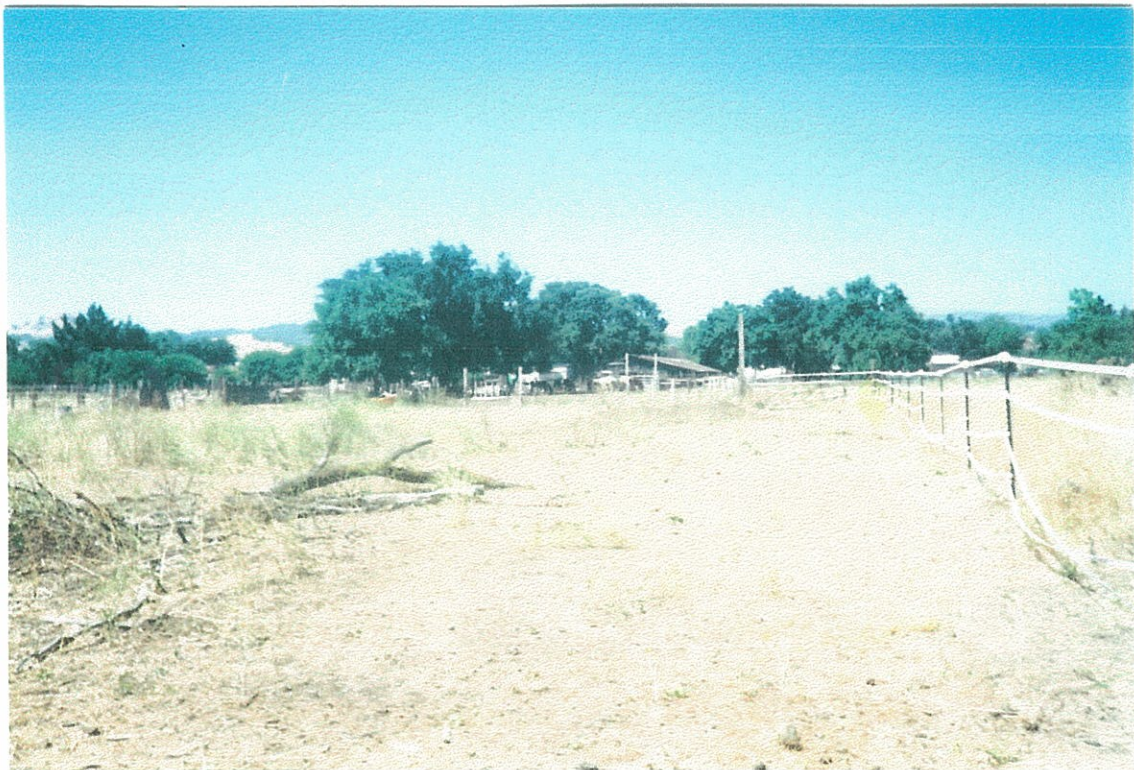
Photo #6: 13660 Llagas Ave. (APN 825-09-026), view to west from near creek.

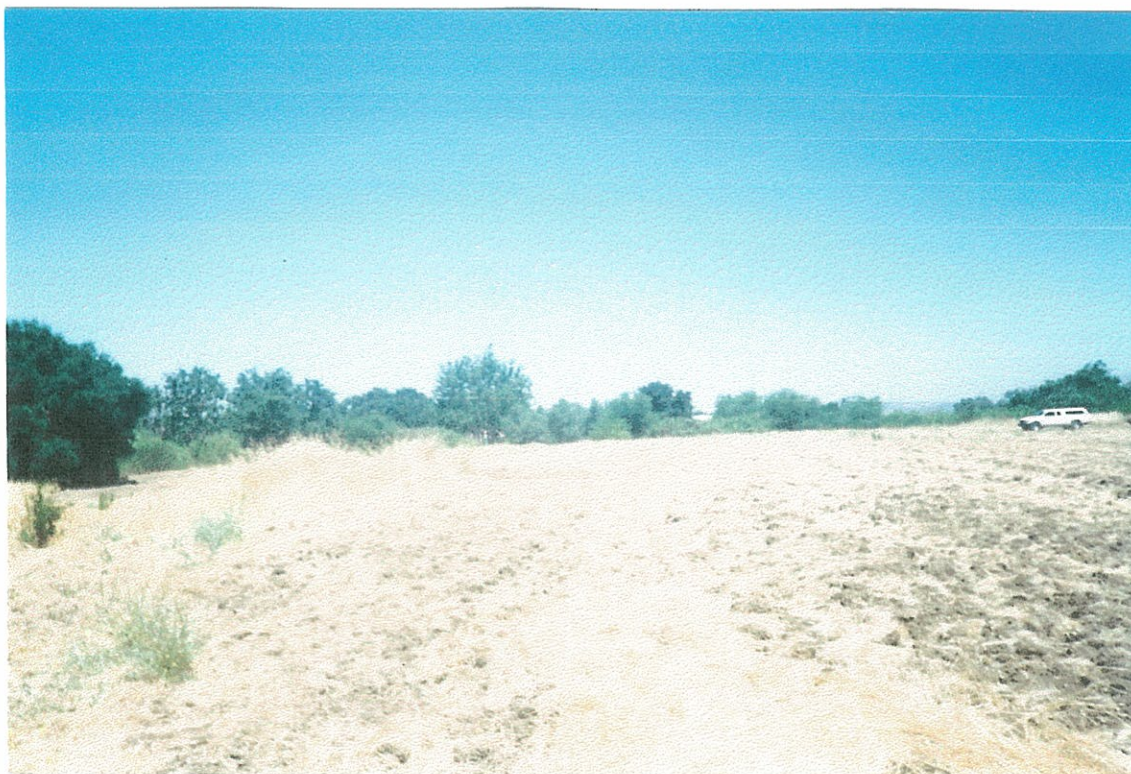
Photo #7: Llagas Avenue, APN 825-09-019, view to north, Llagas Creek to left.

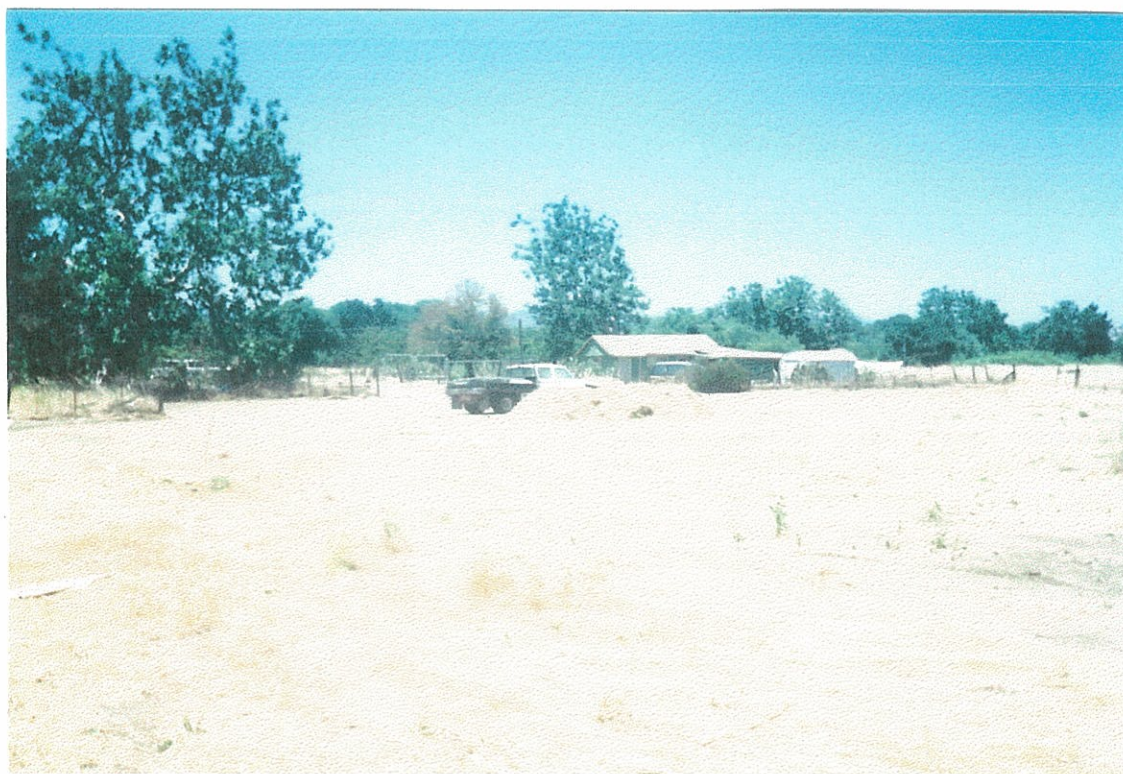
Photo #8: 13990 E. Kimble Court (APN 825-09-038), view to north, Llagas Creek to left.

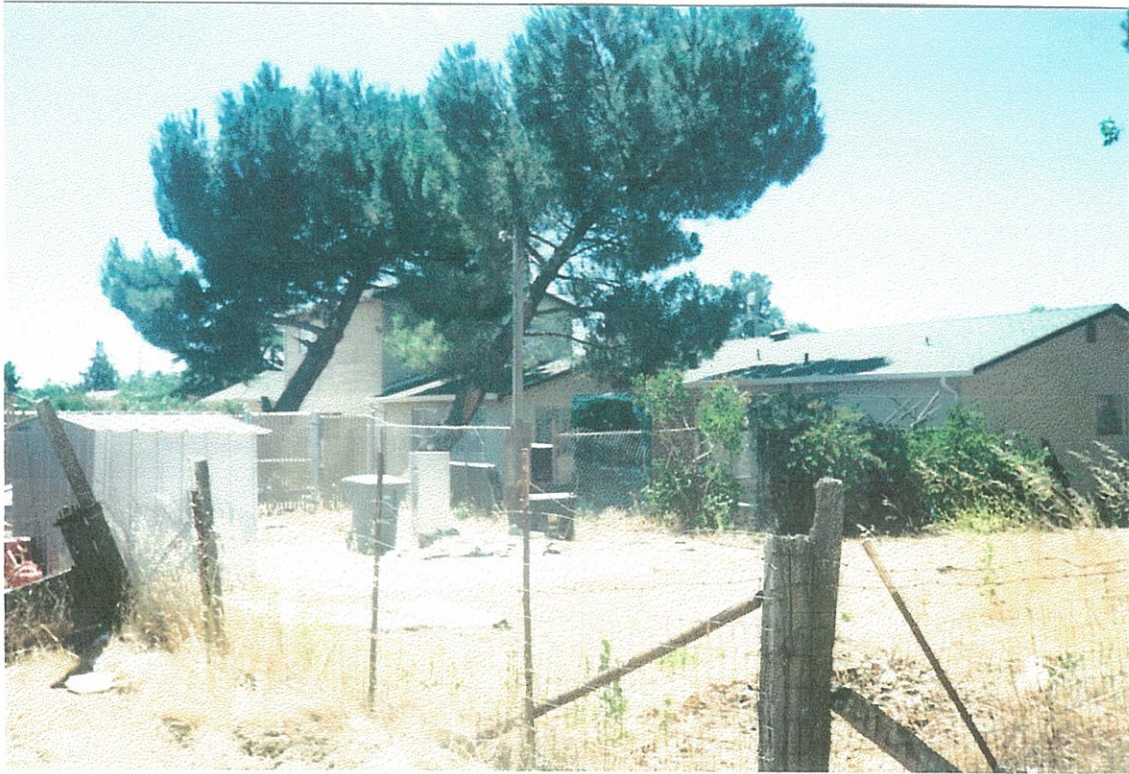
Photo #9: 13370 E. Kimble Court (APN 825-09-039), view south showing residence.

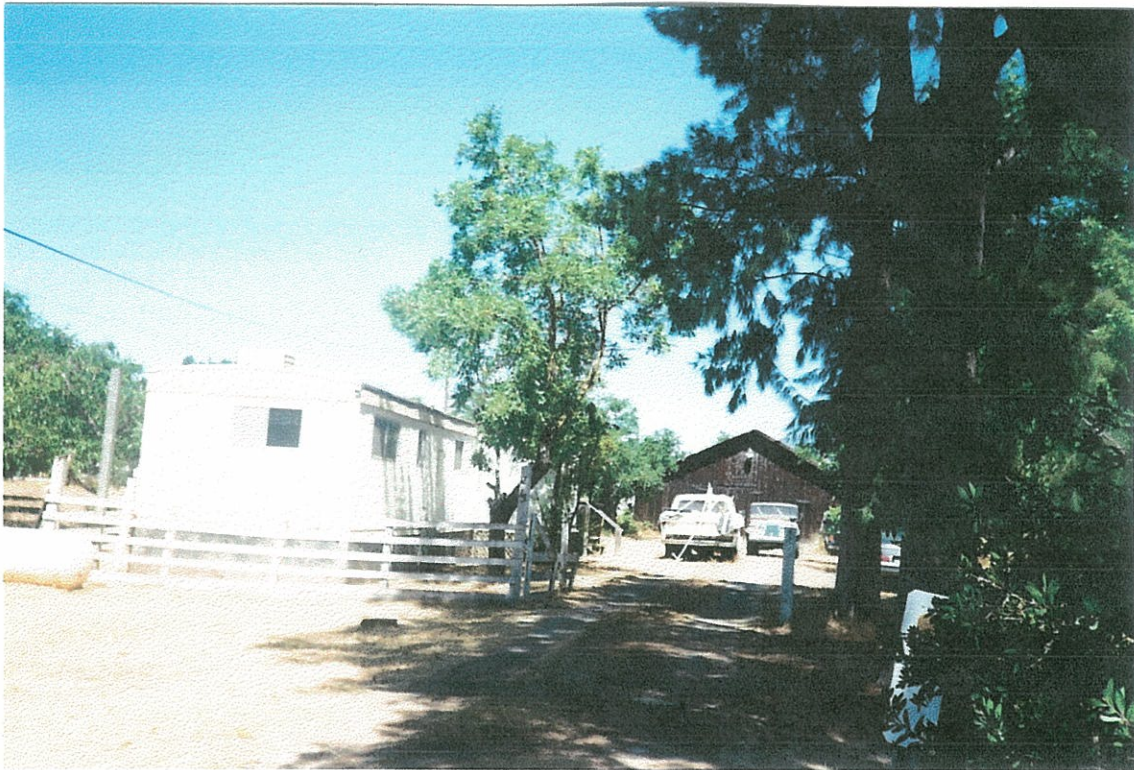
Photo #10: 275 E. San Martin Ave. (APN 825-09-016), view north showing trailer and barn.

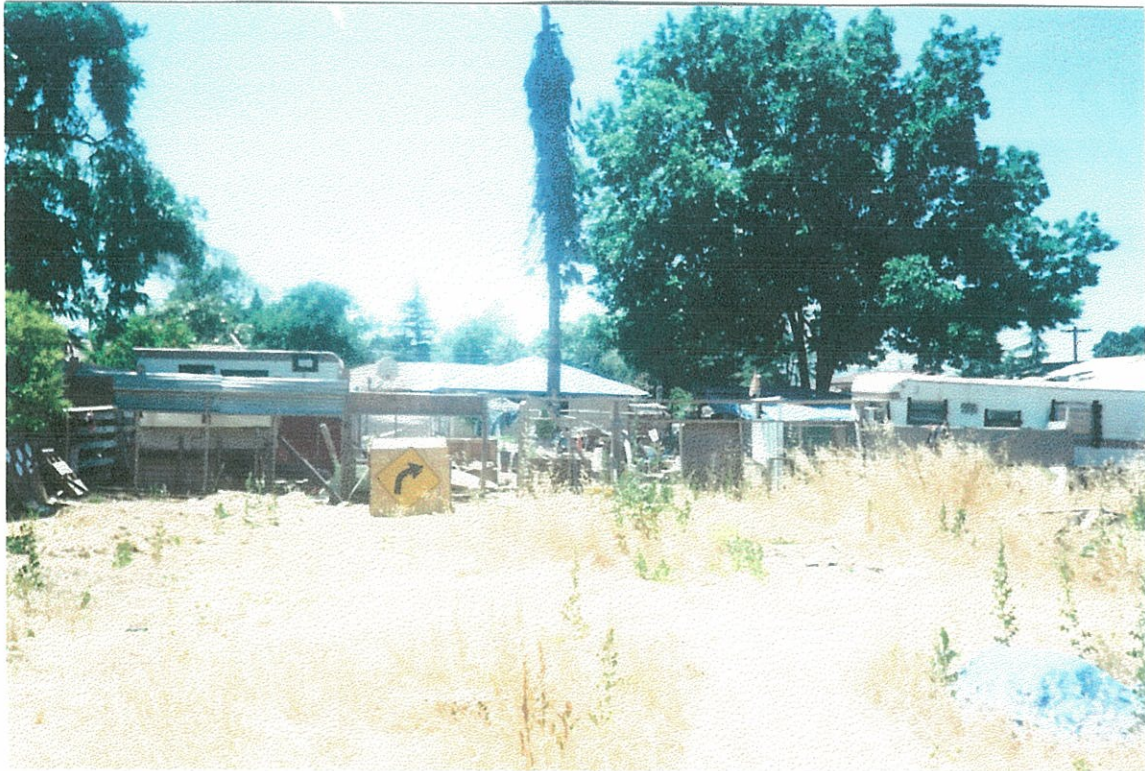
Photo #11: 13150 Llagas Avenue (APN 825-37-023), view west towards street.

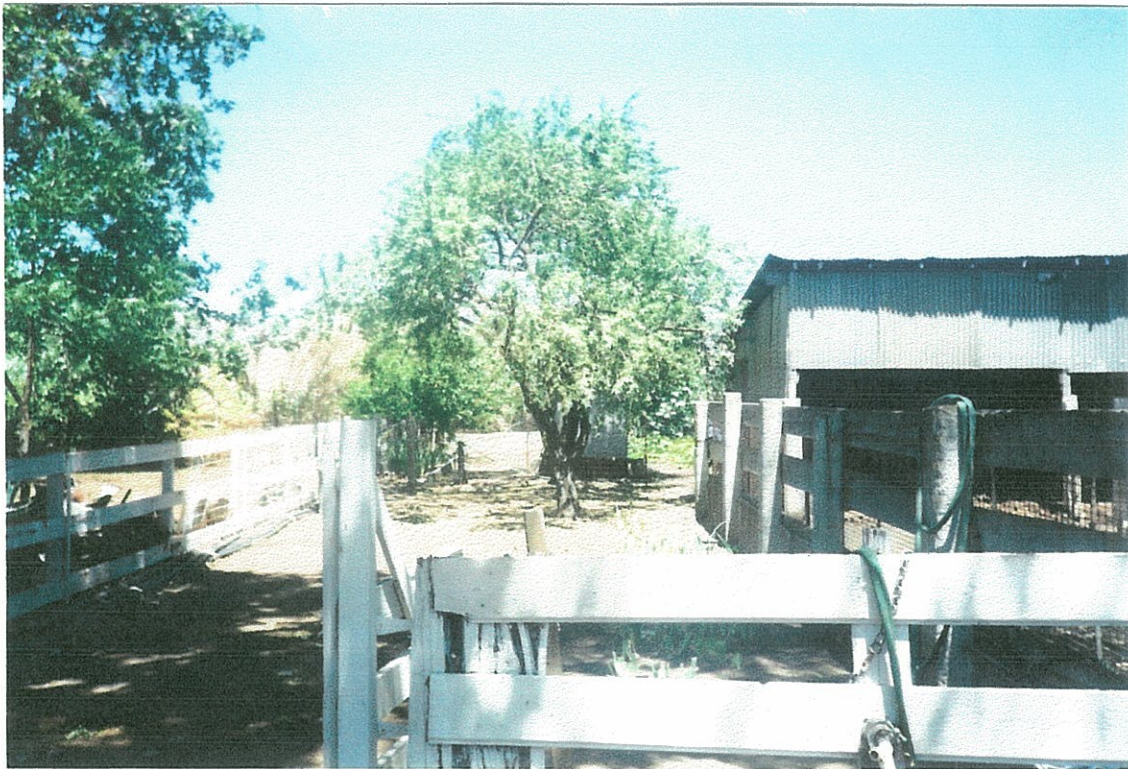
Photo #12: 13120 Llagas Avenue (APN 825-37-020), view towards creek (east).

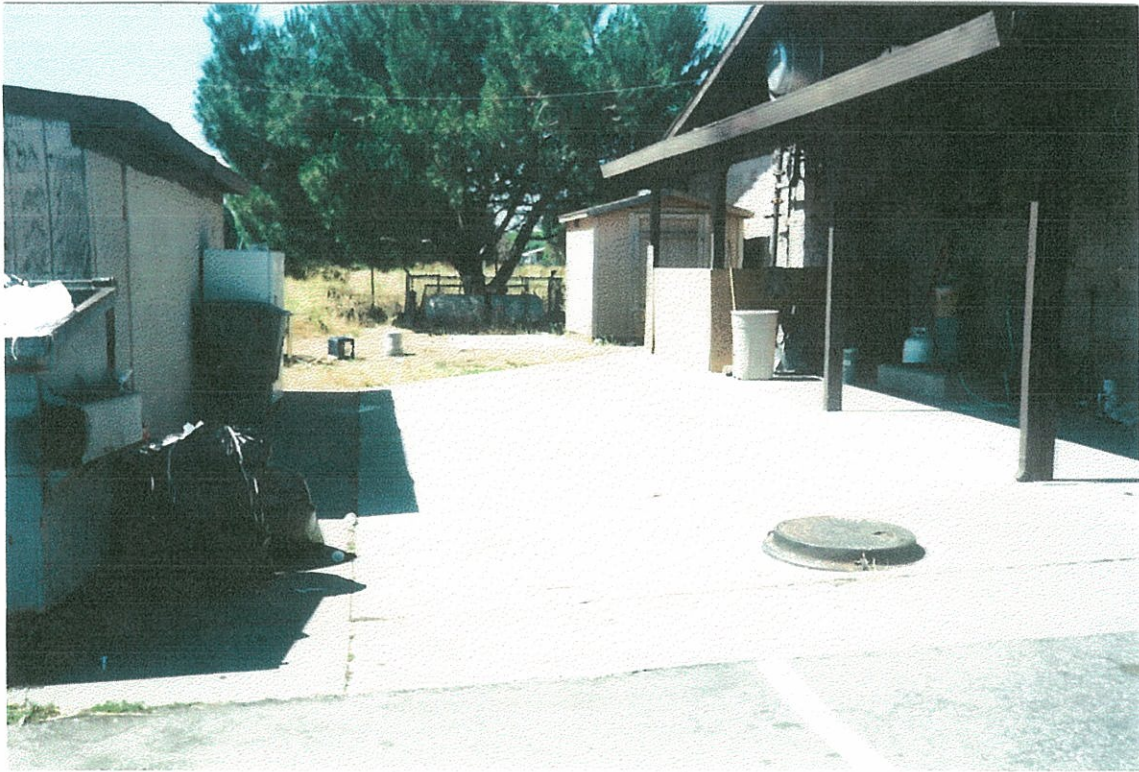
Photo #15: 12415 Murphy Avenue (APN 825-11-017), San Martin Lion's Club, west side of assembly hall.

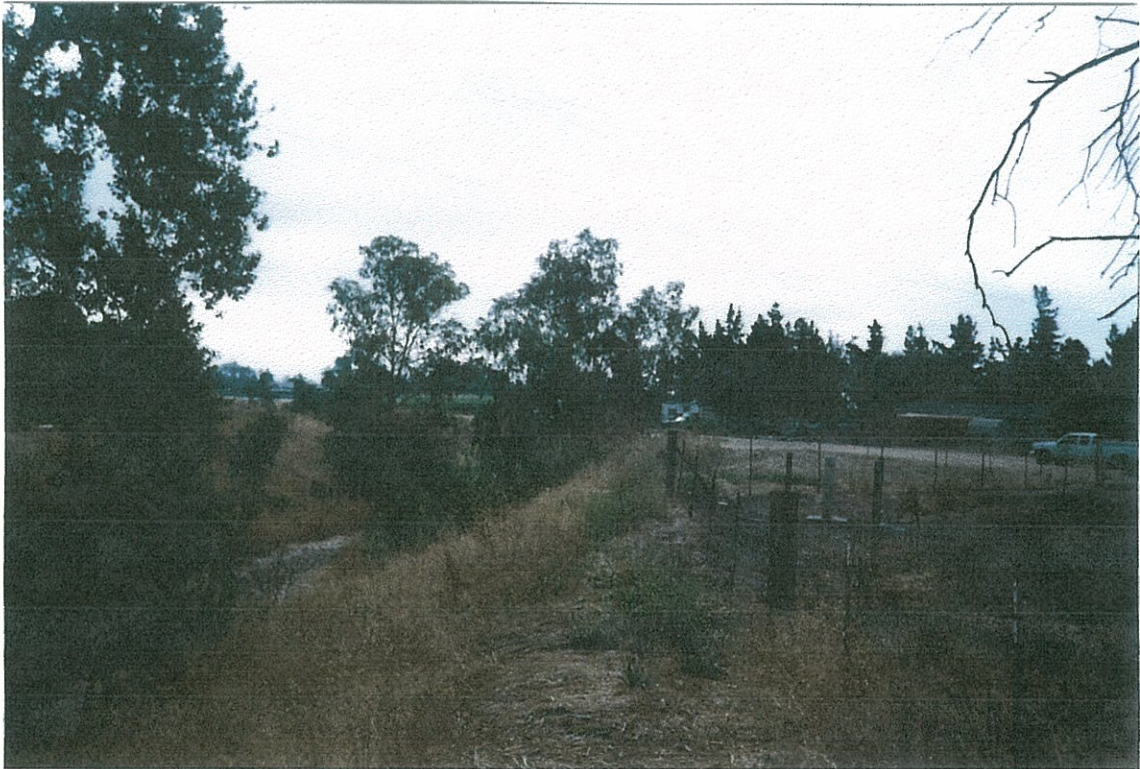
Photo #19: 415 Lena Ave. (APN 830-06-026), view east showing portion of parcel near creek.

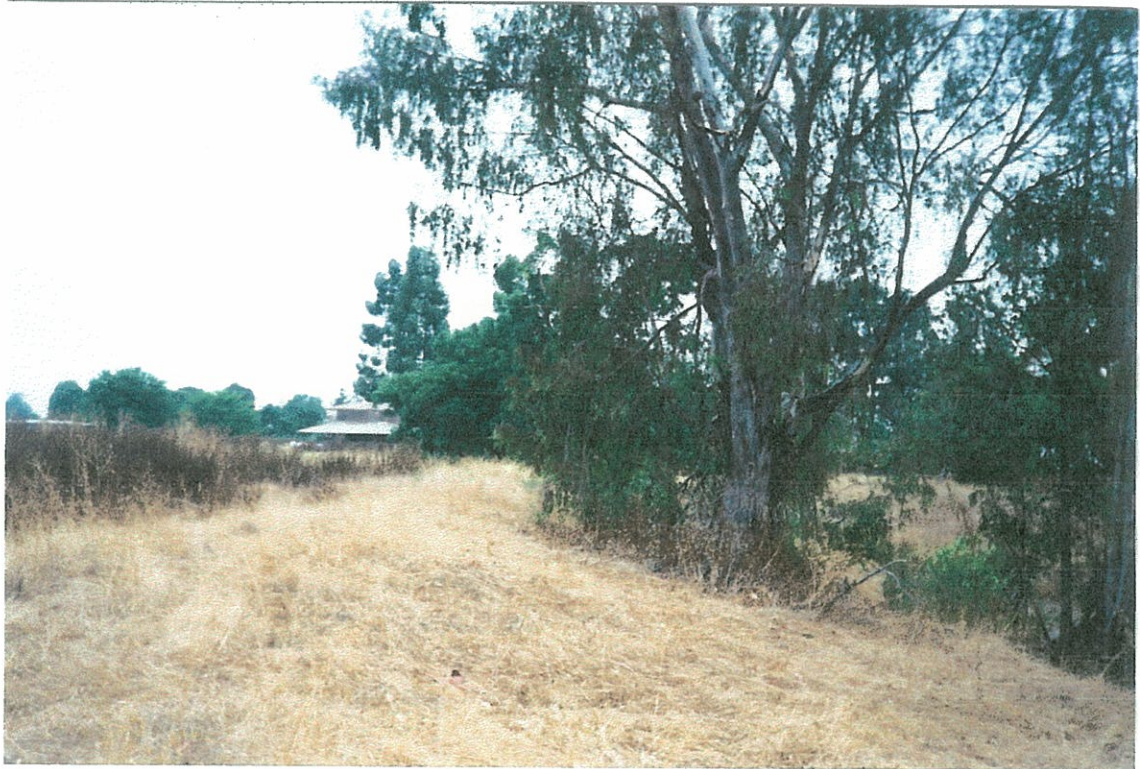
Photo #20: 905 Lena Avenue (APN 830-06-035), view north from western bank of Llagas Creek.

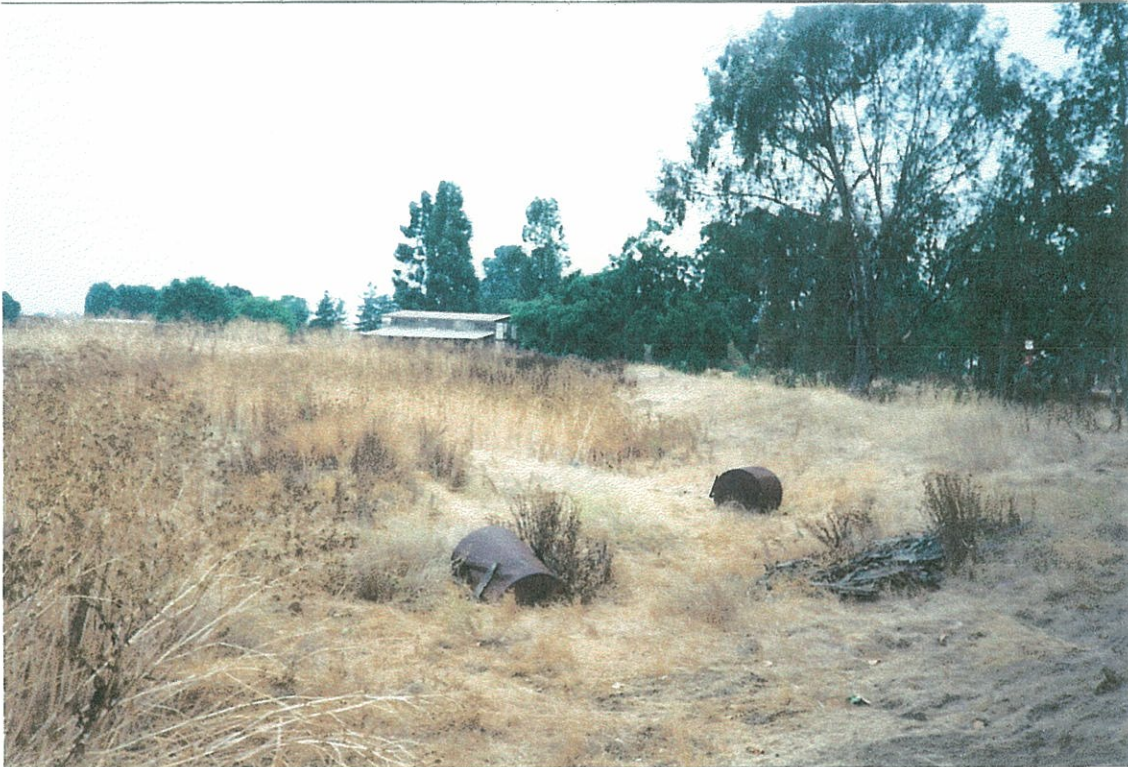
Photo #21: APN 830-06-034 (Lena Ave.), abandoned water tanks in foreground.

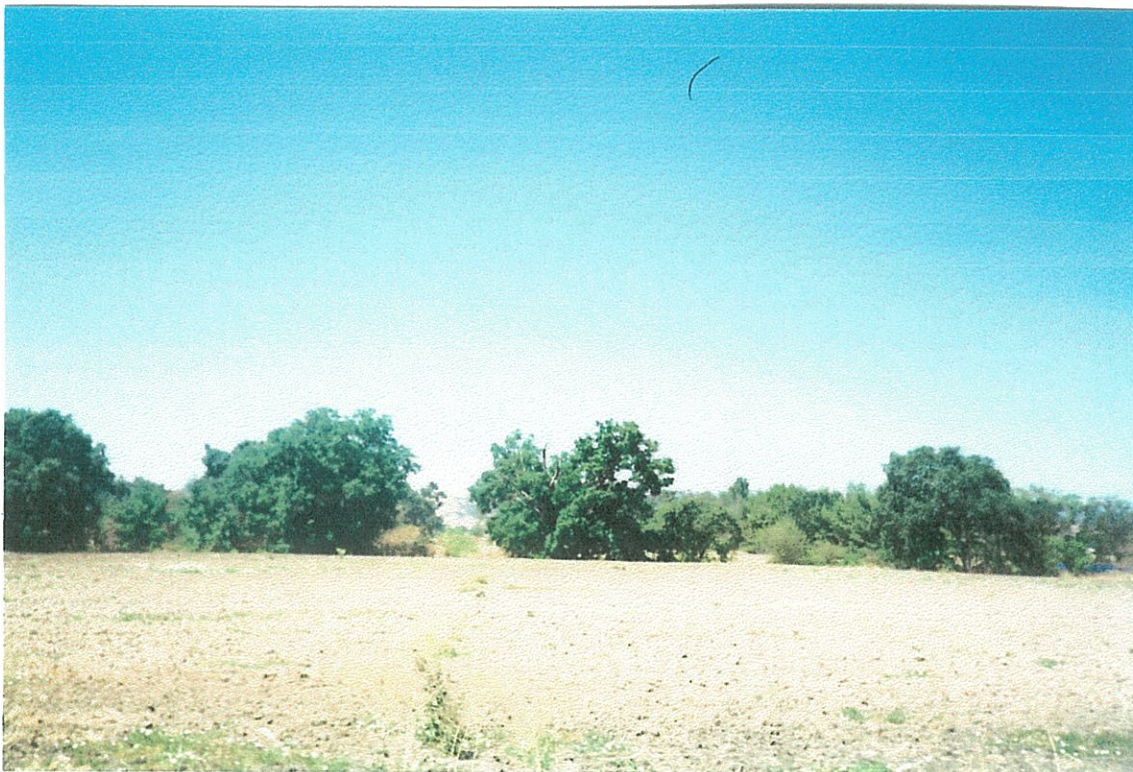
Photo #22: APN 830-06-022 (Columbet Ave.), view southwest towards Llagas Creek.

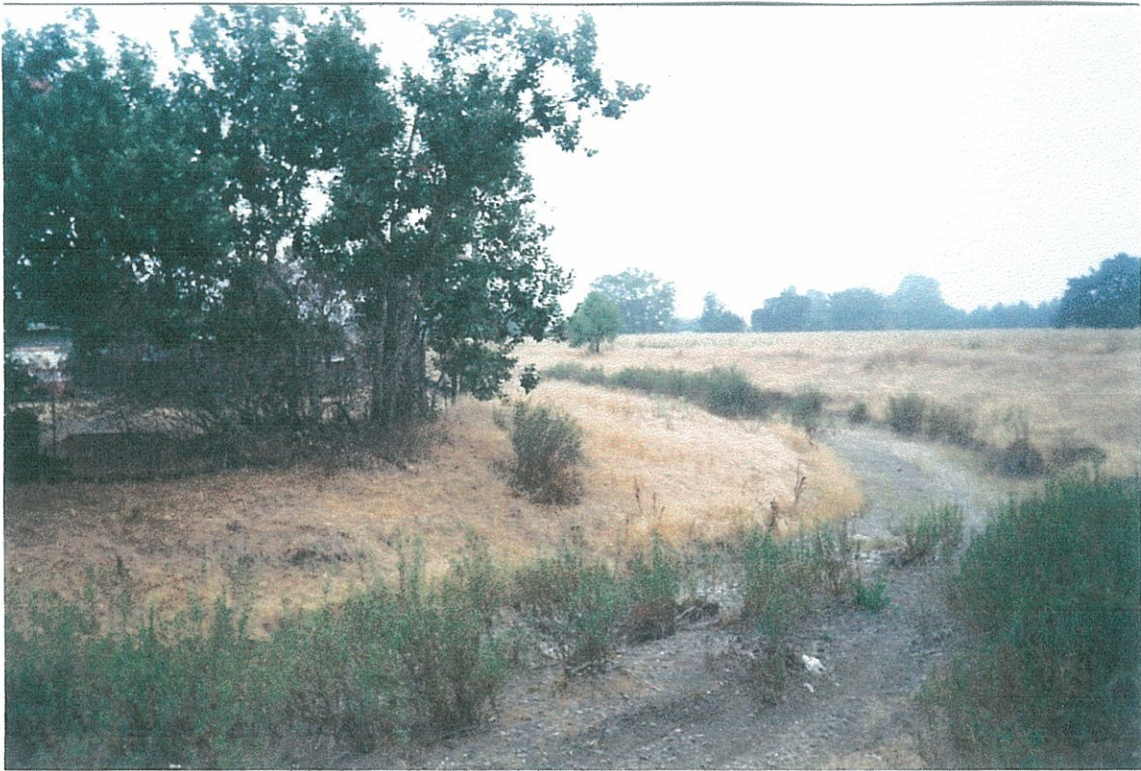
Photo #23: 1025 Masten Avenue (APN 830-06-006), view west along Llagas Creek, parcel to left.

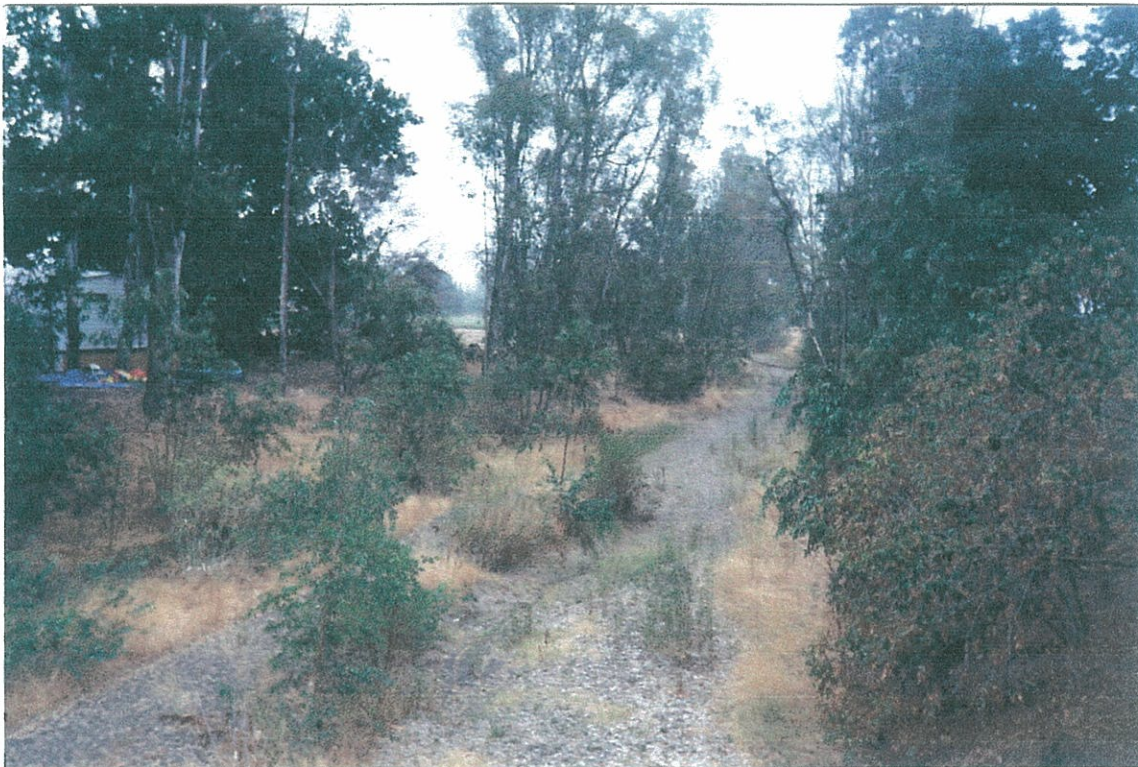
Photo #24: 1100 Masten Avenue (APN 830-19-003), view southeast along Llagas Creek, parcel on left.

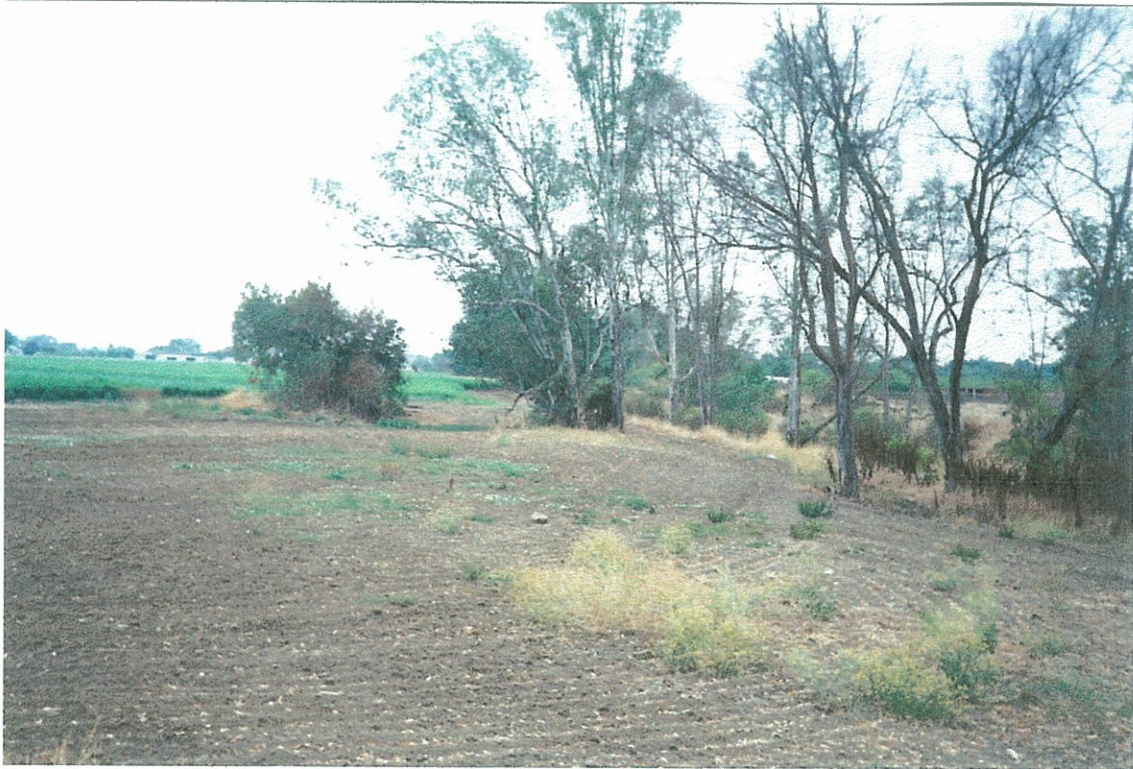
Photo #26: 1115 Rucker Avenue (APN 830-04-025), view northwest Llagas Creek.

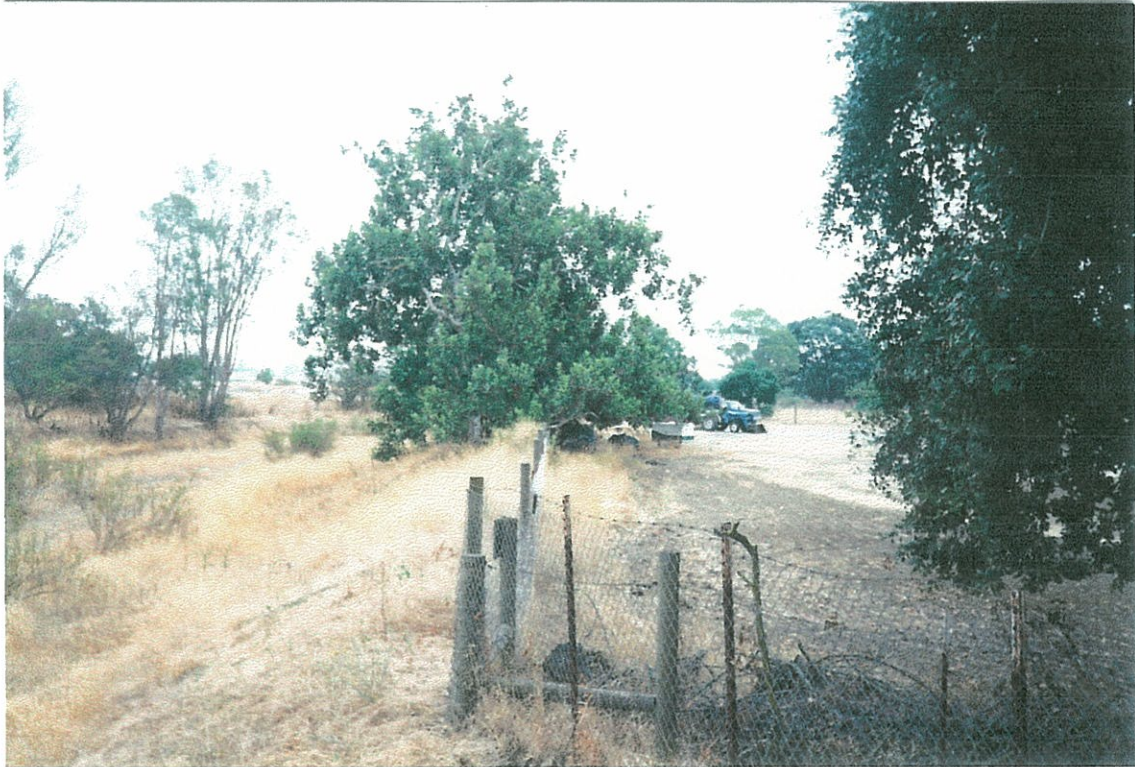
Photo #27: 1240 Rucker Ave. (APN 835-08-036), view southeast along creek, 1280 Rucker in background.

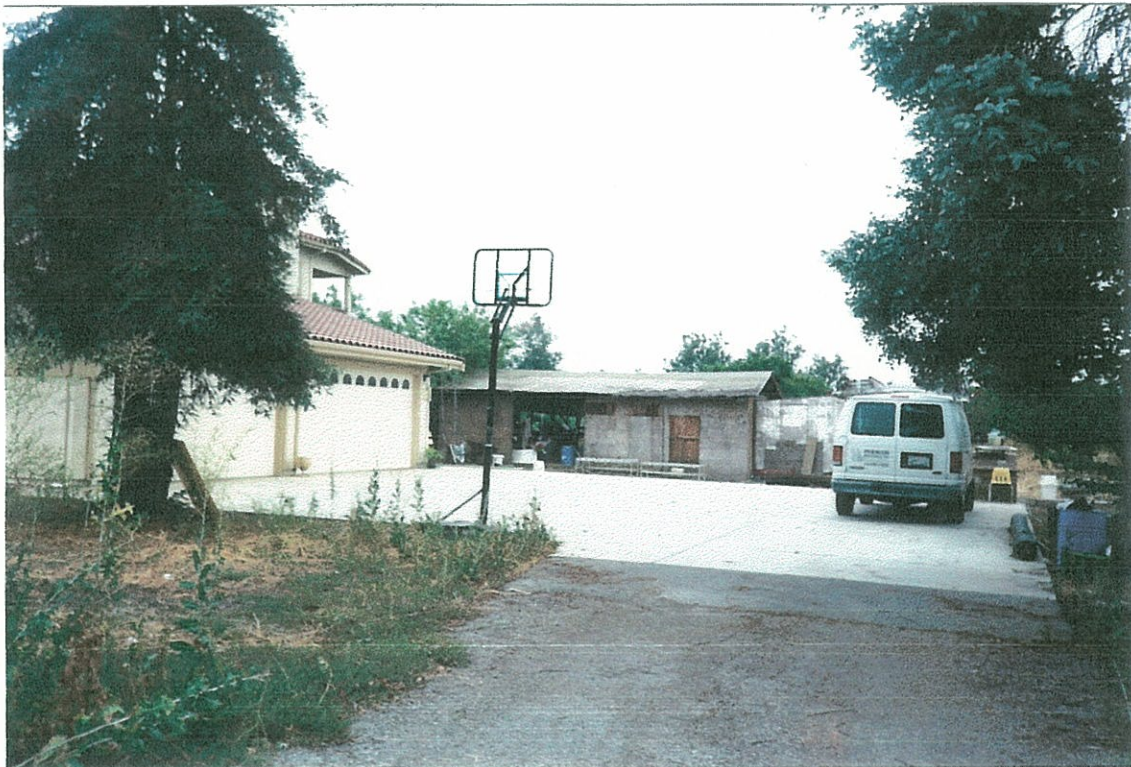
Photo #28: 10105 Center Avenue (APN 835-10-009), view west towards Llagas Creek.

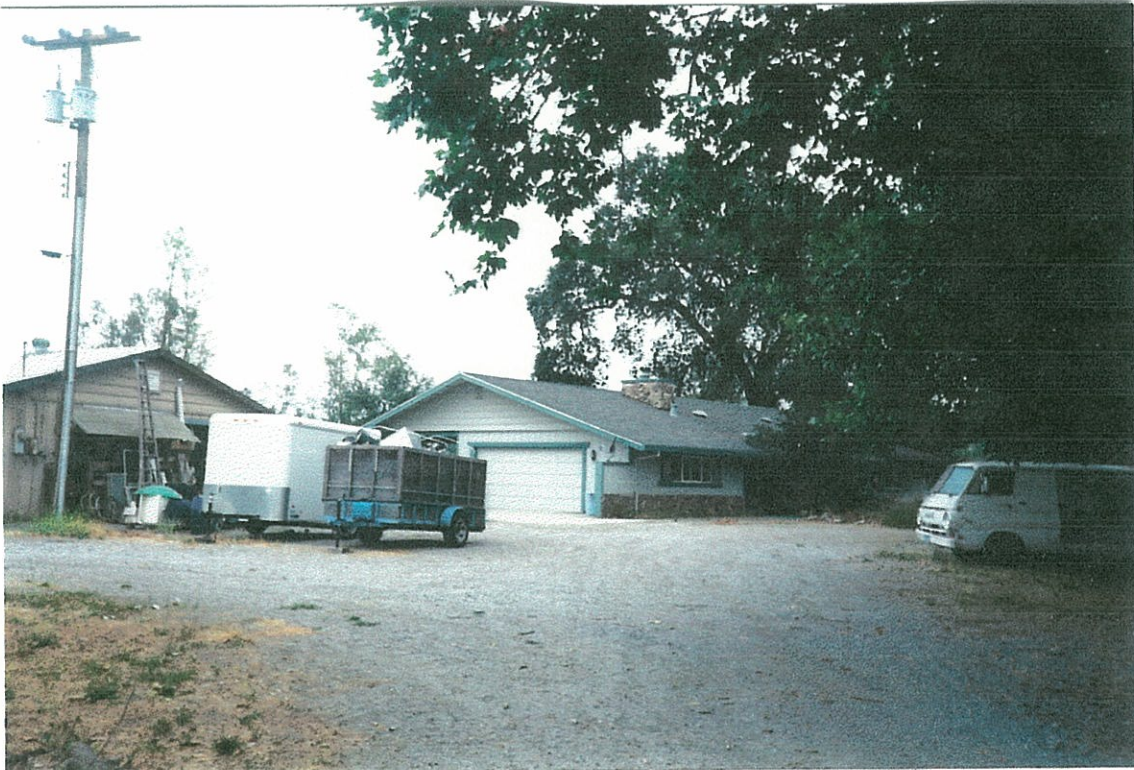
Photo #29: 10295 Center Avenue (APN 835-10-022), view west showing residence proximal to creek.

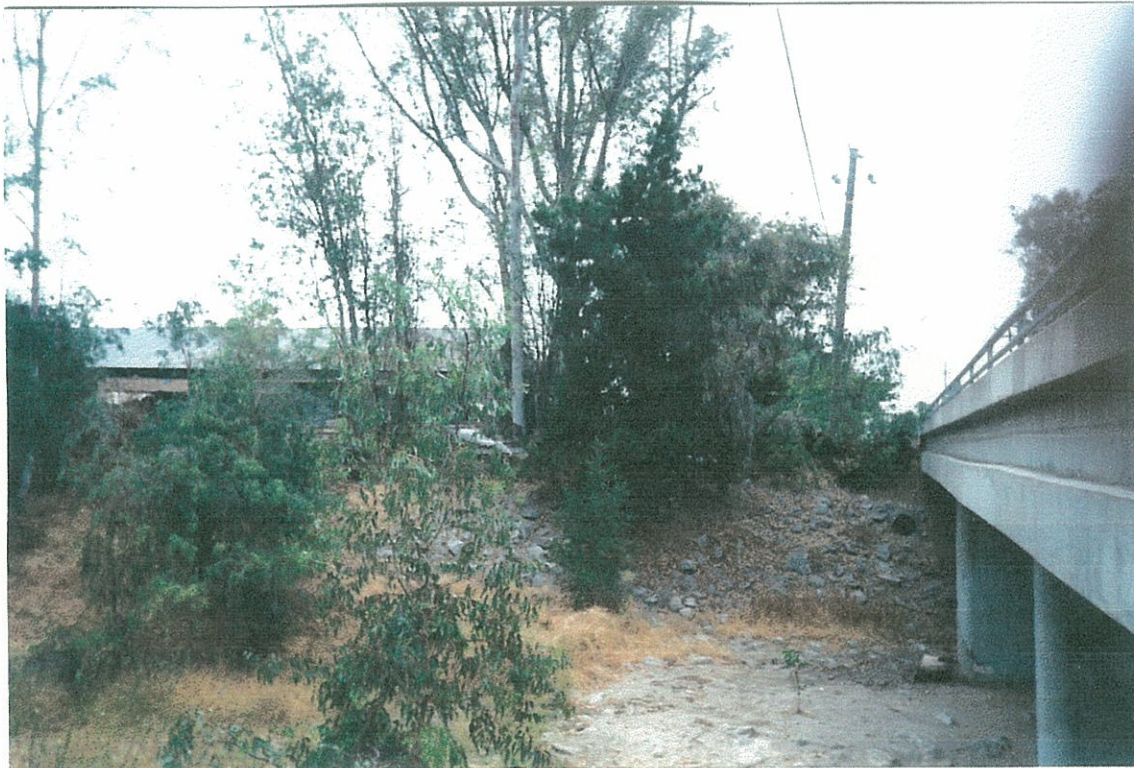
Photo #30: 1625 Buena Vista Ave. (APN 835-10-020), view east towards parcel from across Llagas Creek.
